**MONITORING OF HYDROLOGICAL, HYDRAULIC AND MORPHOLOGICAL CHARACTERISTICS OF THE DANUBE RIVER AND INVENTORY OF BIODIVERSITY COMPONENTS ON THE JOINT CROATIAN-SERBIAN SECTOR OF THE DANUBE RIVER**

**INVENTORY OF RIVER REGULATION INFRASTRUCTURE RELATED TO NAVIGATION**

**Project number:** I-2206/24

**LOCATION:** Danube river from rkm 1295,5 (Ilok) to rkm 1433,1  
(border with Hungary)

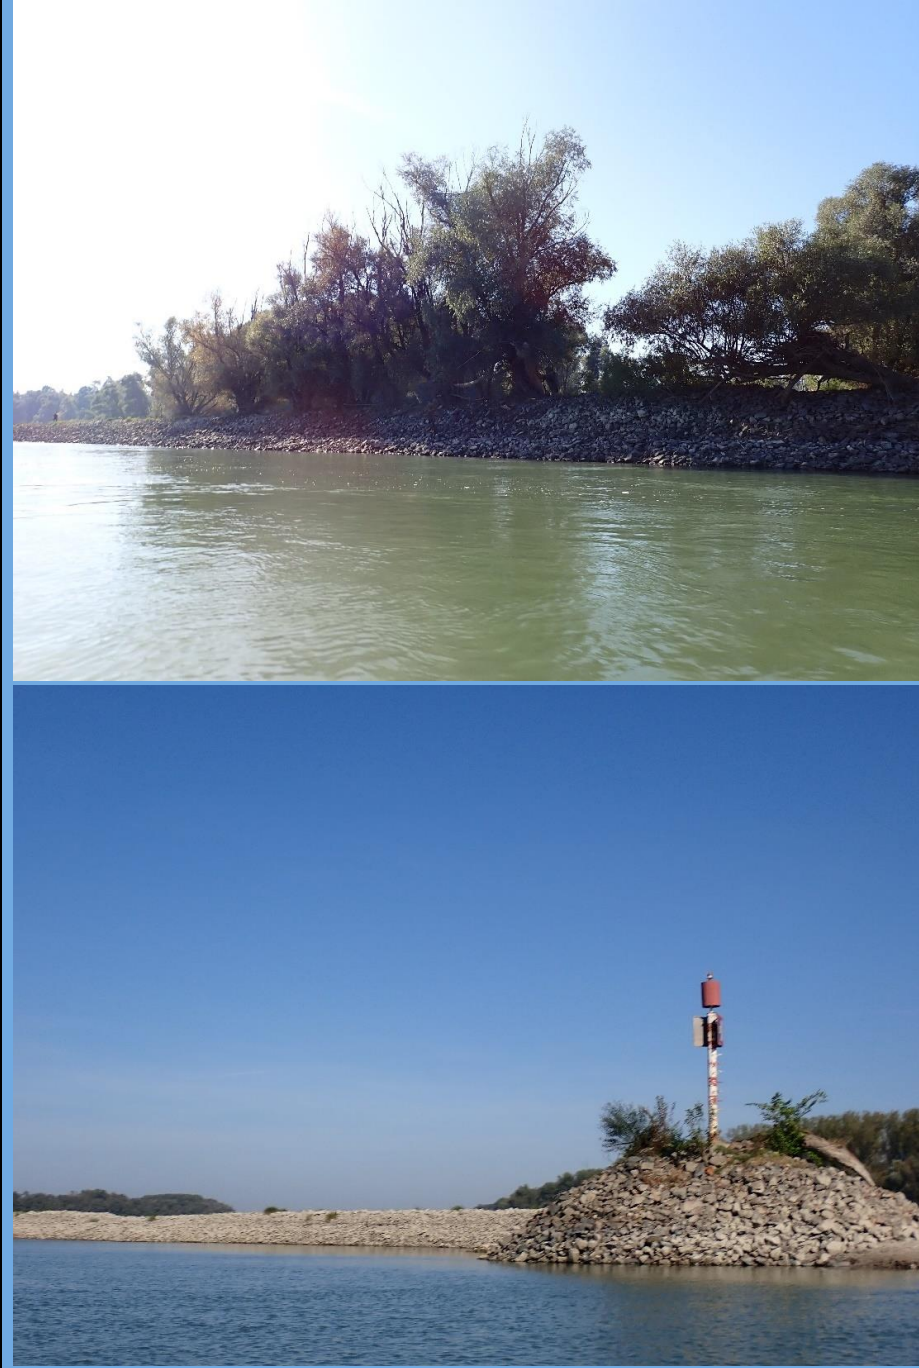
8. Right bank	Type:	Chainage (r.km)	Length (m)	Crown elevation (m.a.s.l.)
<b>1427-D4</b>	T-groyne	1427+615	479,10	82,95

- Infrastructure is in good condition.
- Effect of material deposition ongoing (upstream, downstream).
- Groyne head and groyne connection are visible. The beginning of material deposition upstream and downstream of the groyne and plants and trees on groyne crown are visible.

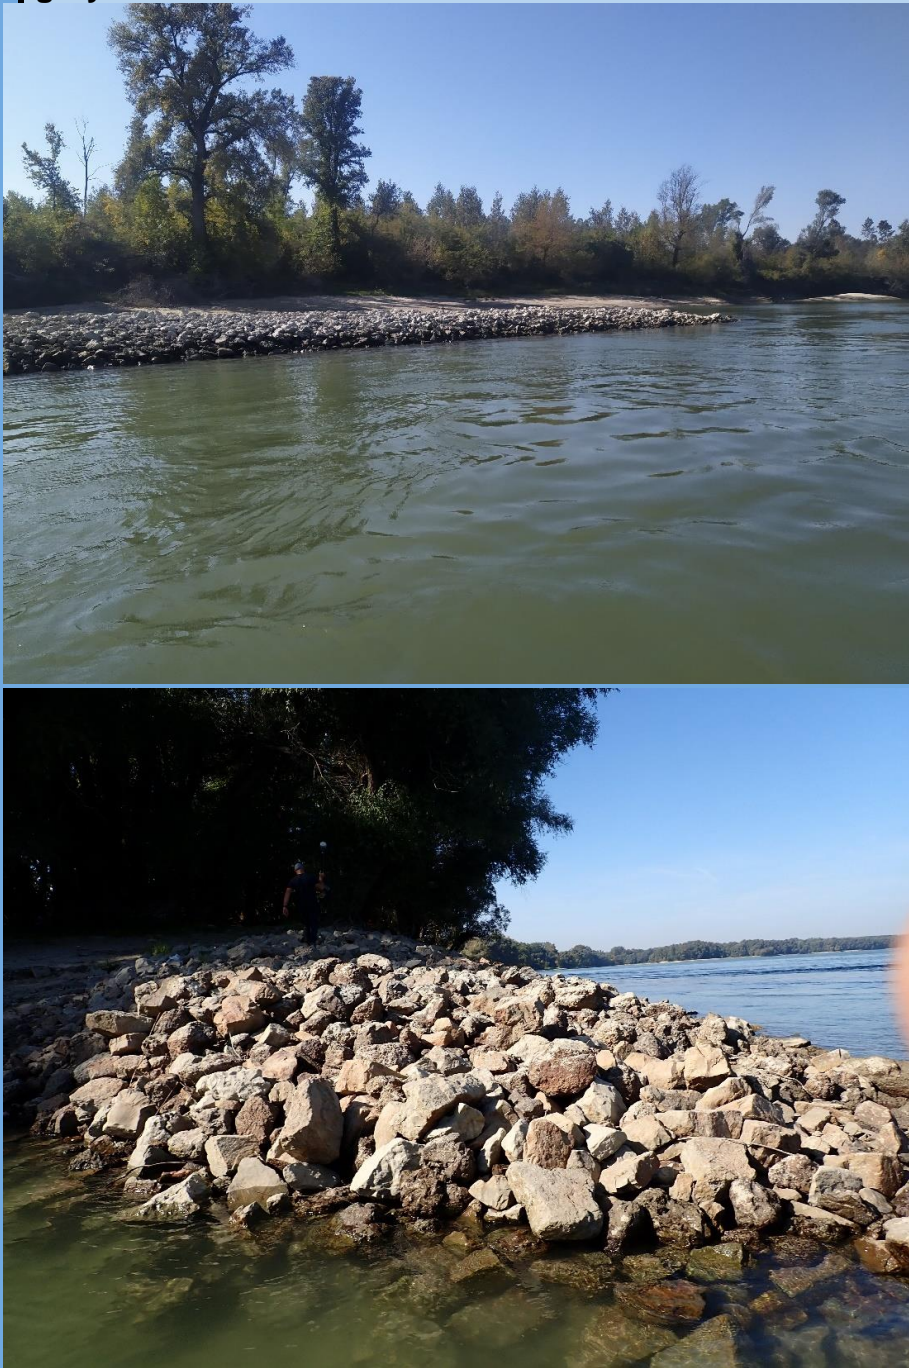
10. Right bank	Type:	Chainage (r.km)	Length (m)	Crown elevation (m.a.s.l.)
<b>1427-D2</b>	Parallel structure with groyne	1427+480 do 1427+307	183,92	81,23

- Infrastructure is in excellent condition.
- Effect of material deposition ongoing (upstream, downstream).
- Rooting of the parallel is connected to the barrier 1427-D1. Stone material and material deposit upstream of the parallel structure are visible.

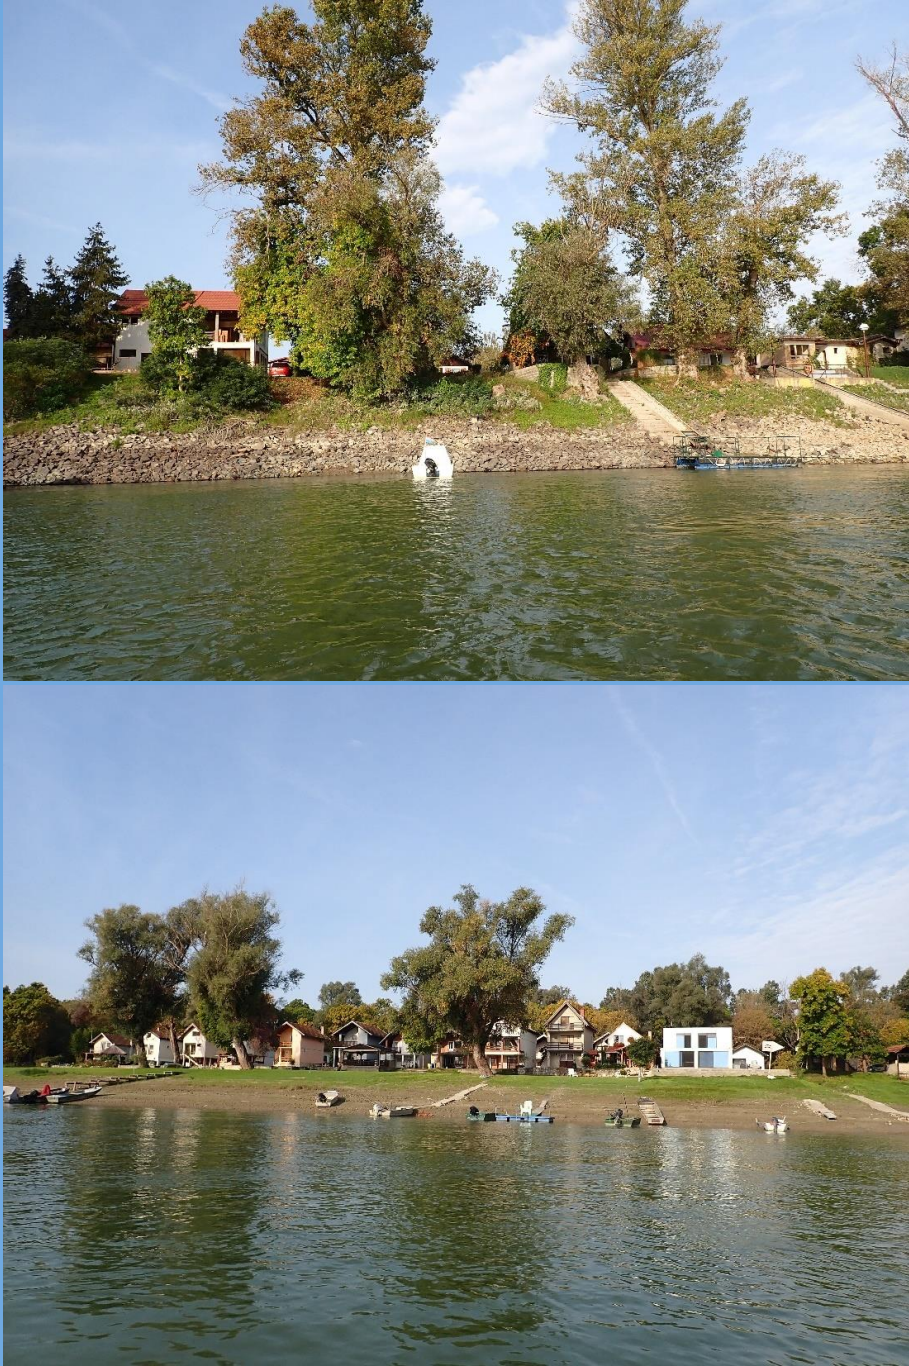
20. Right bank	Type:	Chainage (r.km)	Length (m)	Crown elevation (m.a.s.l.)
<b>1422-D2</b>	Revetment	1423+211 do 1422+590	620,66	85,32

- Infrastructure is in good condition.
- River bank erosion protection ongoing at medium water levels.
- Stone revetment in settlement "Zeleni otok". Concrete staircases and approaches to pontoons for boats along the bevels.

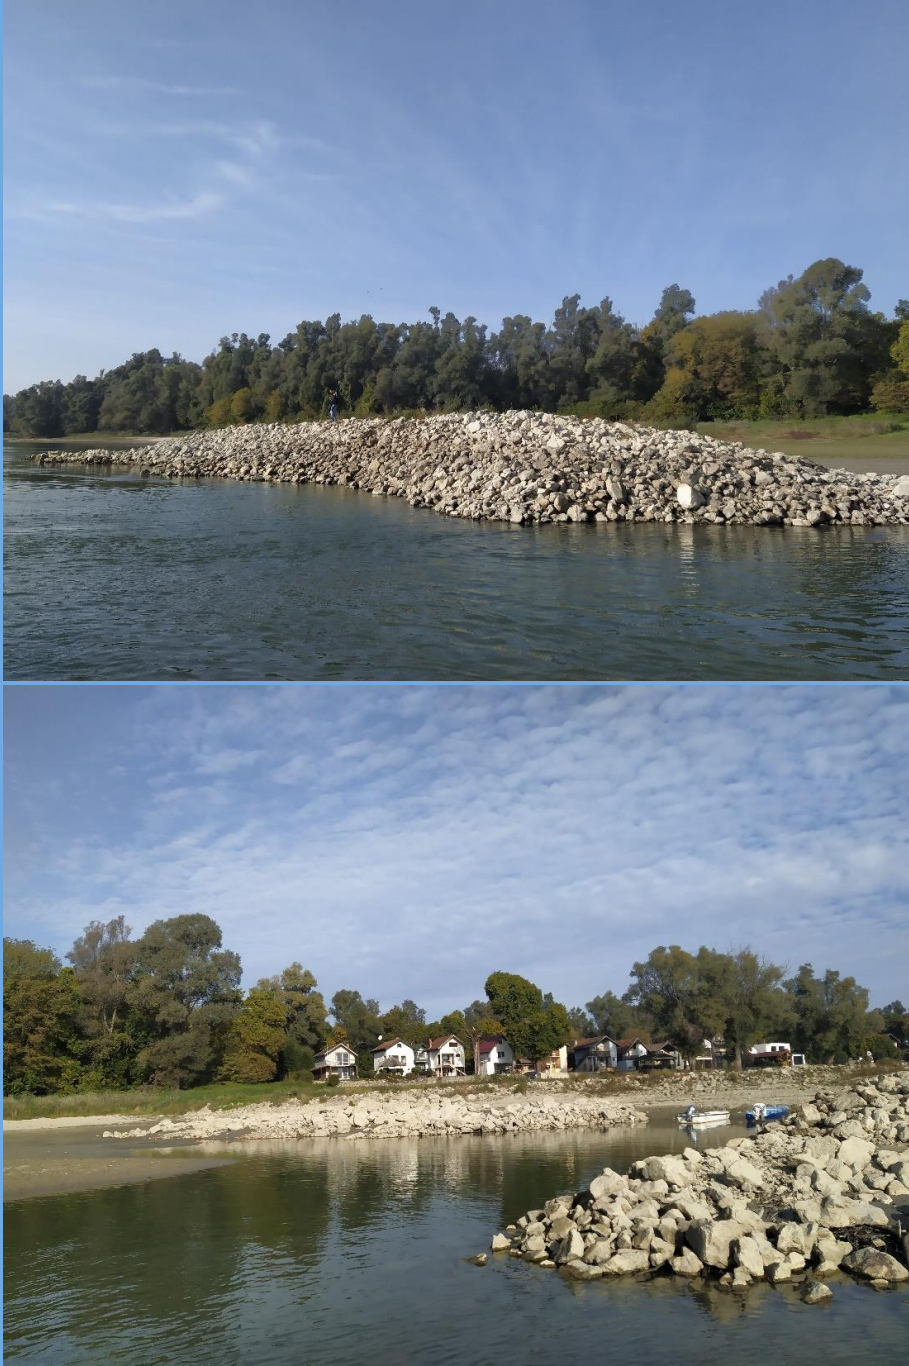
21. Right bank	Type:	Chainage (r.km)	Length (m)	Crown elevation (m.a.s.l.)
<b>1422-D1</b>	T-groyne	1422+025	69,87	81,76

- Infrastructure is in satisfying condition.
- Effect of material deposition ongoing (upstream, downstream).
- Collapsed part of the groyne head is visible. Material deposit upstream and downstream of the groyne is visible.

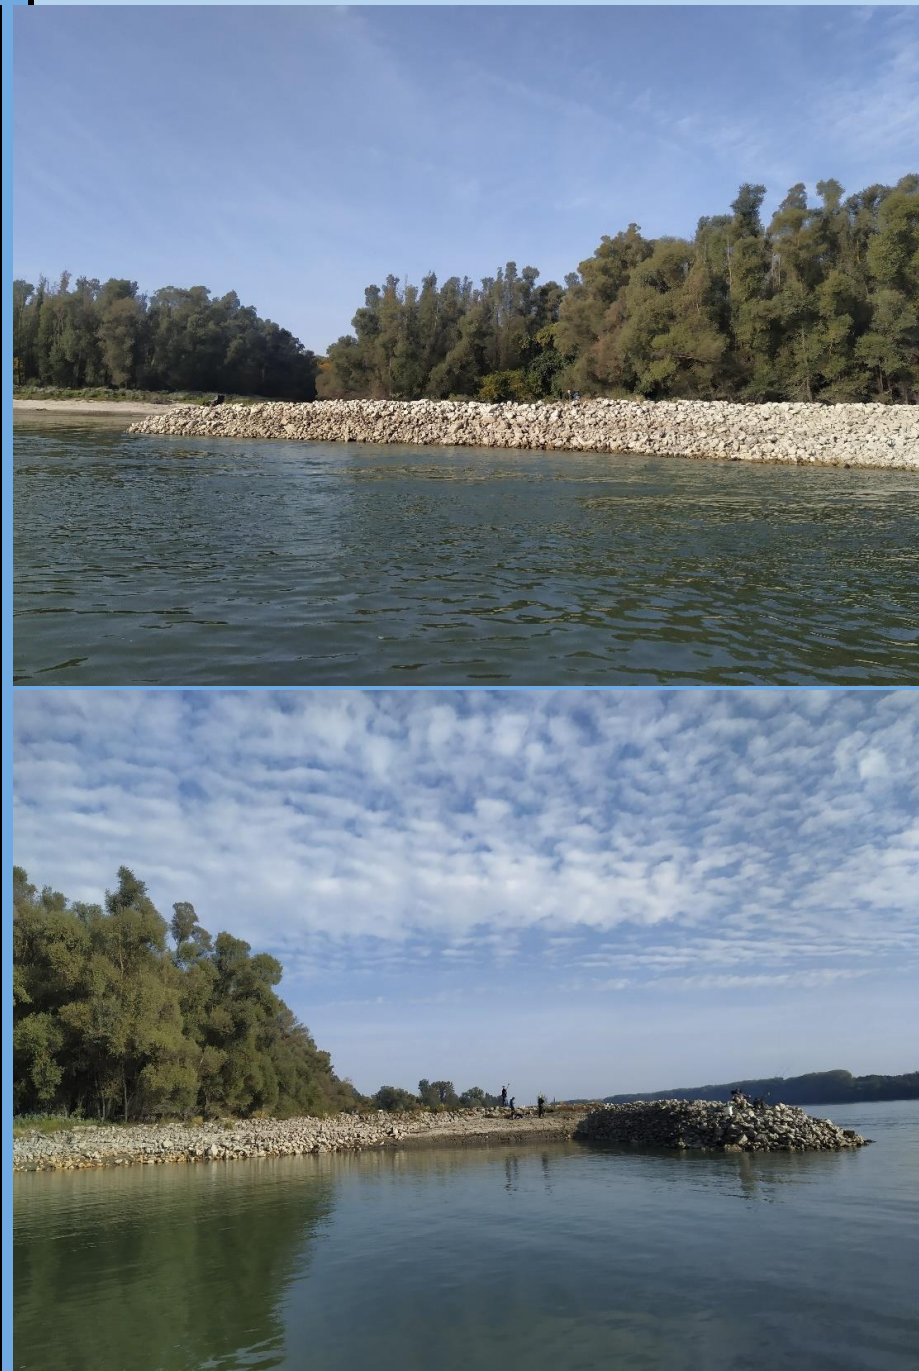
22. Right bank	Type:	Chainage (r.km)	Length (m)	Crown elevation (m.a.s.l.)
<b>1421-D2</b>	T-groyne	1421+655	55,22	81,71

- Infrastructure is in good condition.
- Effect of material deposition ongoing (upstream, downstream).
- Material deposit upstream and downstream of the groyne is visible. Downstream on the groyne connection, stone washout under the groyne crown connection is visible.

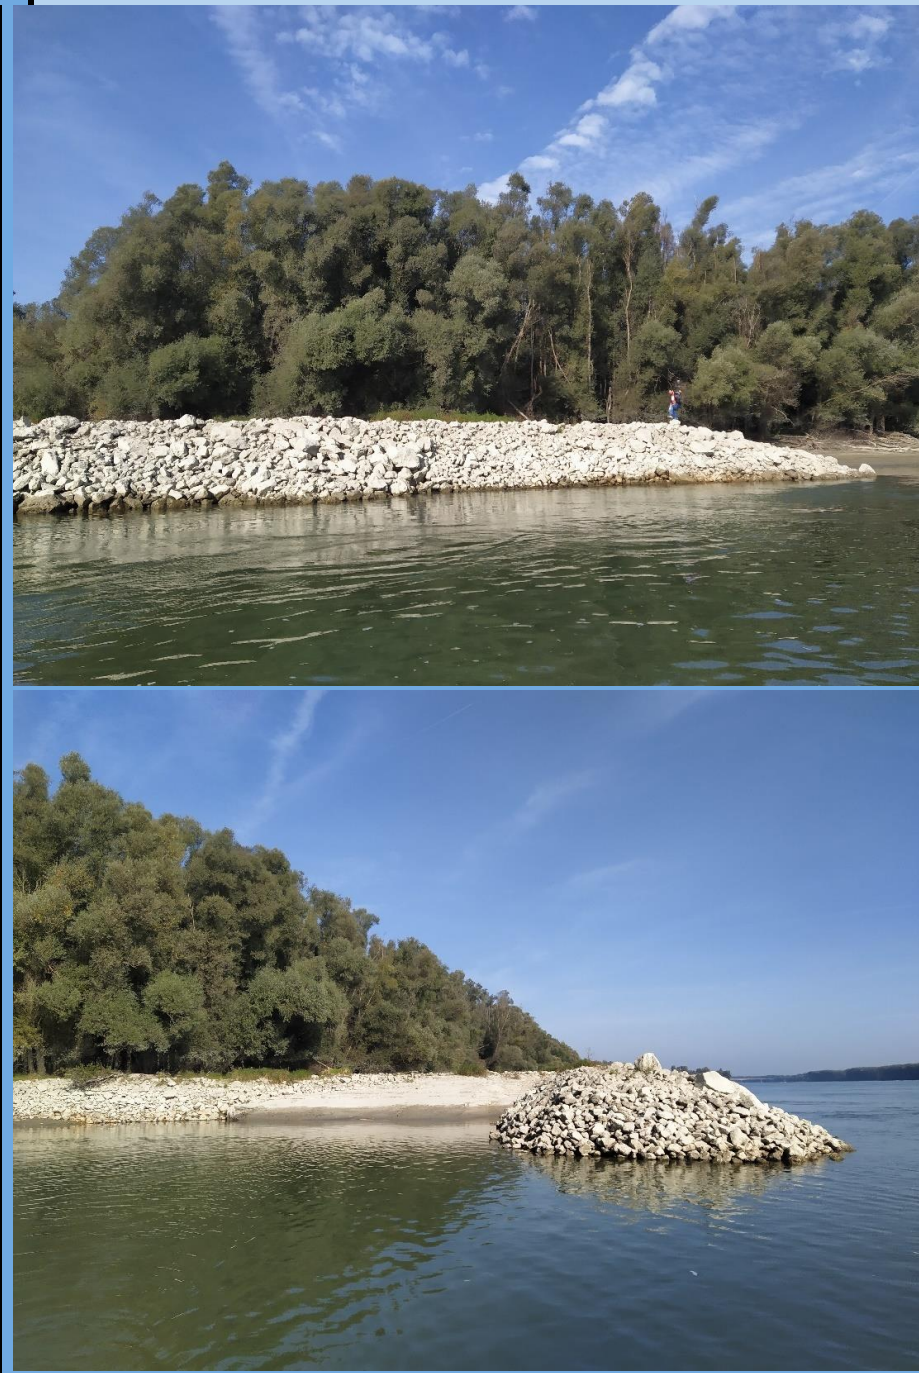
25. Right bank	Type:	Chainage (r.km)	Length (m)	Crown elevation (m.a.s.l.)
<b>1420-D1</b>	T-groyne	1420+748	56,29	81,77

- Infrastructure is in good condition..
- Effect of material deposition ongoing (upstream, downstream).
- Material deposit upstream and downstream of the groyne is visible. Downstream on the groyne connection, stone washout under the groyne crown connection is visible.

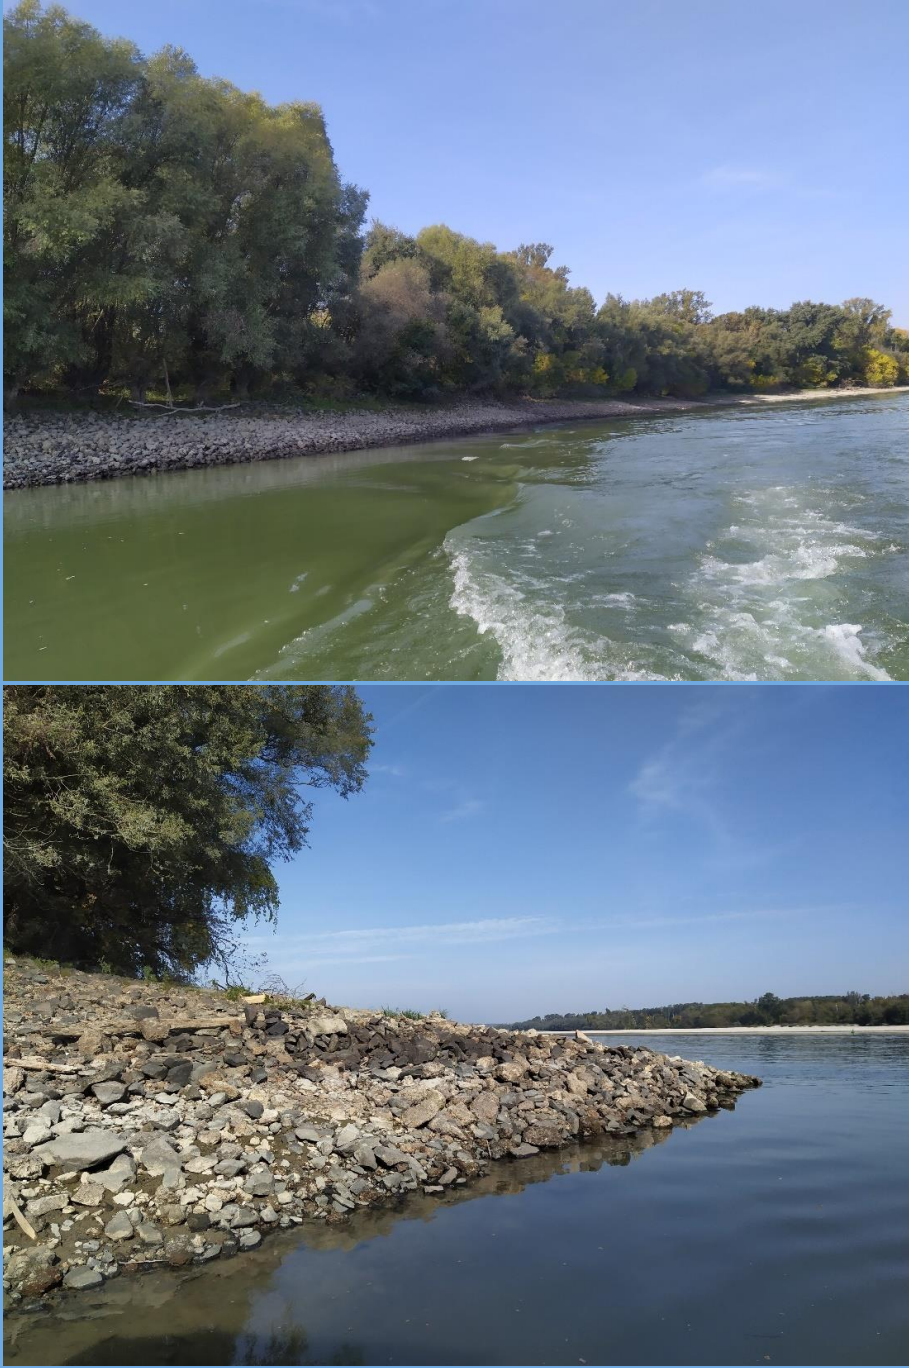
26. Right bank	Type:	Chainage (r.km)	Length (m)	Crown elevation (m.a.s.l.)
<b>1418-D1</b>	Revetment	1420+760 do 1418+067	2862,74	81,19

- Infrastructure is in good condition.
- River bank erosion protection ongoing at low water levels.
- Stone revetment above which is a stone river bank overgrown with plants and trees. Revetment ends at the entrance in Zmajevački Dunavac.

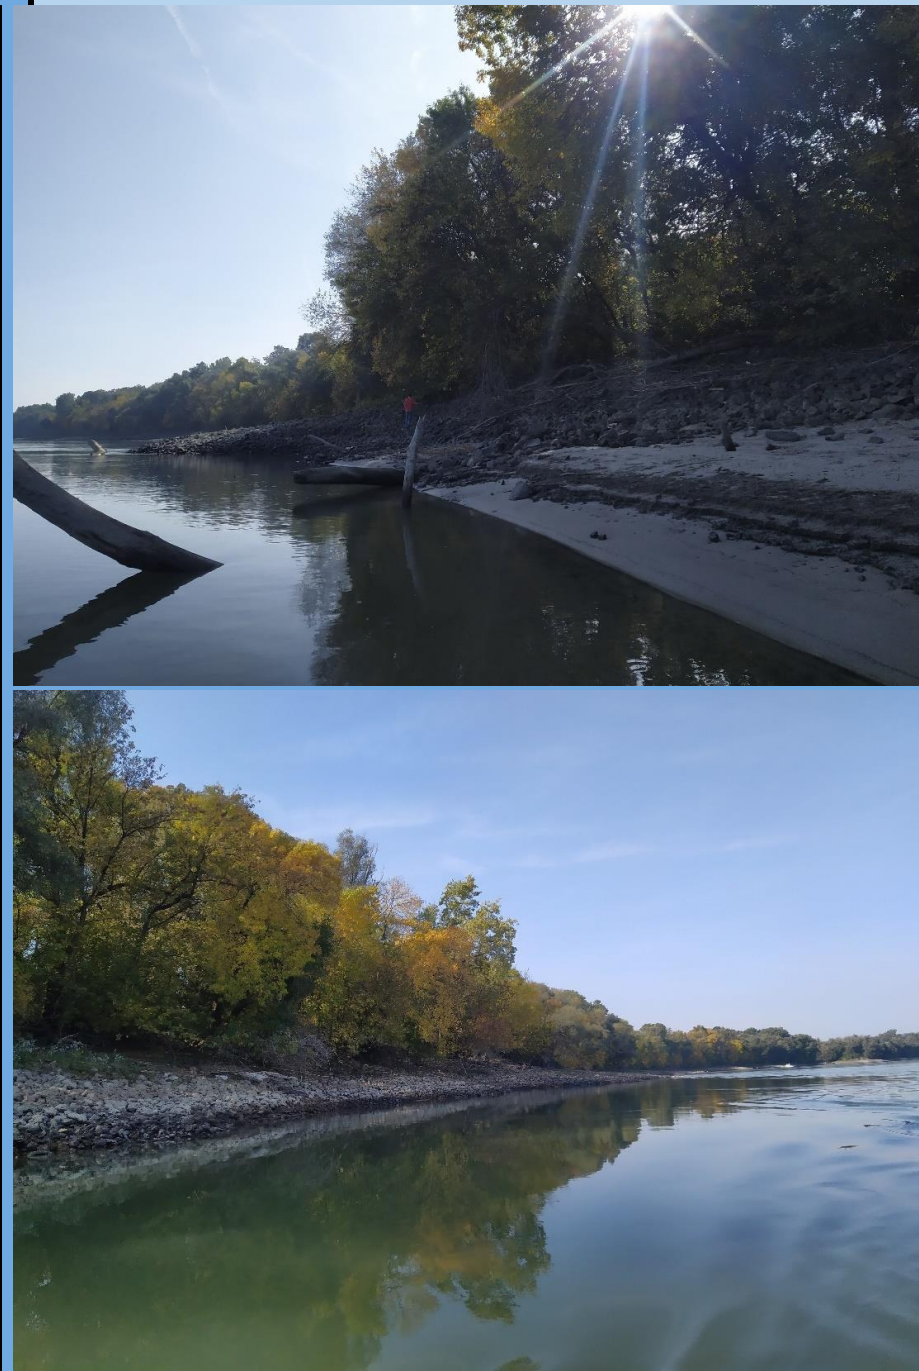
28. Right bank	Type:	Chainage (r.km)	Length (m)	Crown elevation (m.a.s.l.)
<b>1417-D2</b>	Revetment	1418+032 do 1417+169	1137,08	81,14

- Infrastructure is in satisfying condition.
- River bank erosion protection ongoing at low water levels.
- Revetment is partially collapsed. Behind groyne 1417-D4 stone material of revetment is not visible.

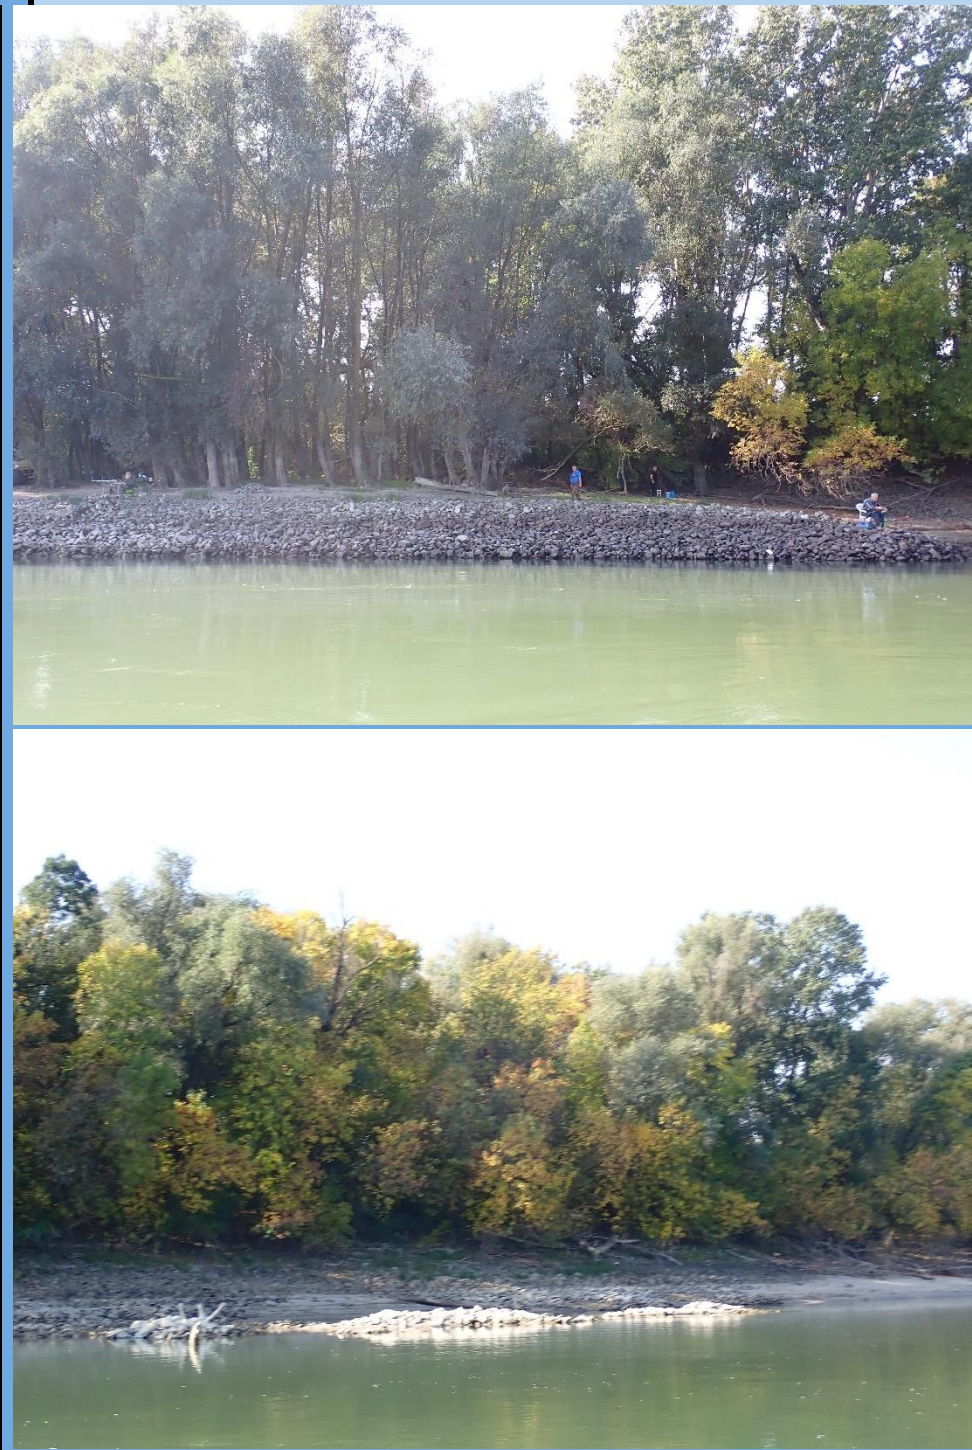
29. Right bank	Type:	Chainage (r.km)	Length (m)	Crown elevation (m.a.s.l.)
<b>1417-D1</b>	Parallel structure	1417+156 do 1417+022	149,82	80,38

- Infrastructure is in good condition.
- Effect of material deposition failed (upstream, downstream).
- Stone material of parallel structure is visible and it has an irregular geometry.

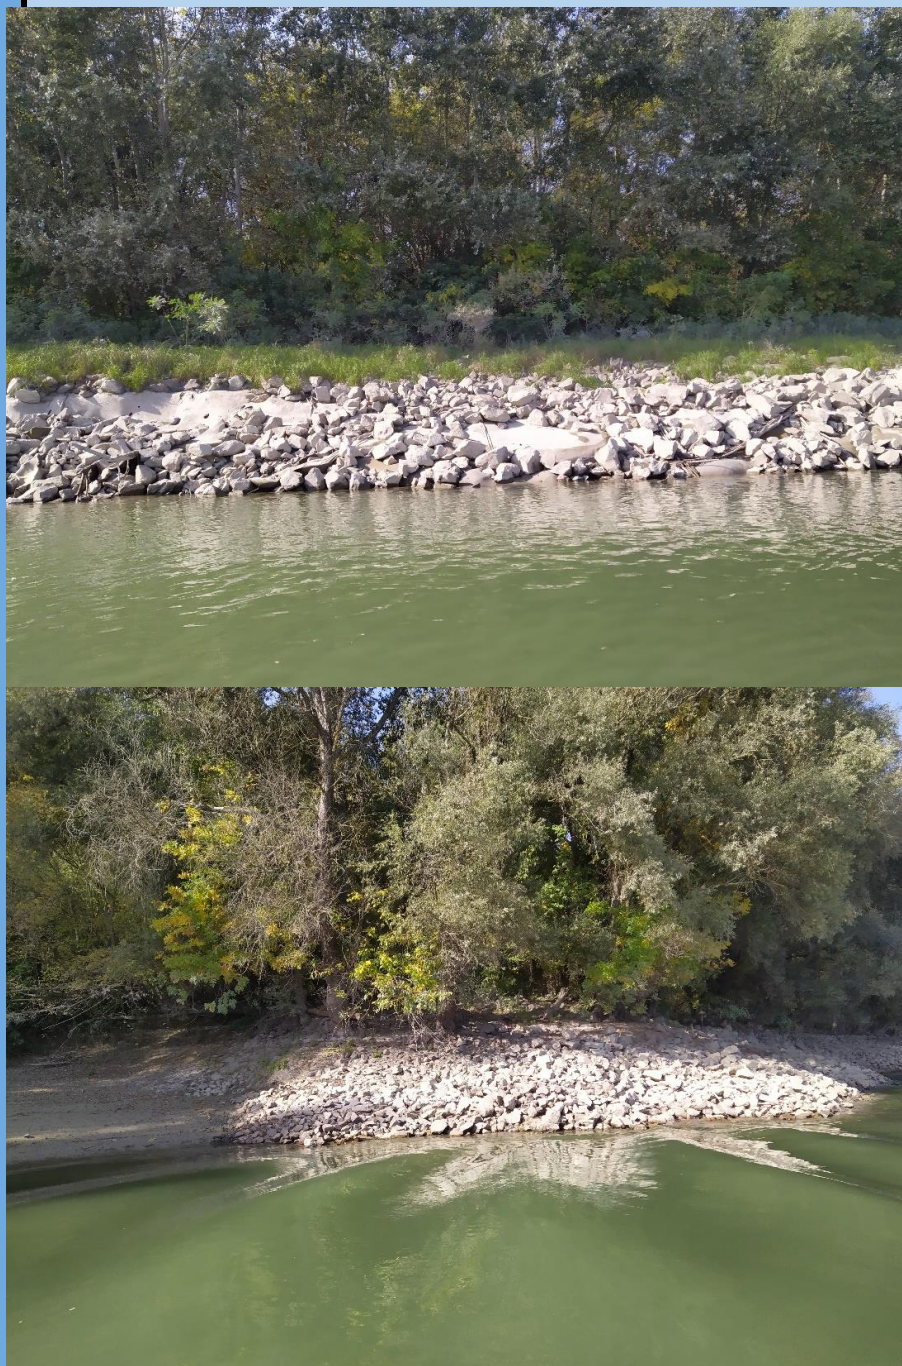
32. Right bank	Type:	Chainage (r.km)	Length (m)	Crown elevation (m.a.s.l.)
<b>1412-D1</b>	Revetment	1412+888 do 1412+363	518,67	80,27

- Infrastructure is in satisfying condition.
- River bank erosion protection ongoing at low water levels.
- Stone material of revetment is visible. Revetment is partially washed away and geotextile is spotted beneath the stone material.

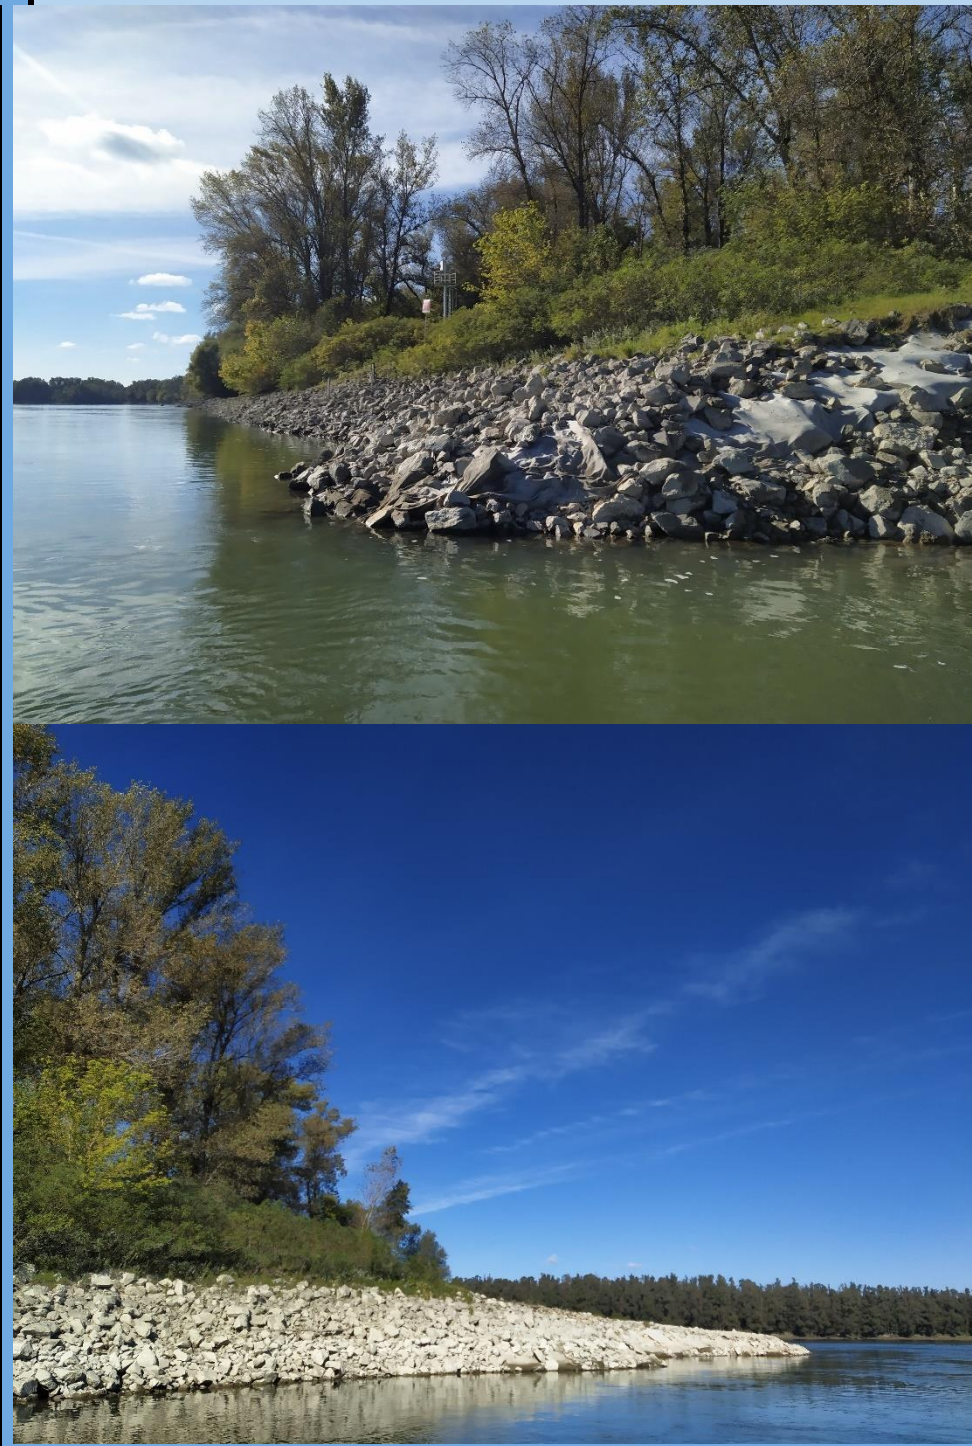
51. Right bank	Type:	Chainage (r.km)	Length (m)	Crown elevation (m.a.s.l.)
<b>1392-D1</b>	Revetment	1393+056 do 1392+961	141,42	82,25

- Infrastructure is in bad condition.
- River bank erosion protection failed.
- Revetment is collapsed and the geotextile beneath the stone material is visible.
