**MONITORING OF HYDROLOGICAL, HYDRAULIC AND MORPHOLOGICAL CHARACTERISTICS OF THE DANUBE RIVER AND INVENTORY OF BIODIVERSITY COMPONENTS ON THE JOINT CROATIAN-SERBIAN SECTOR OF THE DANUBE RIVER**

**INVENTORY OF RIVER REGULATION INFRASTRUCTURE RELATED TO NAVIGATION**

**Project number:** I-2206/24

**LOCATION:** Danube river from rkm 1295,5 (Ilok) to rkm 1433,1  
(border with Hungary)

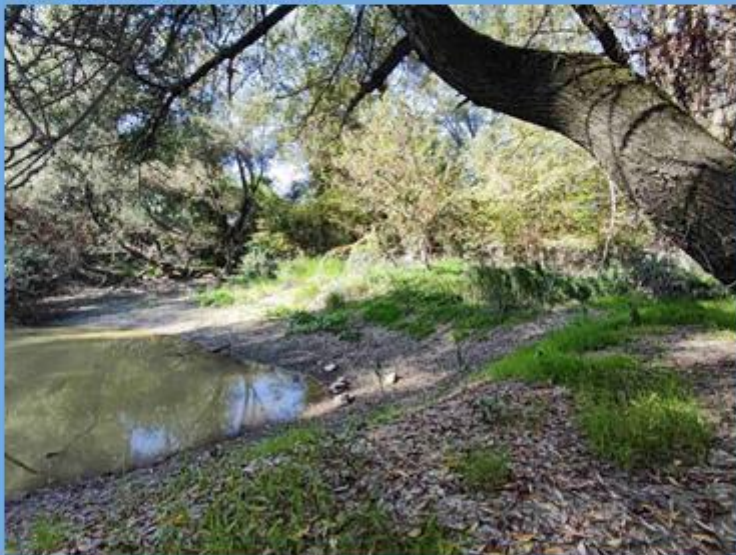
- CADASTRE MARK 1424/2
- CADASTRE PAGE 2/3

- Infrastructure is in satisfying condition.
- Effect of material deposition finished (upstream,downstream).
- Material deposit upstream and downstream of the groyne and overgrowth of plants are visible. Stone material is not visible.

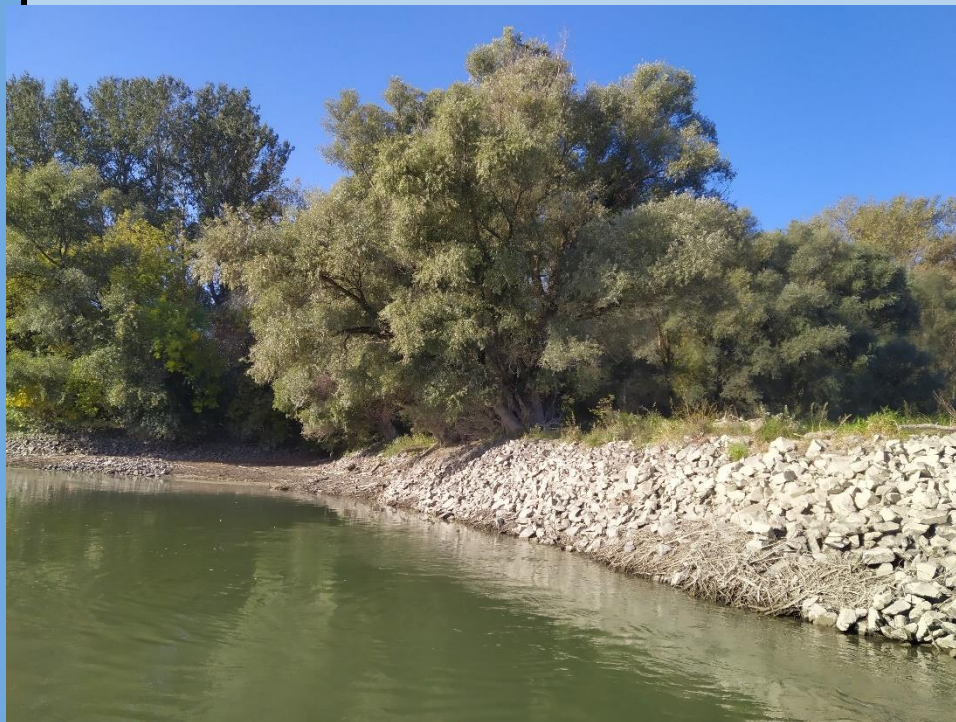
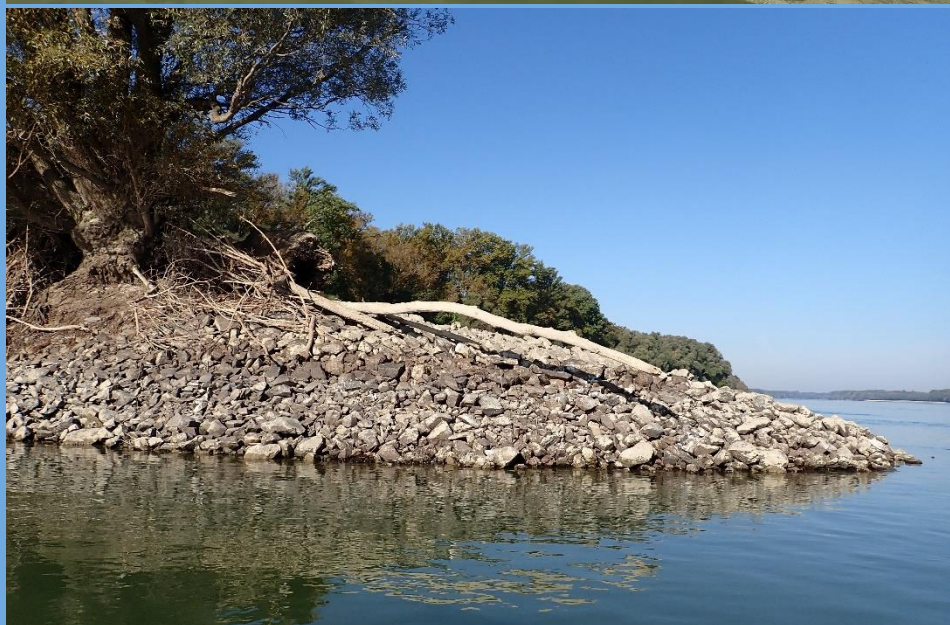
1. Right bank	Type:	Chainage (r.km)	Length (m)	Crown elevation (m.a.s.l.)
<b>1432-D3</b>	Groyne	1432+638	81,06	83,05

- Infrastructure is in good condition.
- Effect of material deposition ongoing (upstream, downstream).
- Groyne, the beginning of material deposition upstream and downstream of the groyne and trees on the groyne crown are visible.

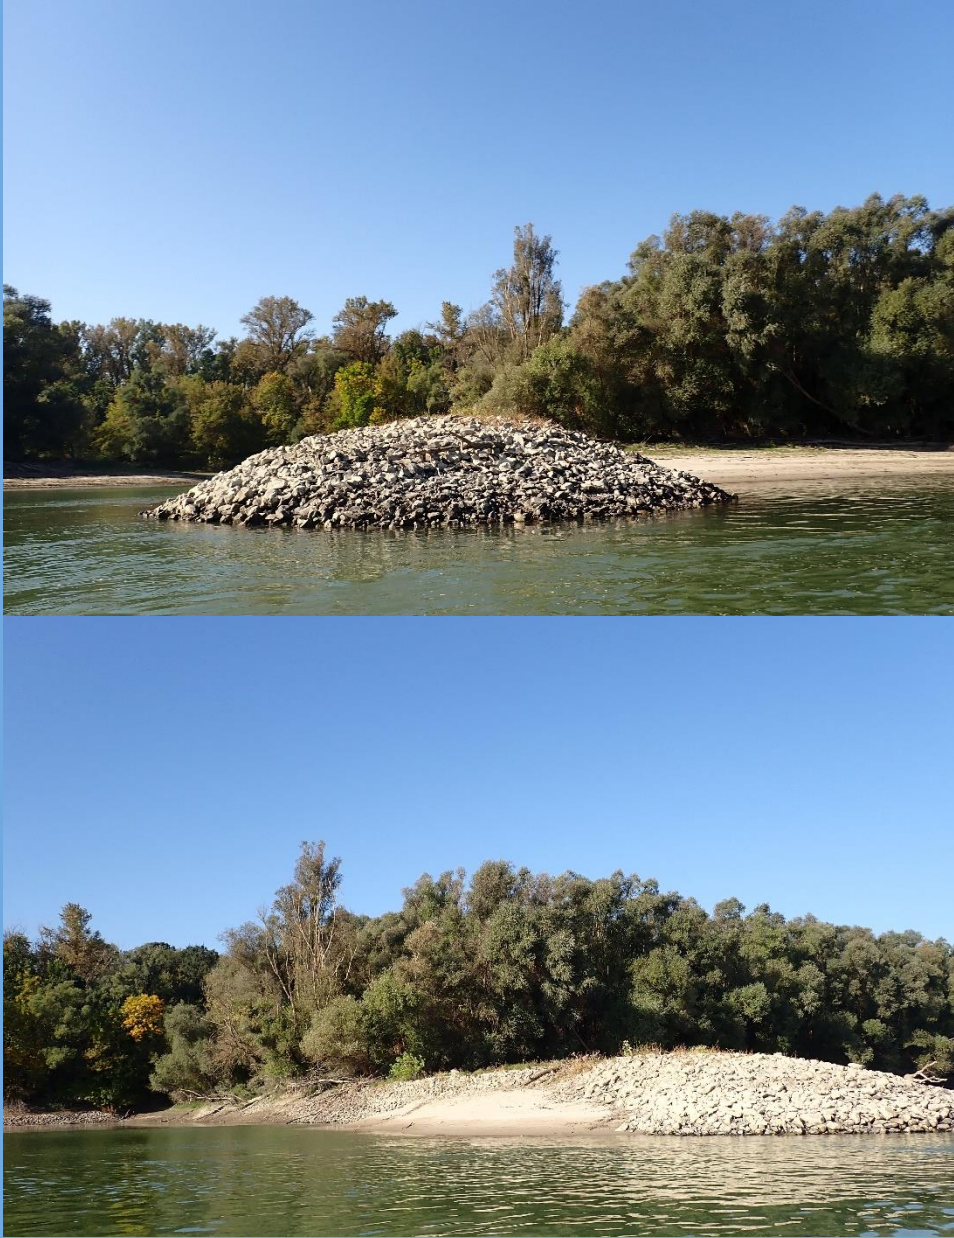
2. Right bank	Type:	Chainage (r.km)	Length (m)	Crown elevation (m.a.s.l.)
<b>1432-D2</b>	Groyne	1432+339	137,41	82,33

- Infrastructure is in good condition.
- Effect of material deposition ongoing (upstream, downstream).
- Groyne and the beginning of material deposition upstream and downstream of the groyne are visible. Upstream on the groyne, stone washout under the groyne crown connection is visible.

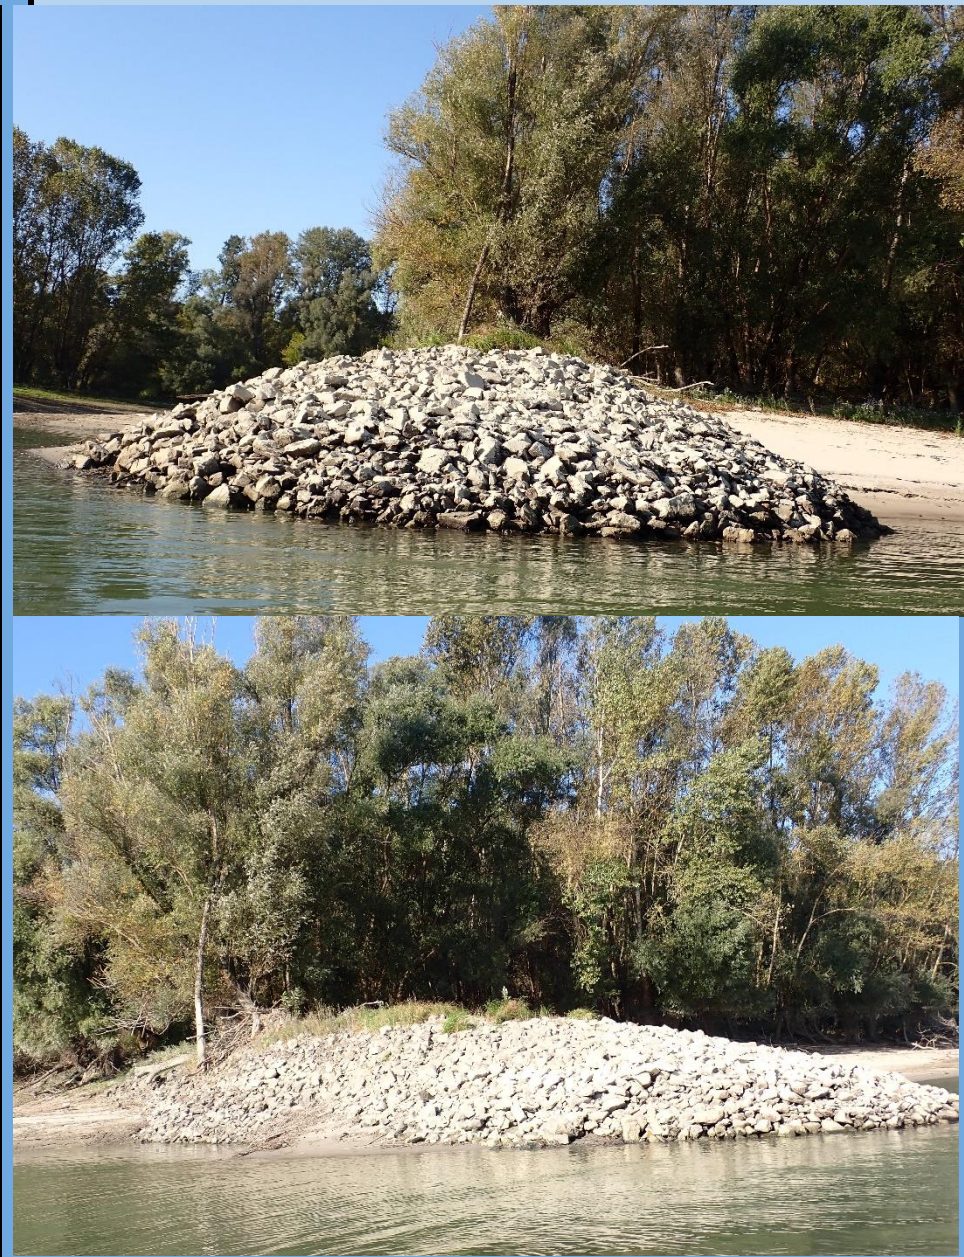
3. Right bank	Type:	Chainage (r.km)	Length (m)	Crown elevation (m.a.s.l.)
<b>1432-D1</b>	Groyne	1432+073	185,72	82,20

- Infrastructure is in good condition.
- Effect of material deposition ongoing (upstream, downstream).
- Groyne and the beginning of material deposition upstream and downstream of the groyne are visible. Upstream on the groyne, stone washout under the groyne crown connection is visible.

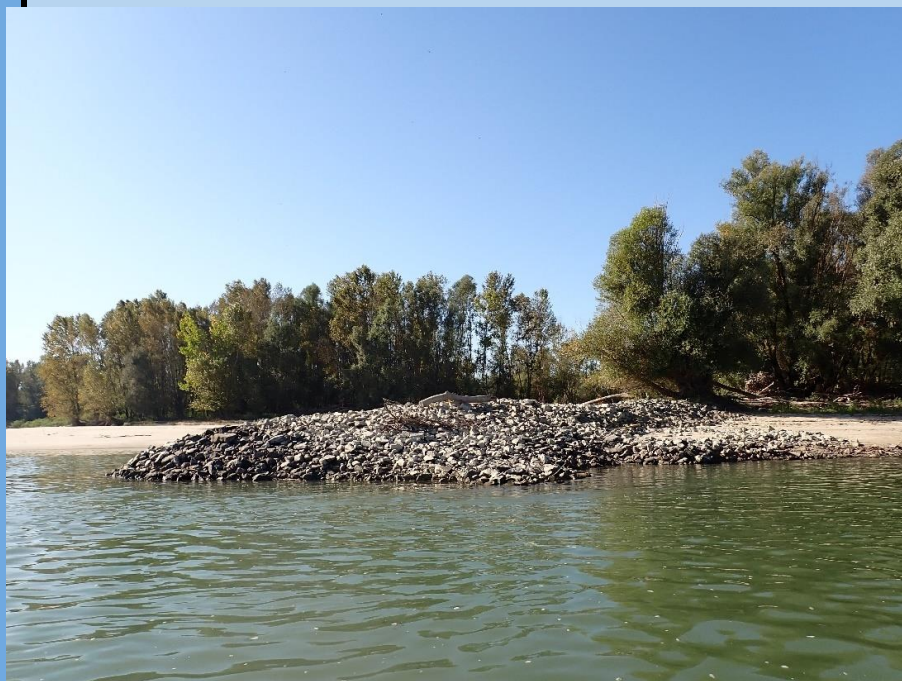
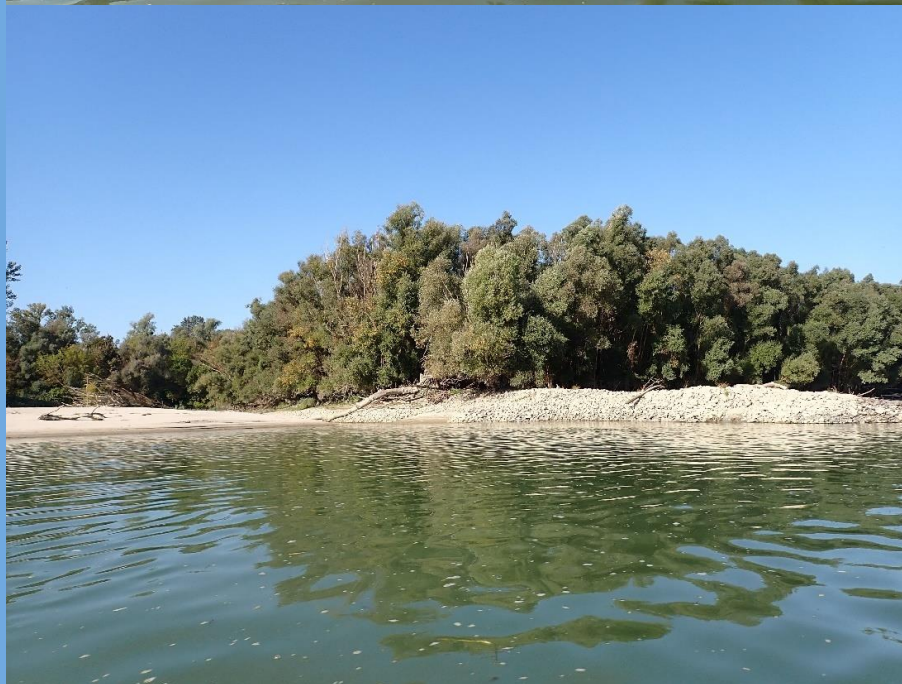
4. Right bank	Type:	Chainage (r.km)	Length (m)	Crown elevation (m.a.s.l.)
<b>1431-D1</b>	Groyne	1431+633	202,23	81,93

- Infrastructure is in good condition.
- Effect of material deposition ongoing (upstream, downstream).
- Groyne and the beginning of material deposition upstream and downstream of the groyne are visible. Upstream on the groyne, stone washout under the groyne crown connection is visible.

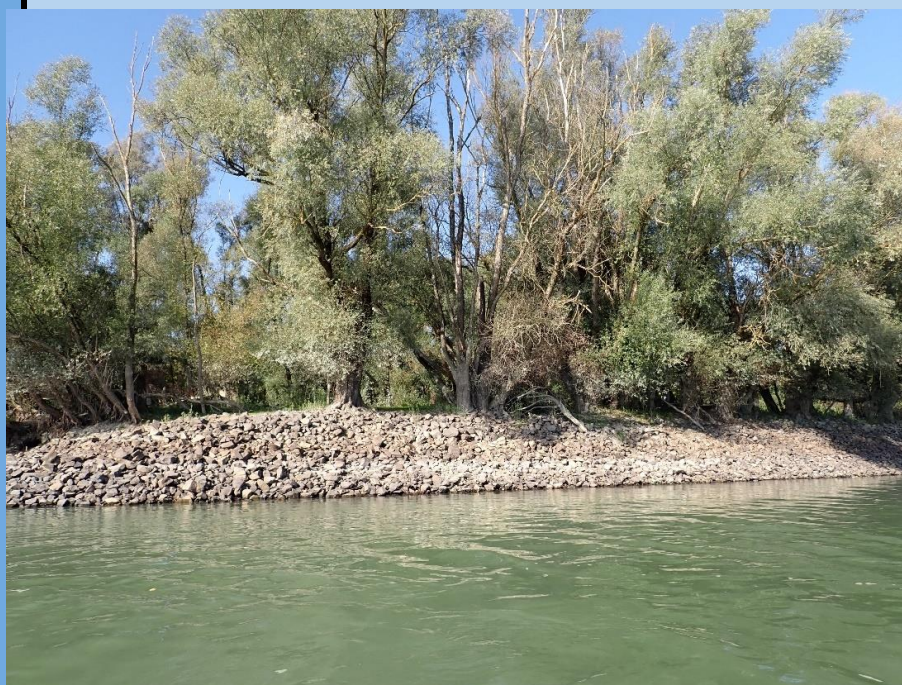
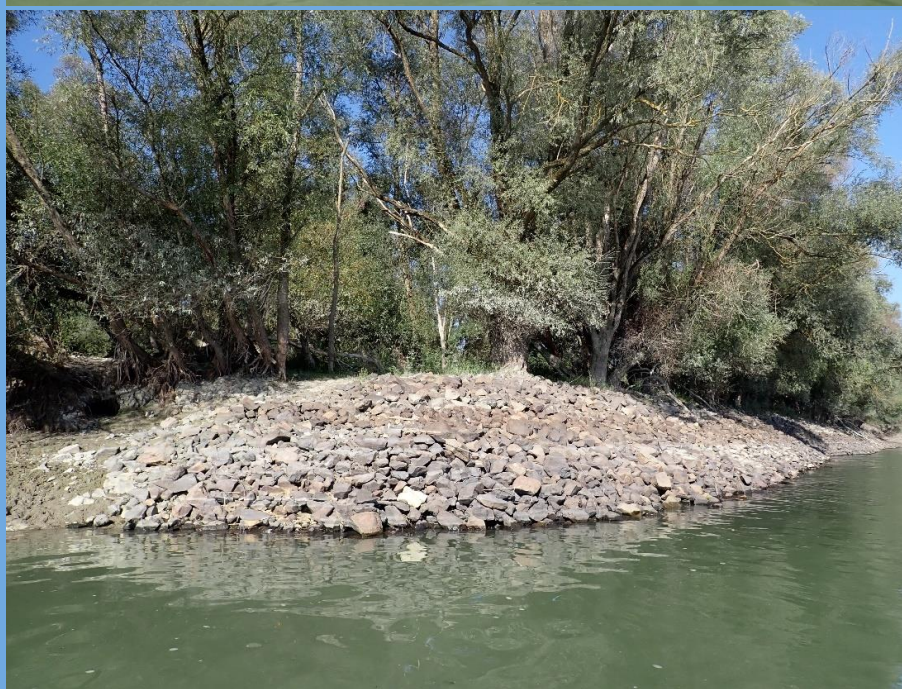
5. Right bank	Type:	Chainage (r.km)	Length (m)	Crown elevation (m.a.s.l.)
<b>1429-D1</b>	T-groyne	1429+282	124,15	82,45

- Infrastructure is in good condition.
- Effect of material deposition ongoing (upstream, downstream).
- Stone material of groyne head and plants and trees on groyne crown head are visible. Material deposit and overgrowth of trees on groyne connection are visible.

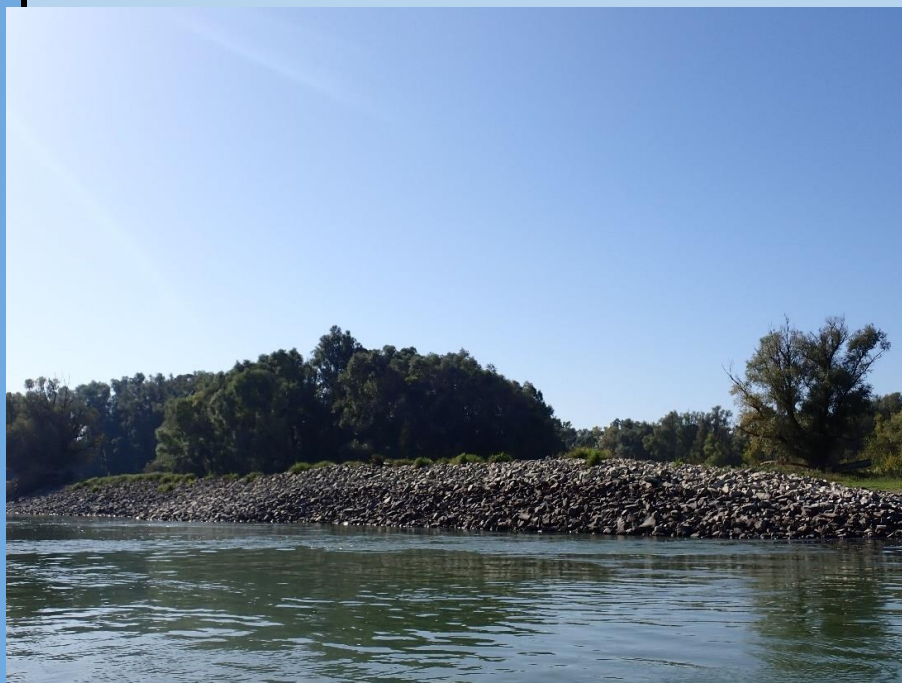
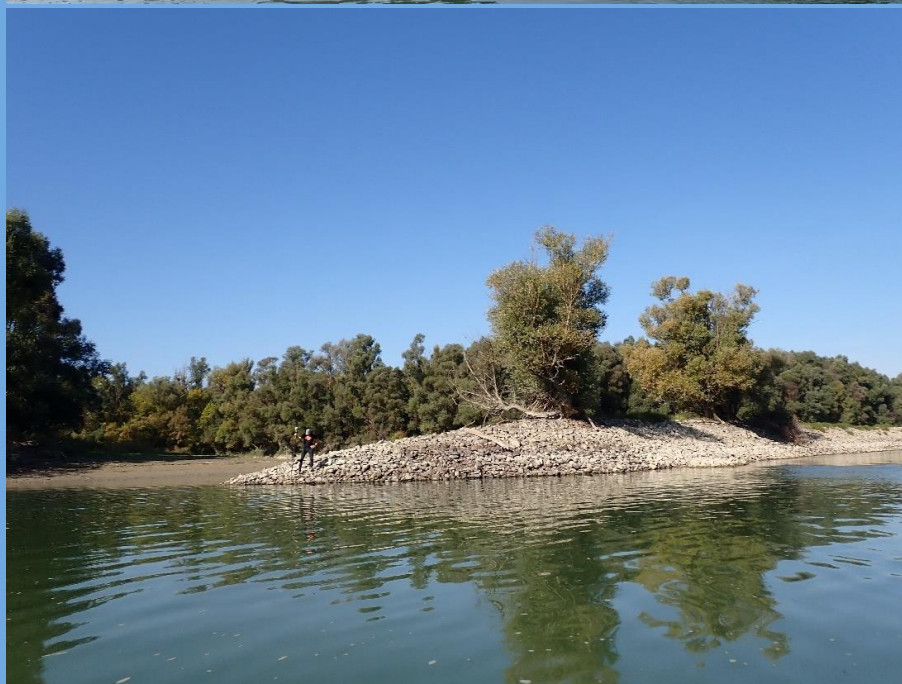
6. Right bank	Type:	Chainage (r.km)	Length (m)	Crown elevation (m.a.s.l.)
<b>1428-D1</b>	T-groyne	1428+940	132,56	82,32

- Infrastructure is in good condition.
- Effect of material deposition ongoing (upstream, downstream).
- Groyne head and groyne connection are visible. The beginning of material deposition upstream and downstream of the groyne and plants and trees on groyne crown are visible.

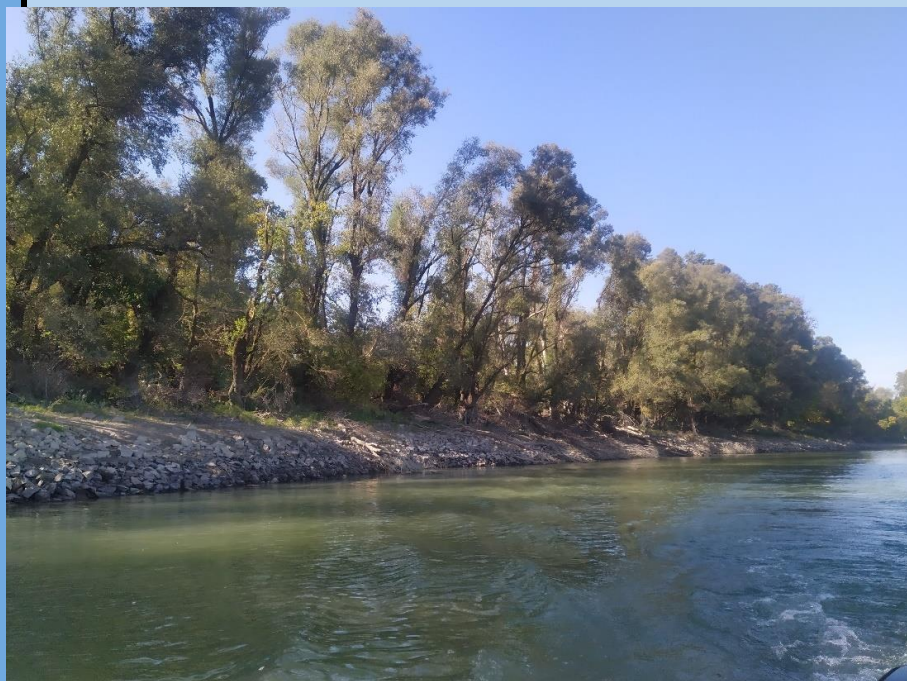
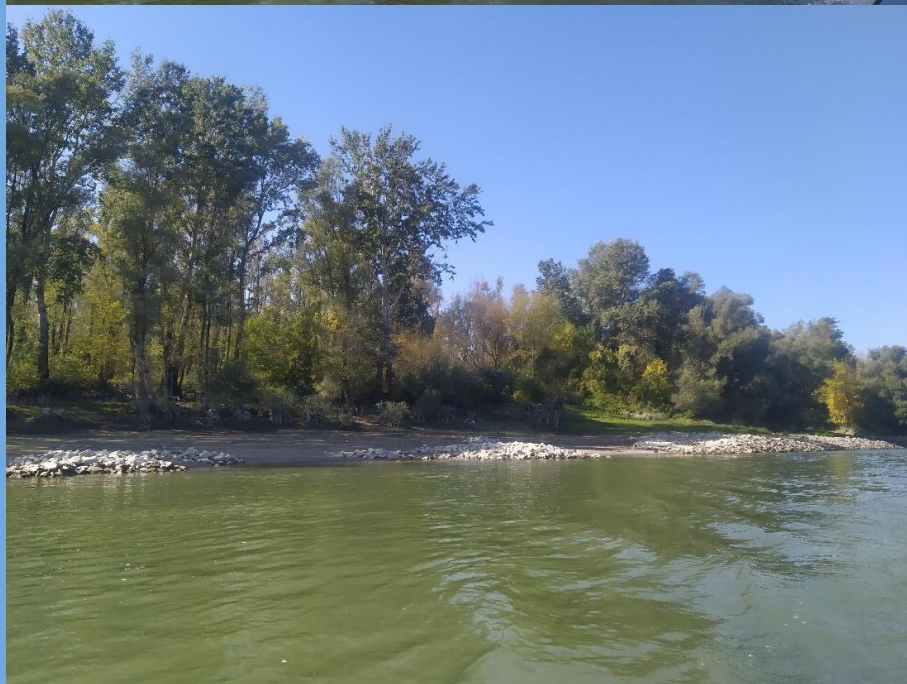
7. Right bank	Type:	Chainage (r.km)	Length (m)	Crown elevation (m.a.s.l.)
<b>1427-D5</b>	Revetment	1428+442 do 1427+617	1015,98	82,16

- Infrastructure is in satisfying condition.
- River bank protection from erosion ongoing at low water levels.
- The beginning of revetment downstream of the groyne 1427-D4 is visible. The river bank is partially collapsed and overgrown with trees and vegetation. The end of revetment is visible upstream of the parallel 1427-D3.

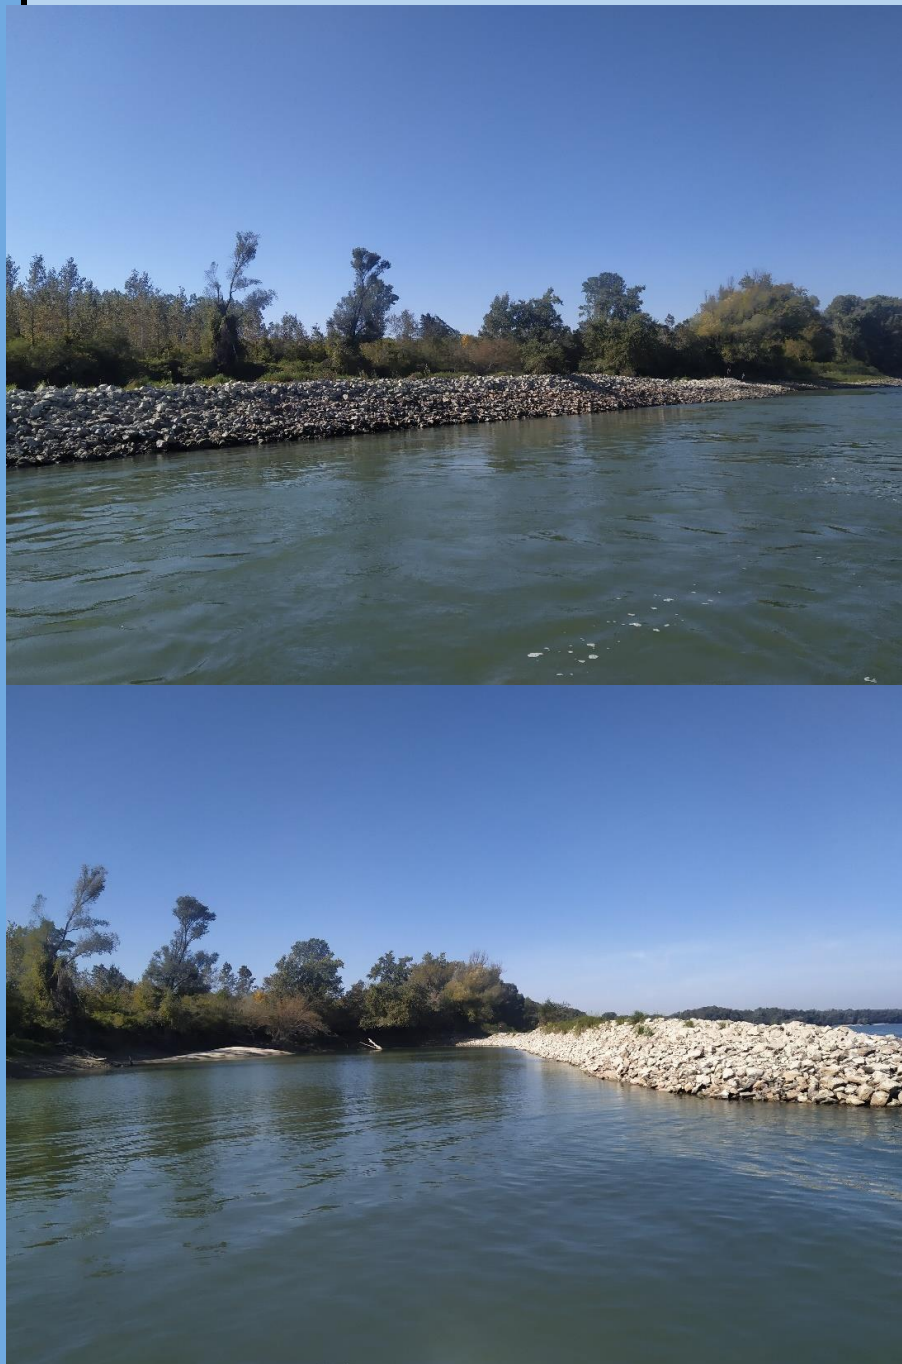
9. Right bank	Type:	Chainage (r.km)	Length (m)	Crown elevation (m.a.s.l.)
<b>1427-D3</b>	Parallel structure	1427+617 do 1427+524	114,10	81,89

- Infrastructure is in good condition.
- Effect of material deposition ongoing (upstream, downstream).
- Parallel structure continues on a revetment 1427-D5. Vegetation is visible on the crown of the parallel structure.

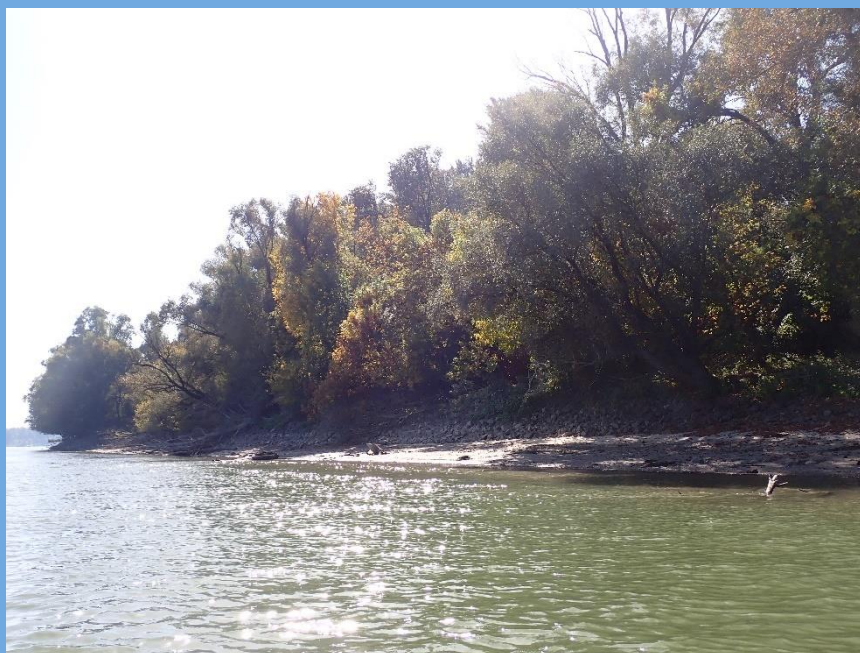
- Infrastructure is in satisfying condition.
- Effect of material deposition finished (upstream, downstream).
- Bevel of the stone connected to the river bank is visible. Material deposition upstream and downstream is visible as well as overgrowth of vegetation.

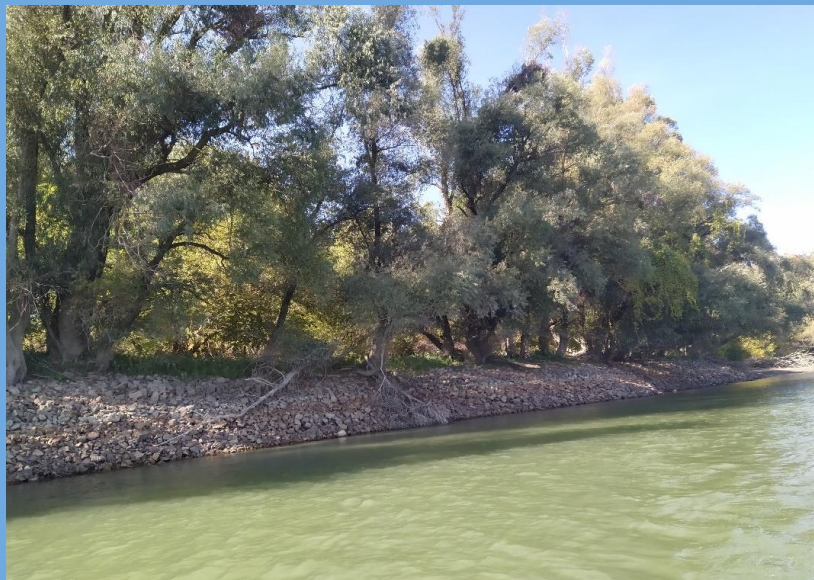
- Infrastructure is in satisfying condition.
- Effect of material deposition ongoing (upstream, downstream).
- Stone material of bevel of groyne head connected to the river bank is visible. Material deposit upstream and downstream of the groyne and overgrowth of plants are visible.

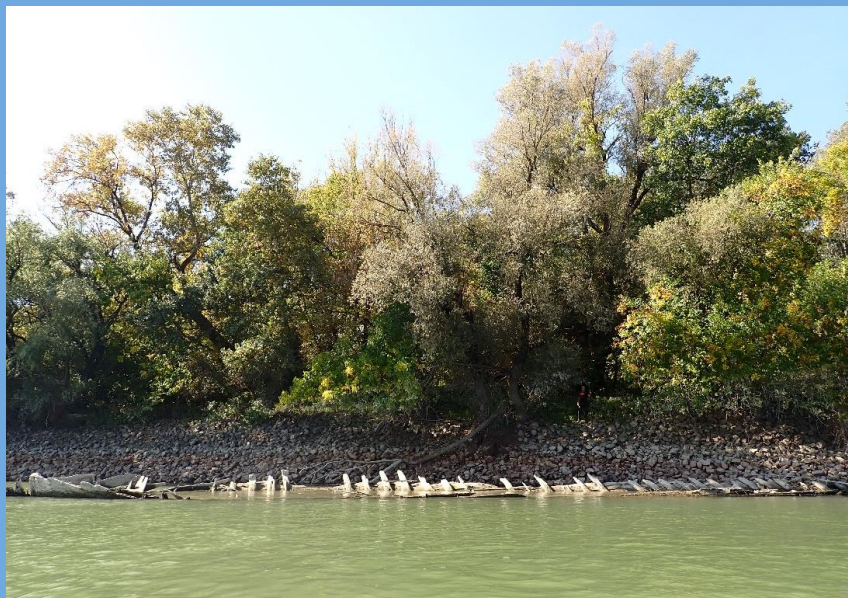
- Infrastructure is in satisfying condition.
- Effect of material deposition ongoing (upstream, downstream).
- Stone material of bevel of groyne head connected to the river bank is visible. Material deposit upstream and downstream and overgrowth of plants are visible.

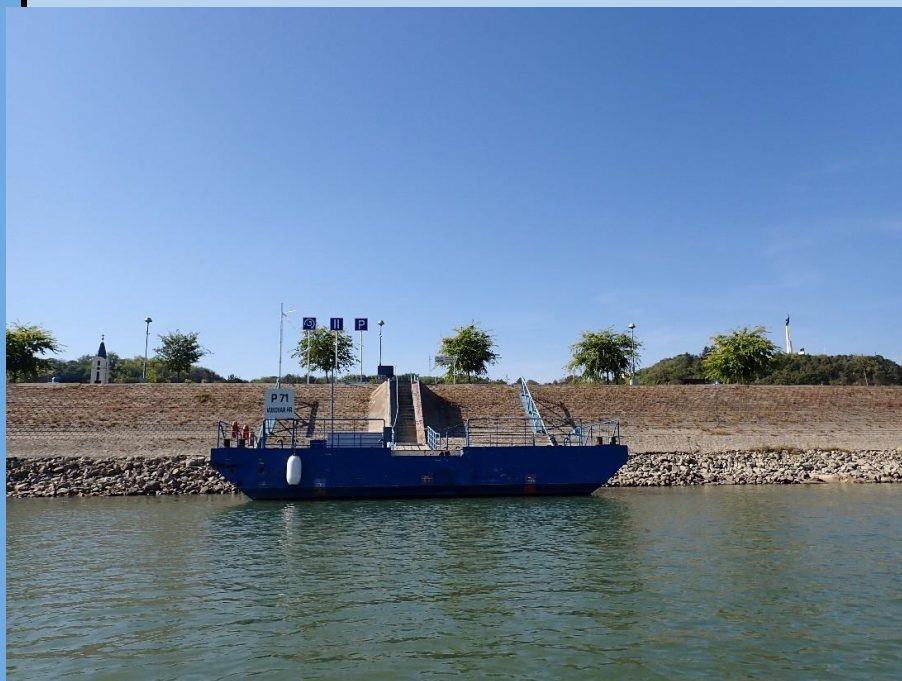
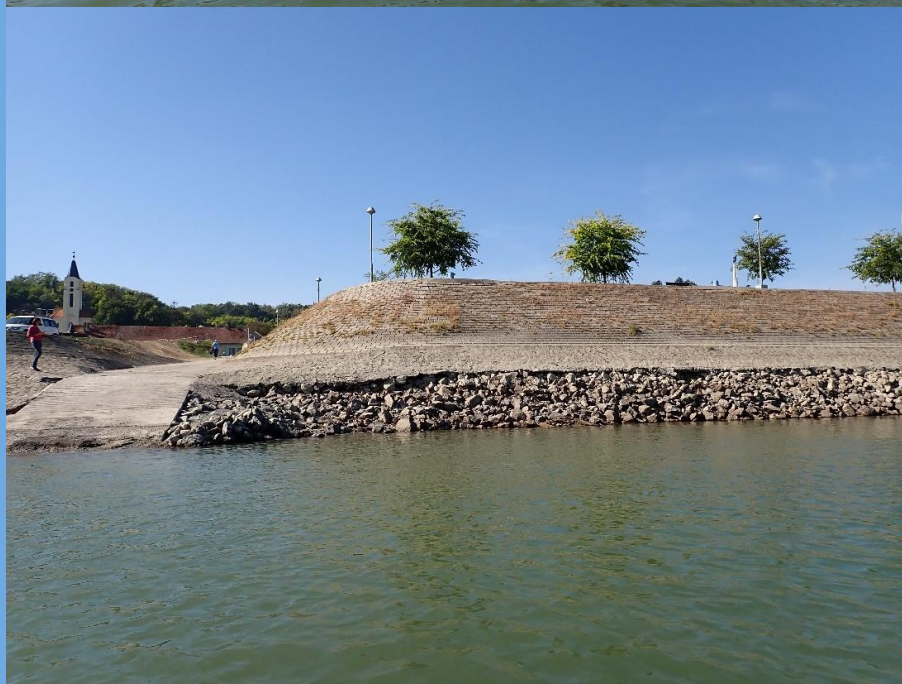
15. Right bank	Type:	Chainage (r.km)	Length (m)	Crown elevation (m.a.s.l.)
<b>1423-D4</b>	Revetment	1425+717 do 1423+743	1581,78 + 410,67	89,00

- Infrastructure is in excellent condition.
- River bank erosion protection ongoing at high water levels.
- City-type revetment. Confluence of Karašica river and revetment near passenger wharf Batina are in excellent condition Downstream of the wharf, revetment is in the process of reconstruction (embankment Gomboš-Batina).

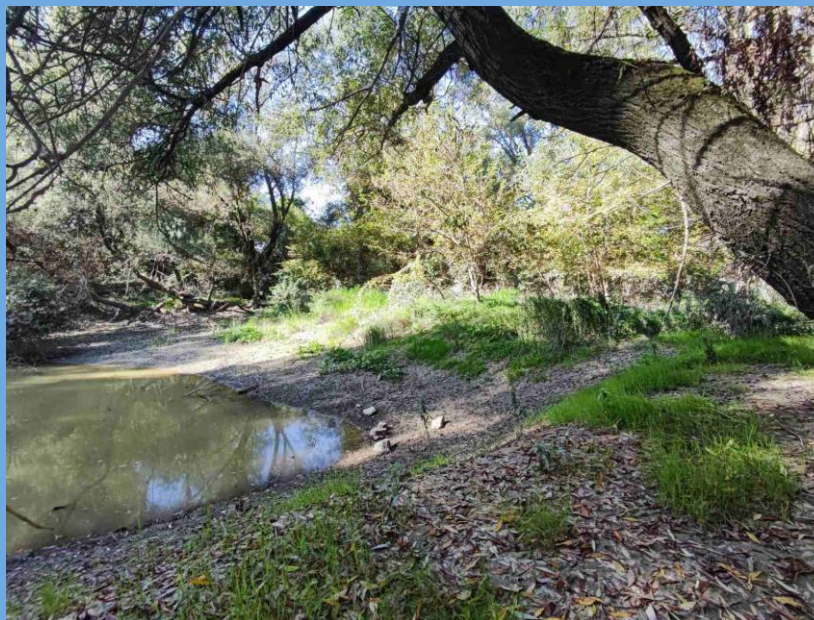
- Infrastructure is in satisfying condition.
- Effect of material deposition finished (upstream, downstream).
- Material deposit upstream and downstream of the groyne and overgrowth of plants are visible. Stone material is not visible.

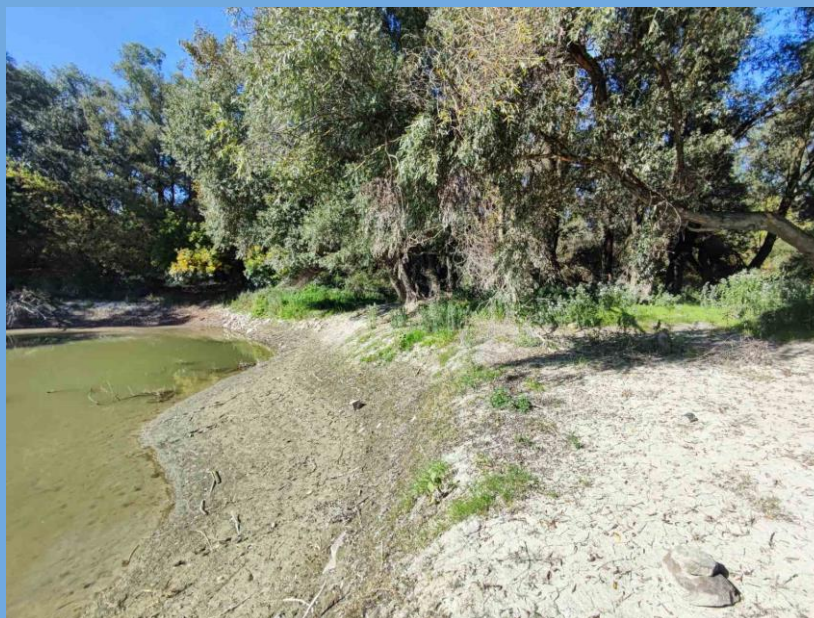
- Infrastructure is in satisfying condition.
- Effect of material deposition finished (upstream, downstream).
- Material deposit upstream and downstream of the groyne and overgrowth of plants are visible. Stone material is not visible.

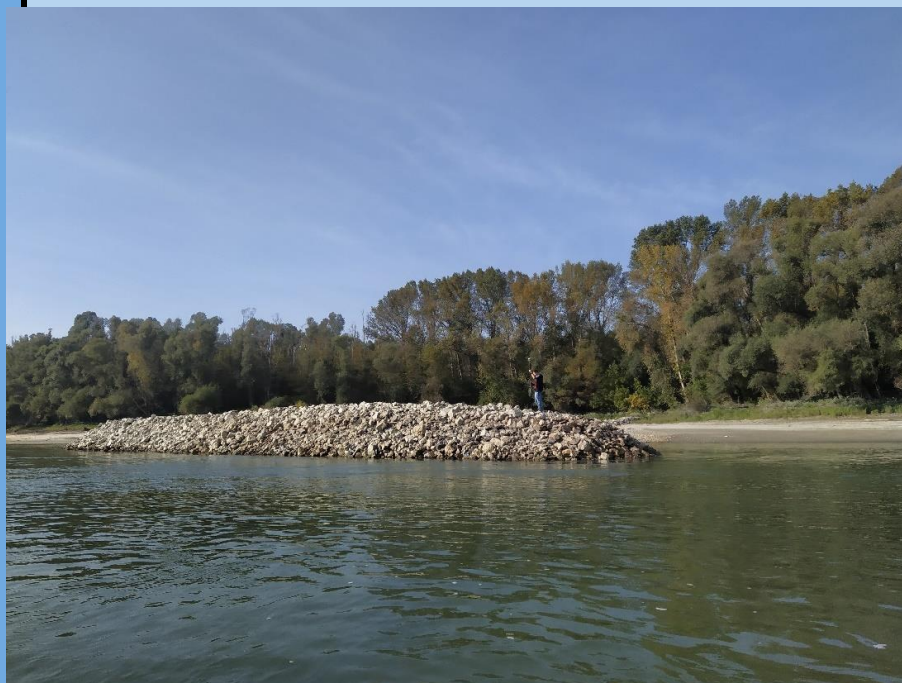
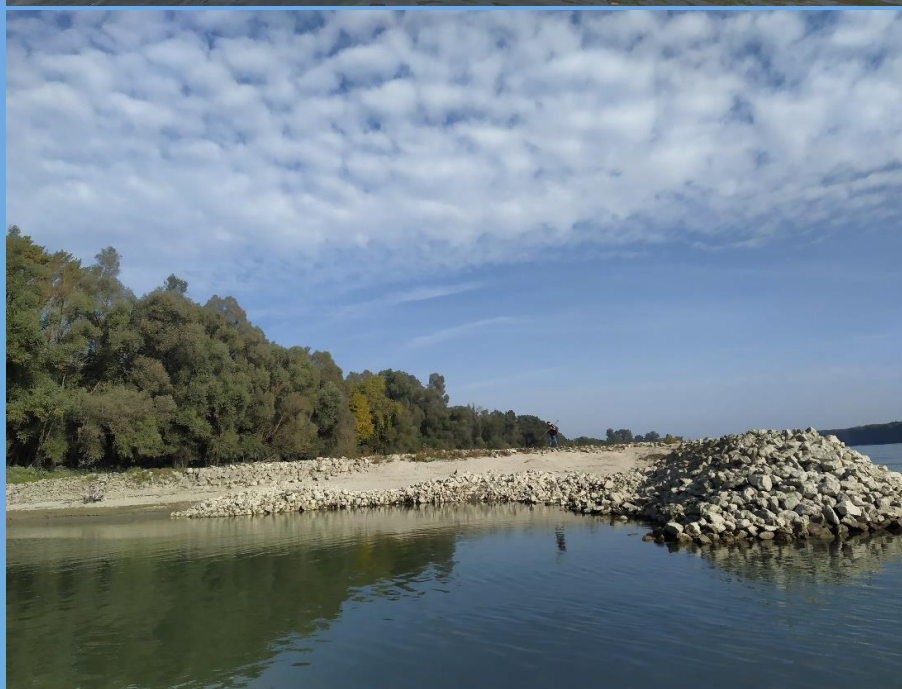
23. Right bank	Type:	Chainage (r.km)	Length (m)	Crown elevation (m.a.s.l.)
<b>1421-D1</b>	T-groyne	1421+288	52,42	81,71

- Infrastructure is in satisfying condition.
- Effect of material deposition ongoing (upstream, downstream).
- Collapsed part of the groyne head and material deposit upstream and downstream of the groyne are visible. Downstream on the groyne connection, stone washout under the groyne crown connection is visible.

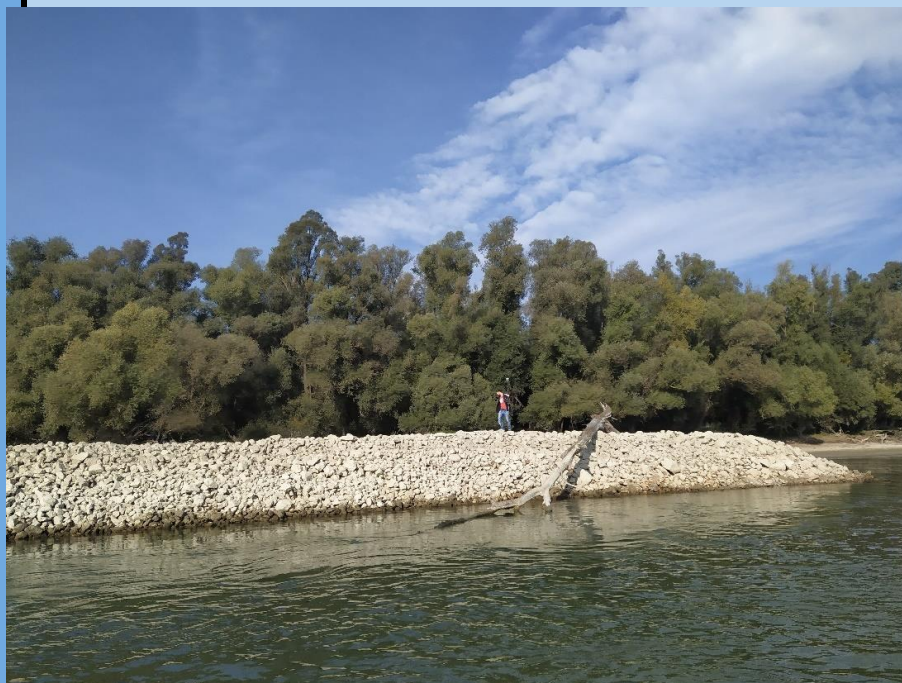
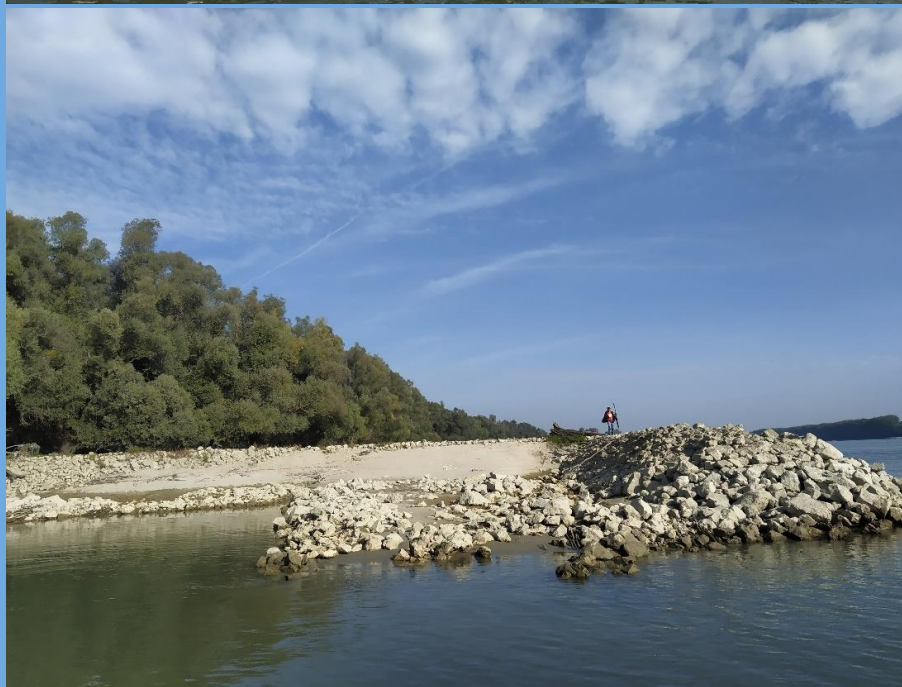
24. Right bank	Type:	Chainage (r.km)	Length (m)	Crown elevation (m.a.s.l.)
<b>1420-D2</b>	T-groyne	1420+980	52,21	81,82

- Infrastructure is in satisfying condition.
- Effect of material deposition ongoing (upstream, downstream).
- Collapsed part of the groyne head and material deposit upstream and downstream of the groyne are visible. Downstream on the groyne connection, stone washout under the groyne crown connection is visible.

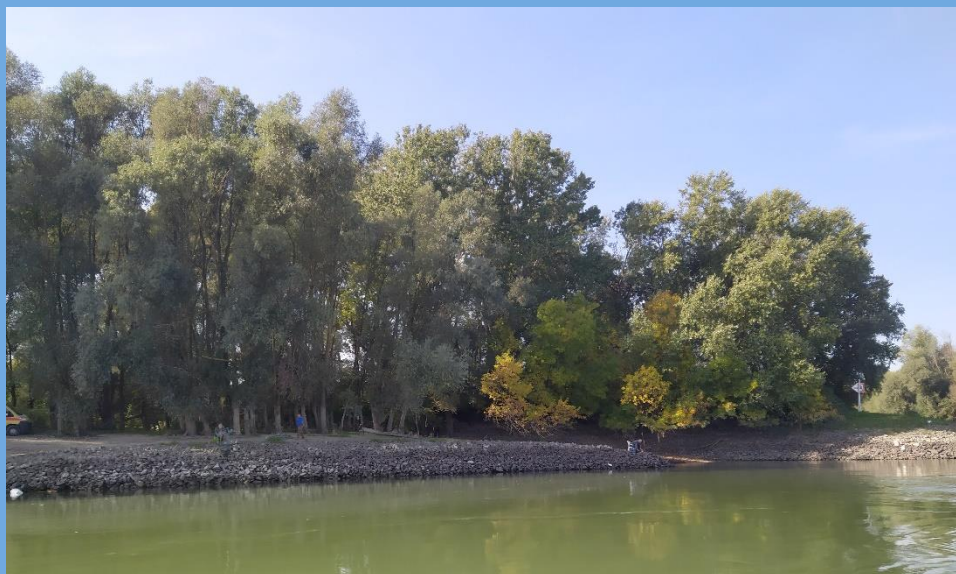
- Infrastructure is in good condition.
- Effect of material deposition ongoing (upstream, downstream).
- Stone material of groyne head is visible. Groyne connection is overgrown with plants and covered with sand.

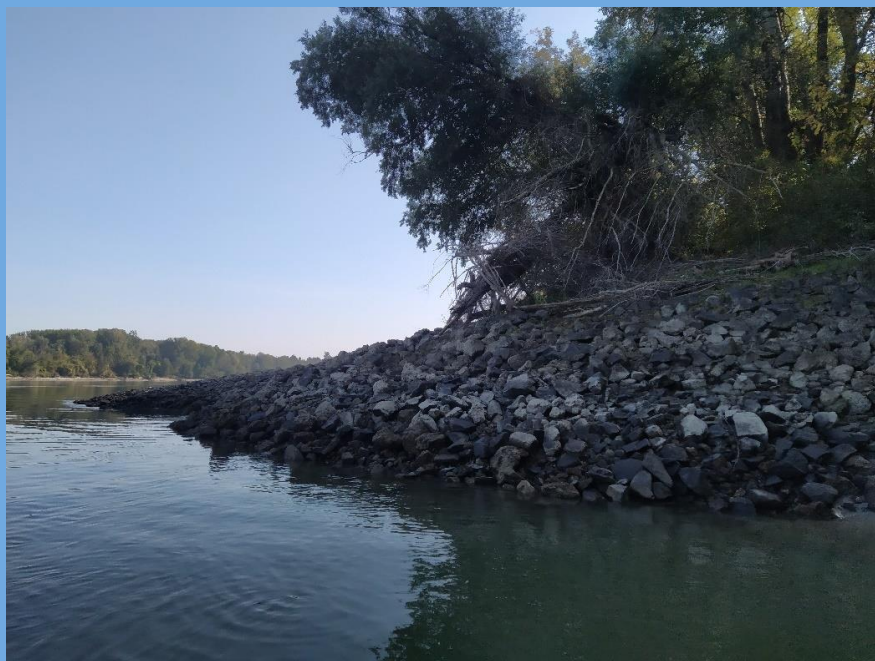
- Infrastructure is in satisfying condition..
- Effect of material deposition ongoing (upstream, downstream).
- Sand deposit upstream and downstream of the groyne. Stone material of groyne head is visible.

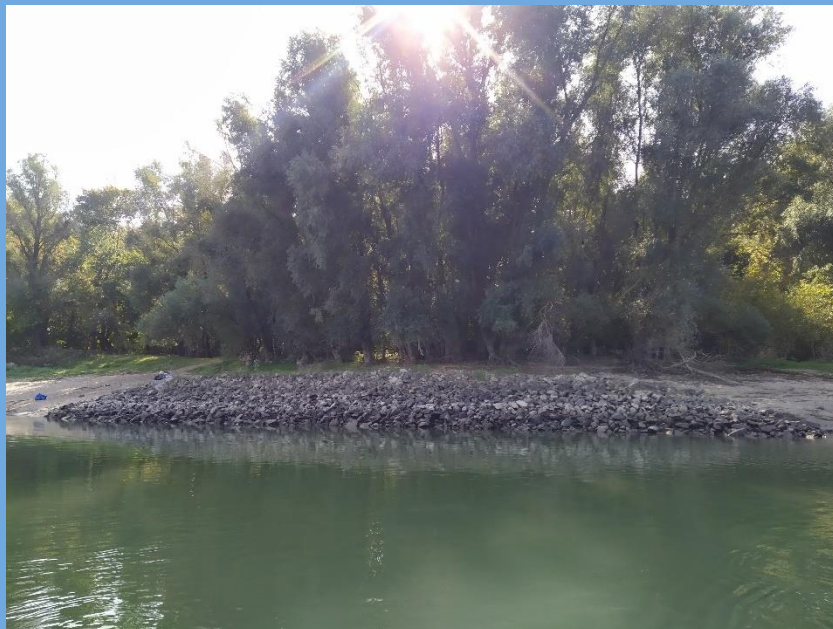
- Infrastructure is in satisfying condition.
- Effect of material deposition ongoing (upstream, downstream).
- Material deposition upstream and downstream of the parallel structure is present. Stone material of parallel structure at low water levels can be seen.

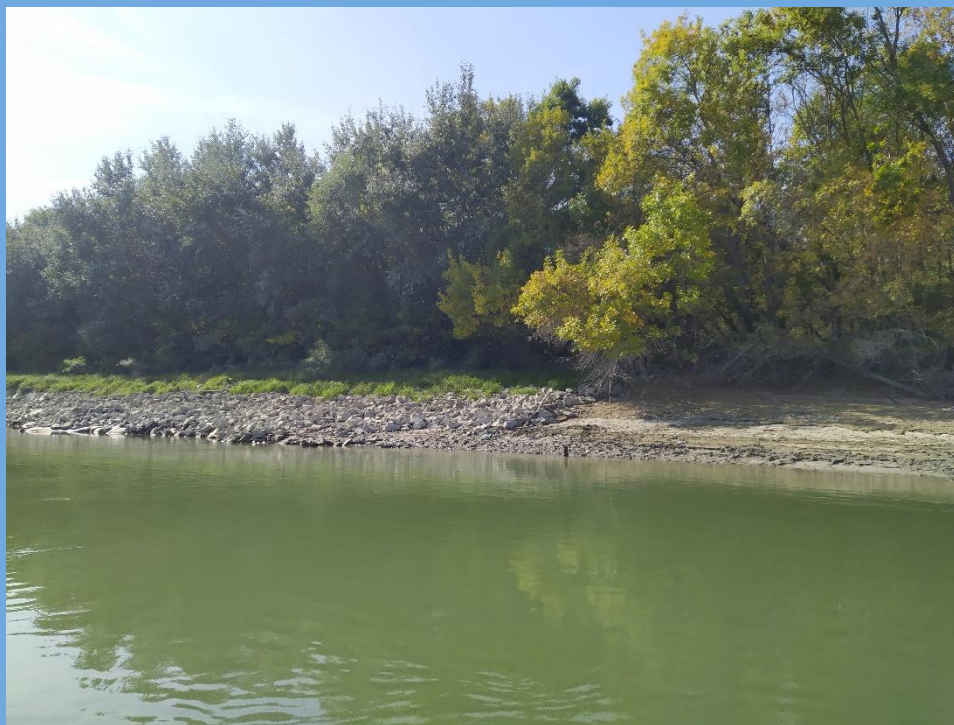
- Infrastructure is in satisfying condition.
- River bank erosion protection ongoing at low water levels.
- Stone material of revetment is visible. Revetment is partially washed away and geotextile is spotted beneath the stone material.

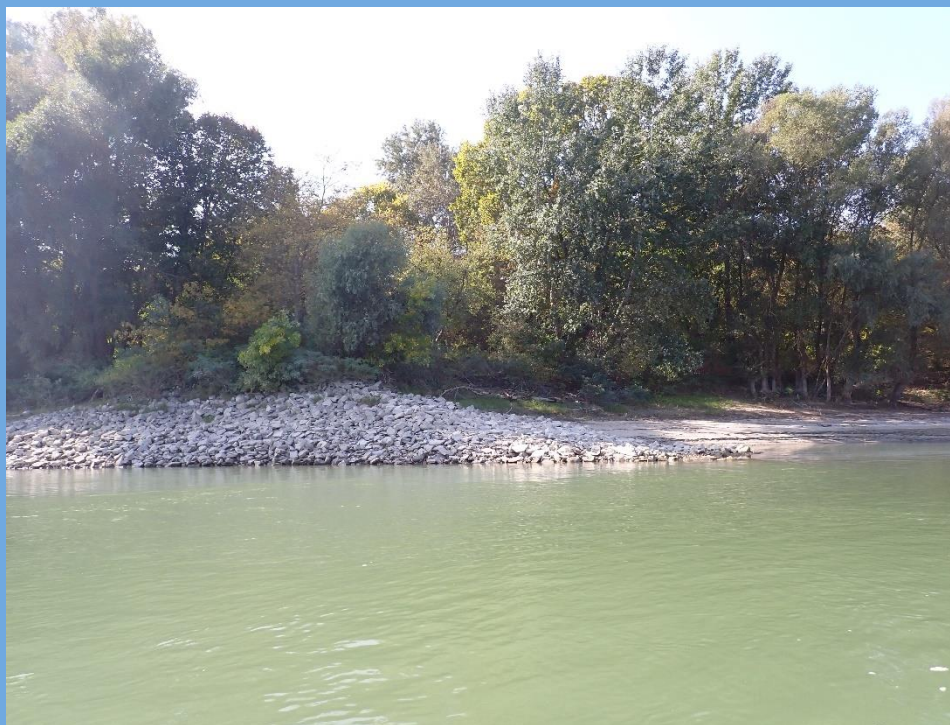
- Infrastructure is in excellent condition.
- River bank erosion protection ongoing at low water levels.
- Stone material of revetment and vegetation above it are visible.

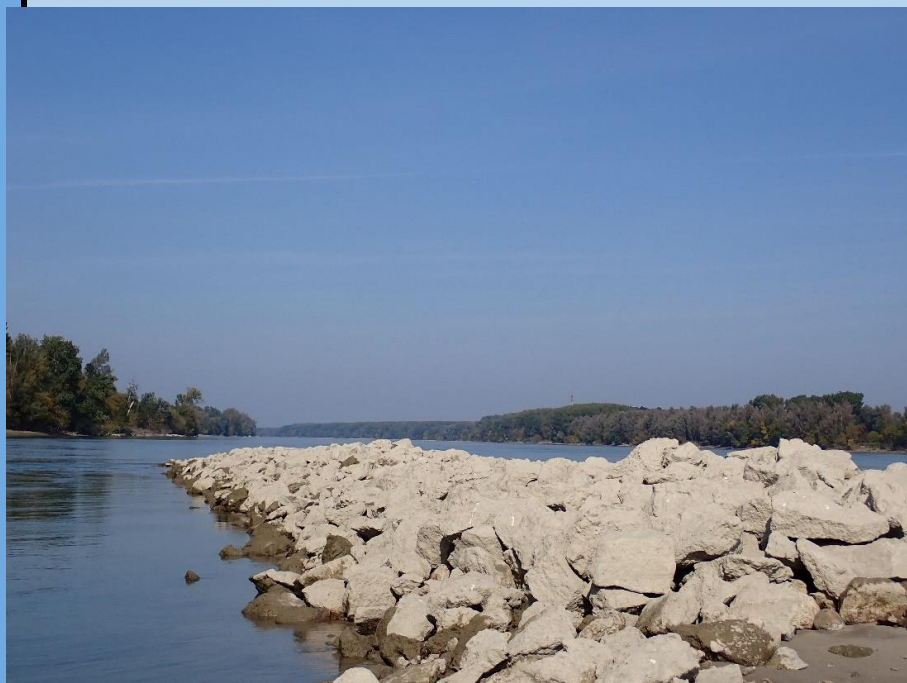
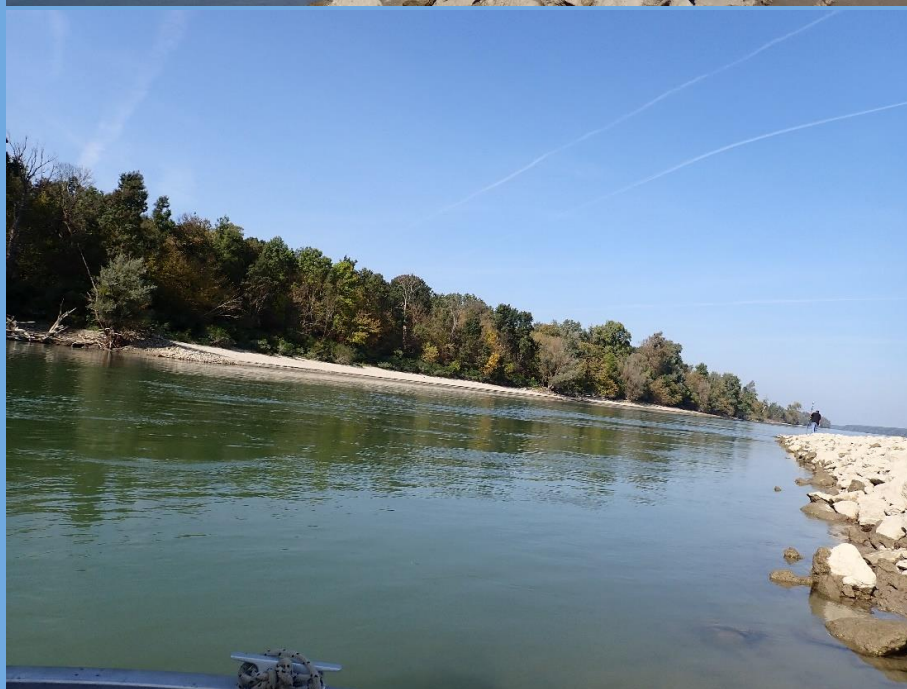
34. Right bank	Type:	Chainage (r.km)	Length (m)	Crown elevation (m.a.s.l.)
<b>1409-D2</b>	T-groyne	1409+413	98,57	78,89

- Infrastructure is in bad condition..
- Effect of material deposition failed.
- Stone material of groyne head and rooting of groyne are visible. Groyne head and groyne connection are separated.
