**MONITORING OF HYDROLOGICAL, HYDRAULIC AND MORPHOLOGICAL CHARACTERISTICS OF THE DANUBE RIVER AND INVENTORY OF BIODIVERSITY COMPONENTS ON THE JOINT CROATIAN-SERBIAN SECTOR OF THE DANUBE RIVER**

**INVENTORY OF RIVER REGULATION INFRASTRUCTURE RELATED TO NAVIGATION**

**Project number:** I-2206/24

**LOCATION:** Danube river from rkm 1295,5 (Ilok) to rkm 1433,1  
(border with Hungary)

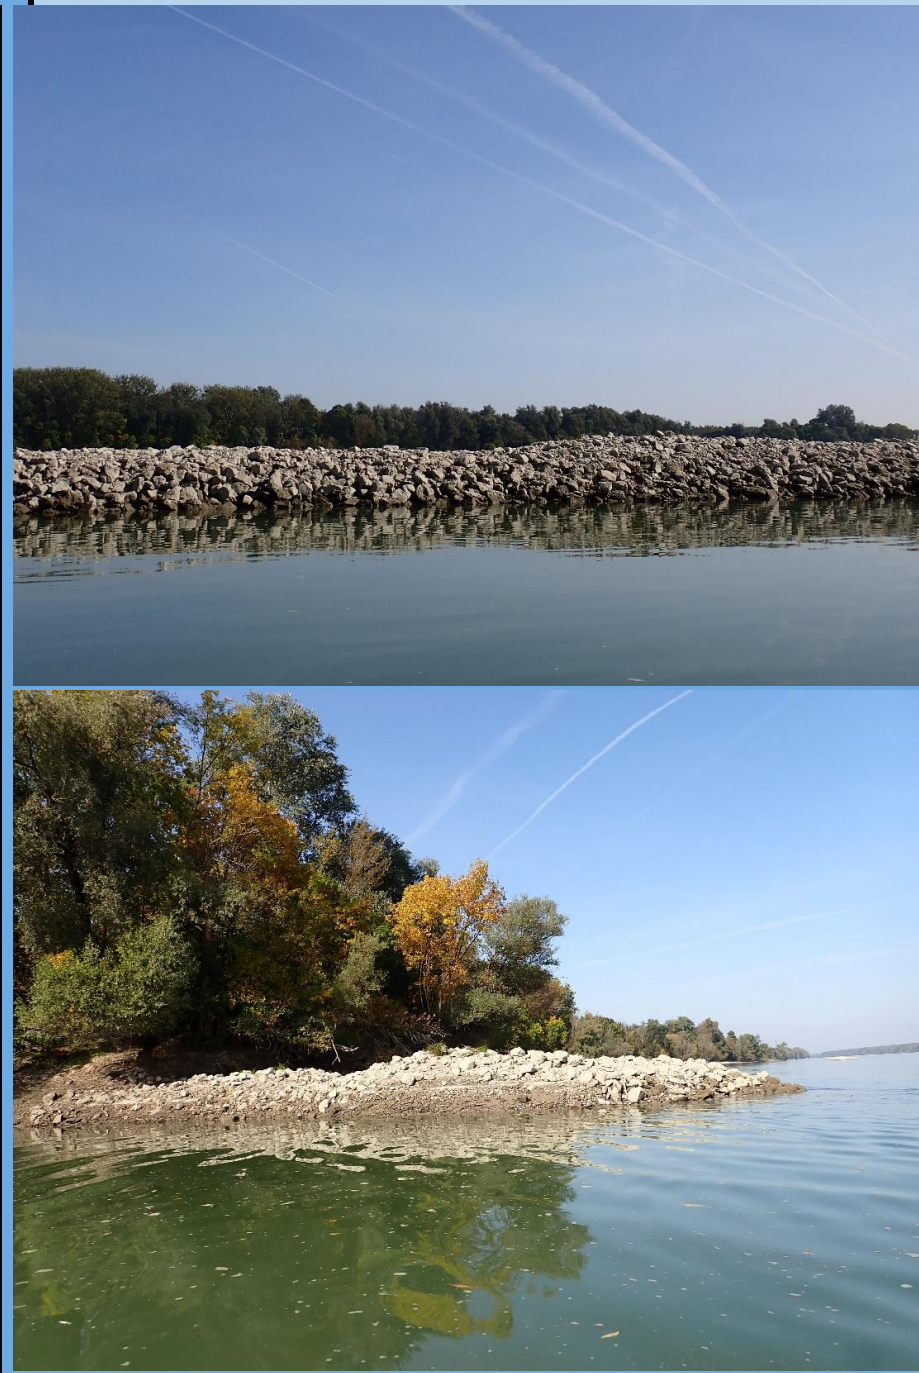
35. Right bank	Type:	Chainage (r.km)	Length (m)	Crown elevation (m.a.s.l.)
<b>1409-D1</b>	T-groyne	1409+115	139,74	80,48

- Infrastructure is in bad condition.
- Effect of material deposition failed.
- Stone material of groyne head and rooting of groyne are visible. Groyne head and groyne connection are separated.

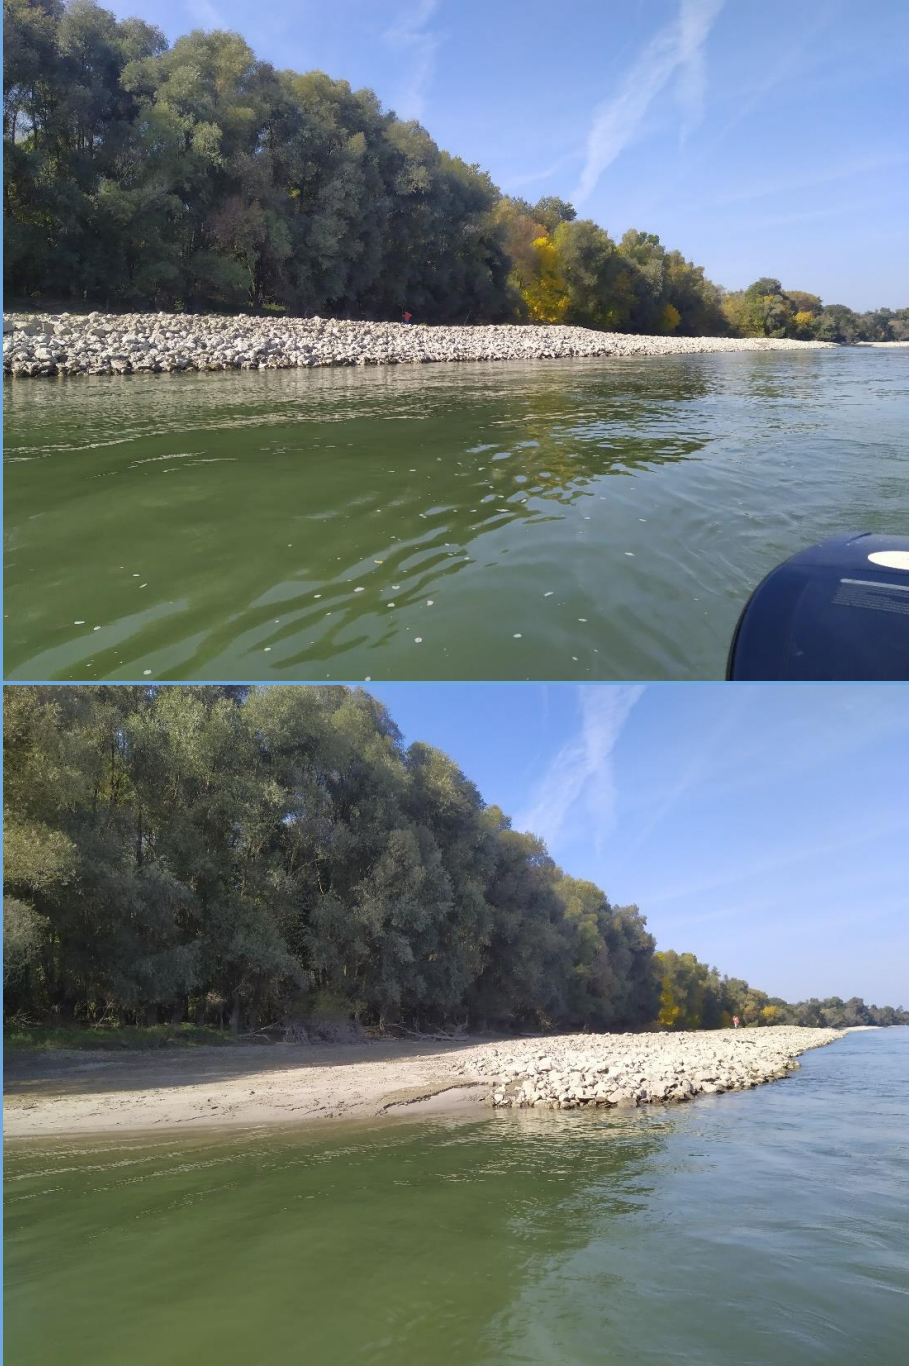
36. Right bank	Type:	Chainage (r.km)	Length (m)	Crown elevation (m.a.s.l.)
<b>1408-D3</b>	T-groyne	1408+819	203,94	80,88

- Infrastructure is in excellent condition.
- Effect of material deposition ongoing (upstream, downstream).
- Groyne head and groyne connection are visible. Material deposition on the river bank downstream of the groyne, upstream still in the function of material deposition.

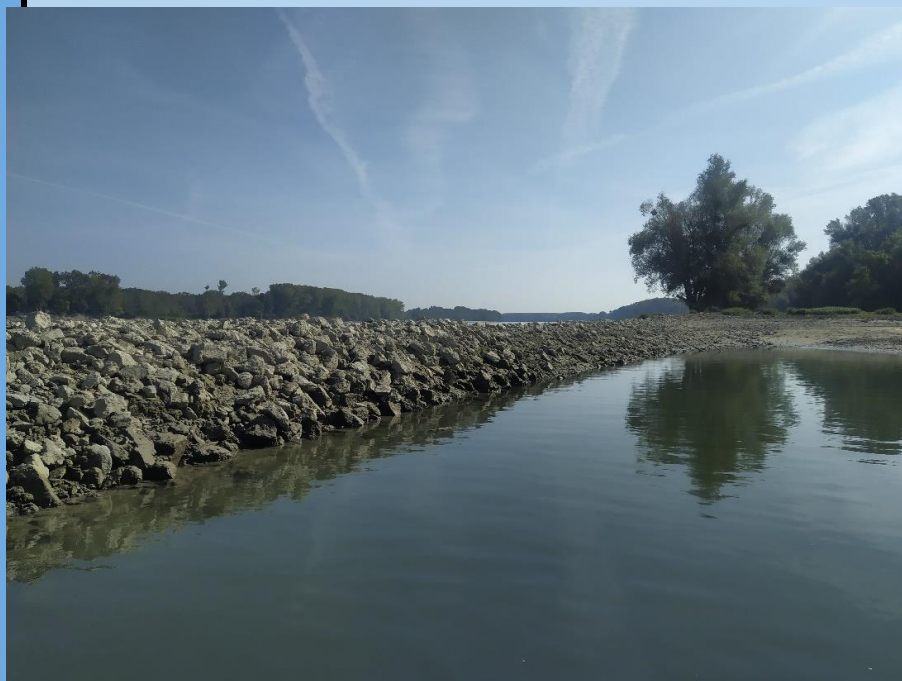
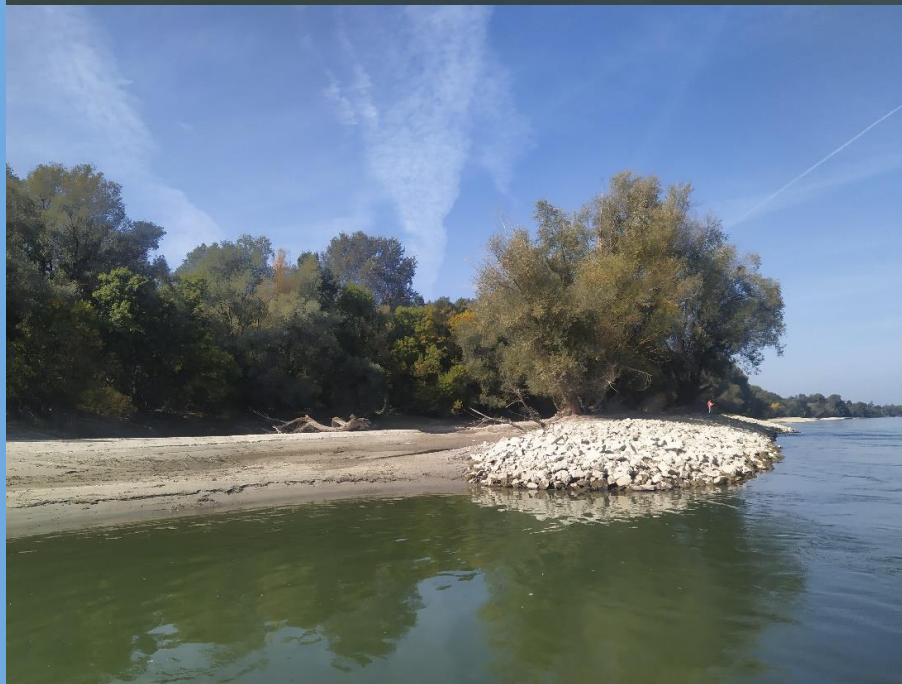
37. Right bank	Type:	Chainage (r.km)	Length (m)	Crown elevation (m.a.s.l.)
<b>1408-D2</b>	T-groyne	1408+532	151,05	80,89

- Infrastructure is in excellent condition.
- Effect of material deposition ongoing (upstream, downstream).
- Groyne head and groyne connection are visible. Material deposition on the river bank downstream of the groyne, upstream still in the function of material deposition. Trees are visible on the groyne crown.

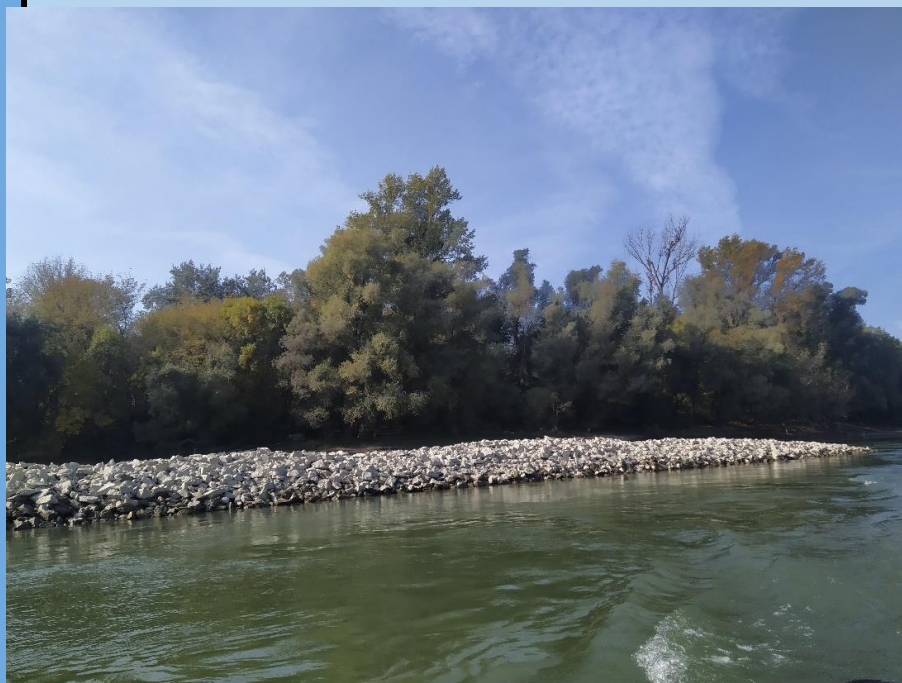
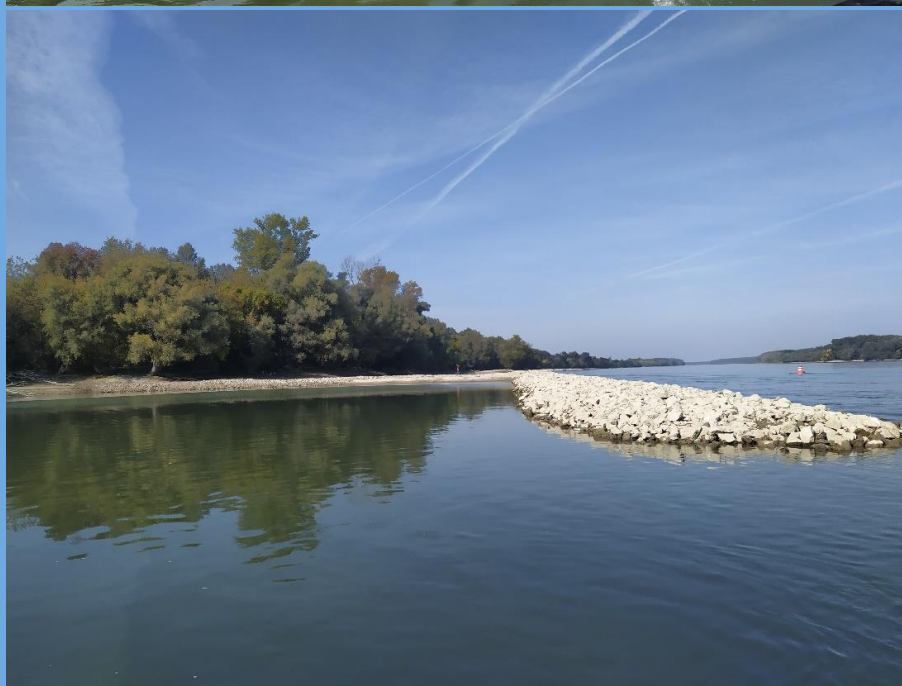
38. Right bank	Type:	Chainage (r.km)	Length (m)	Crown elevation (m.a.s.l.)
<b>1408-D1</b>	T-groyne	1408+245	149,85	80,05

- Infrastructure is in excellent condition.
- Effect of material deposition ongoing (upstream, downstream).
- Groyne head and groyne connection are visible. The beginning of material deposition upstream and downstream of the groyne is present. Downstream on the groyne connection, stone washout under the groyne crown connection is visible.

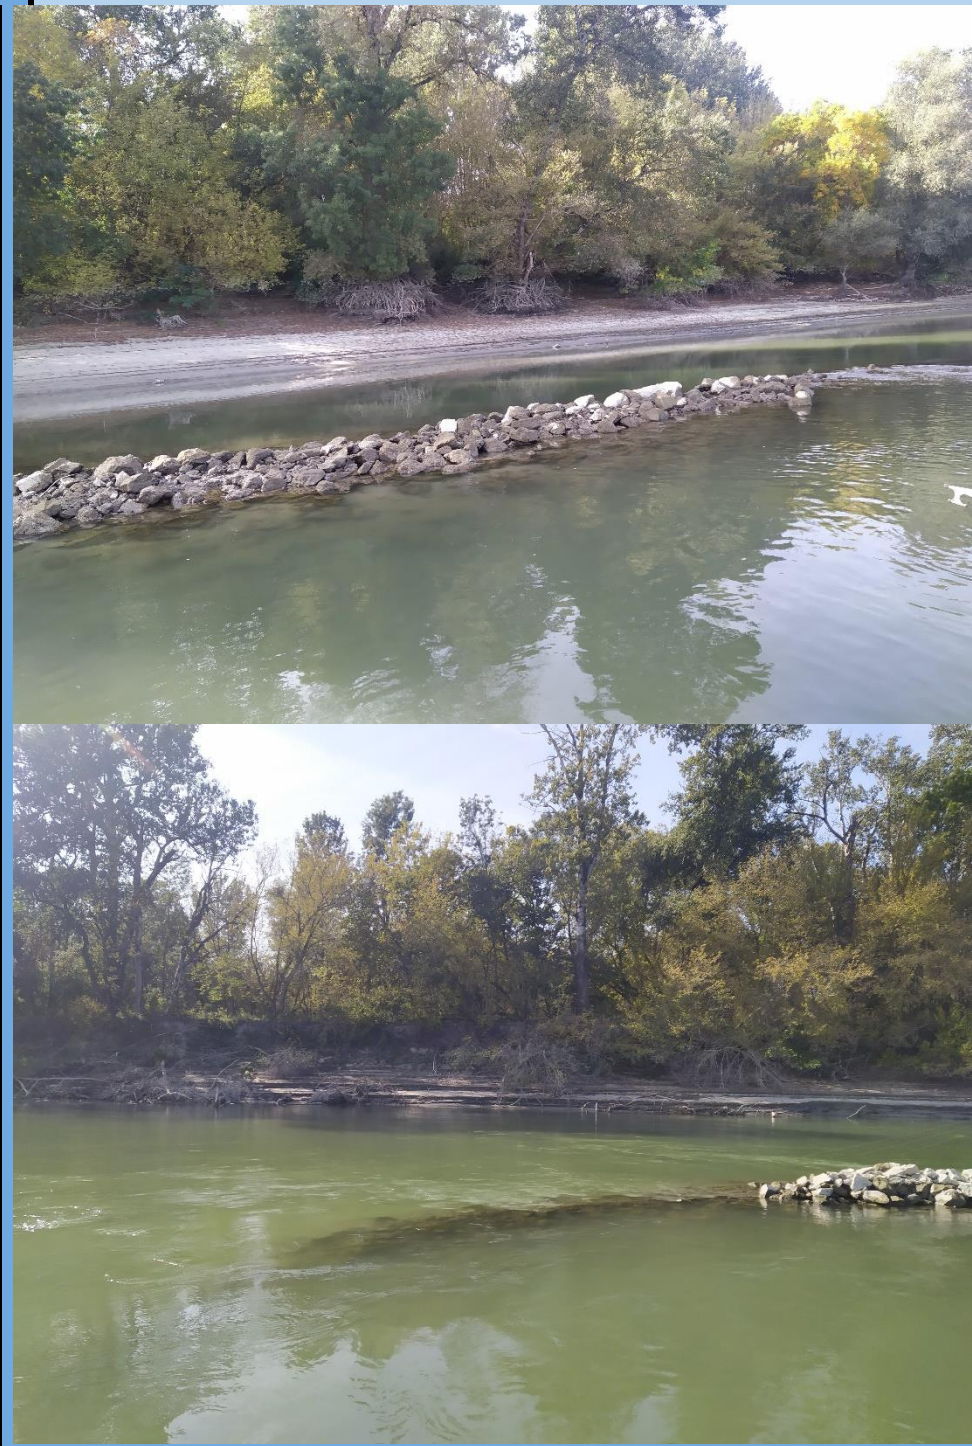
39. Right bank	Type:	Chainage (r.km)	Length (m)	Crown elevation (m.a.s.l.)
<b>1407-D2</b>	Parallel structure	1407+860 do 1407+751	111,89	79,14

- Infrastructure is in bad condition.
- Effect of material deposition failed (upstream, downstream).
- Collapsed stone material of parallel structure is visible at low water levels.

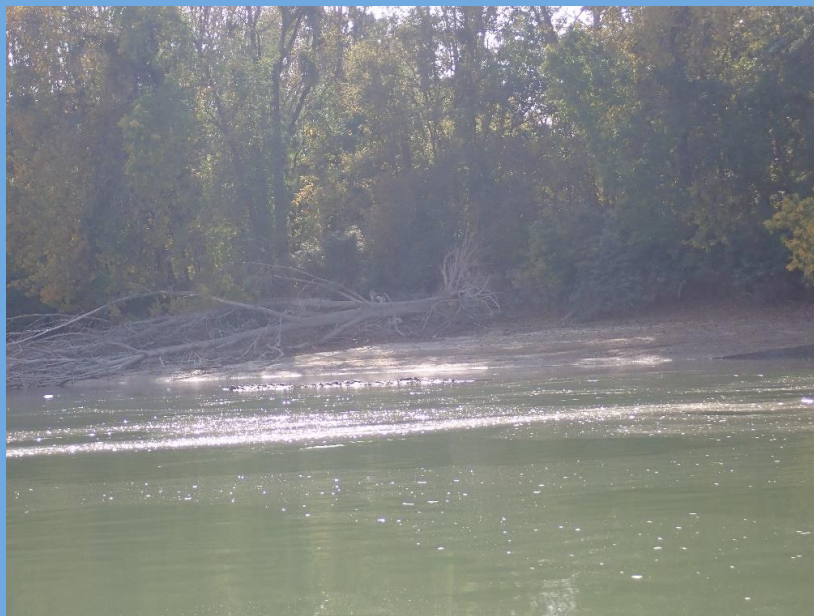
- Infrastructure is in bad condition..
- River bank erosion protection failed.
- Stone revetment. Washout and collapse of river bank behind revetment are spotted. Stone material is visible at low water levels.

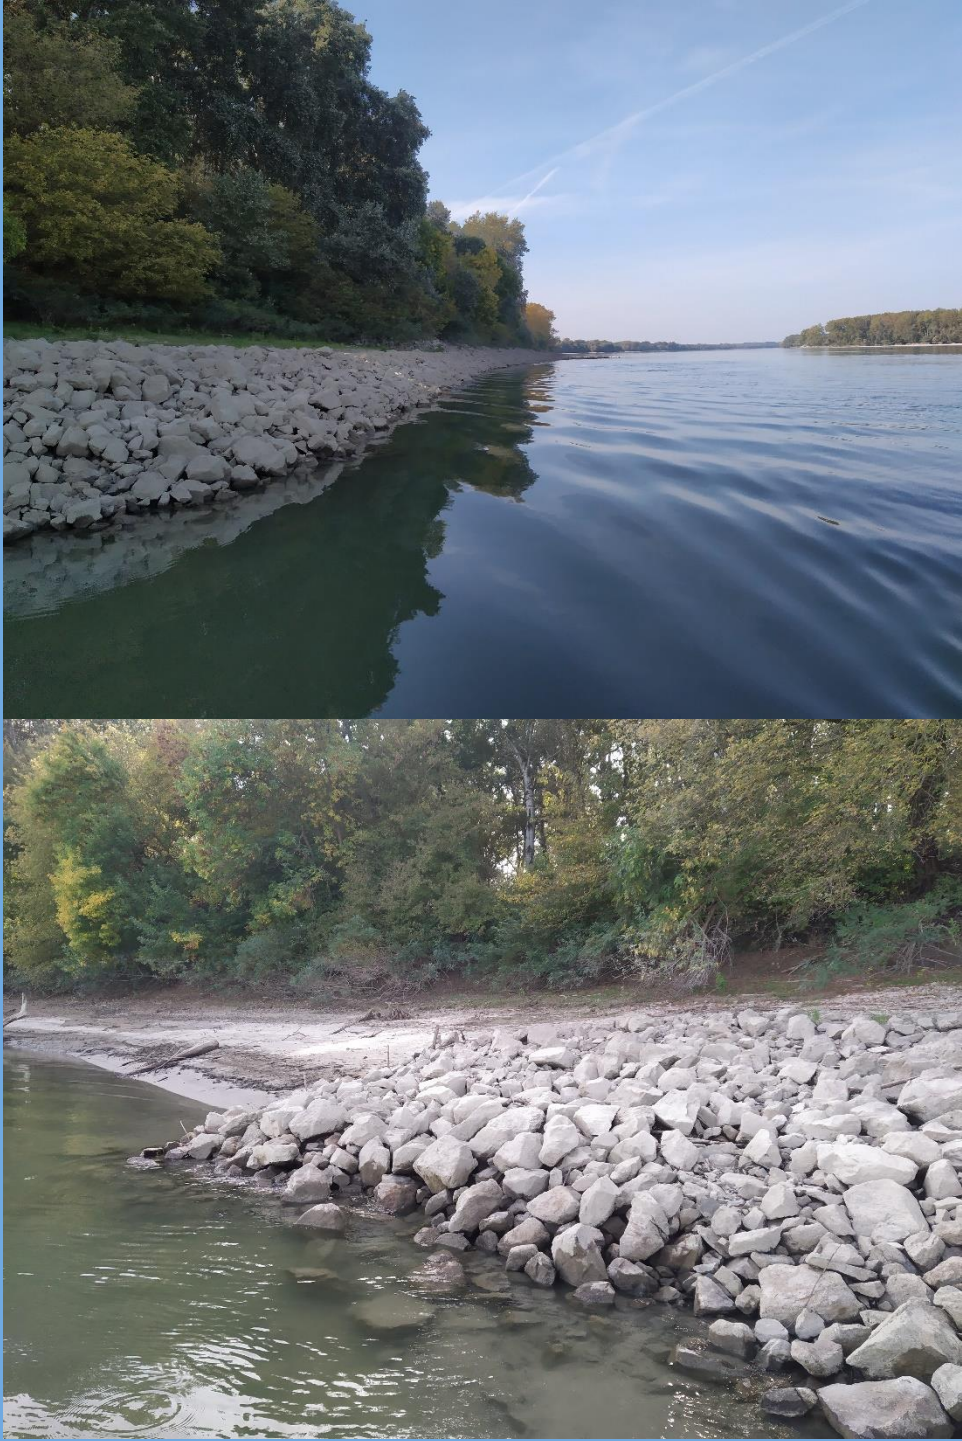
41. Right bank	Type:	Chainage (r.km)	Length (m)	Crown elevation (m.a.s.l.)
<b>1406-D3</b>	Revetment	1406+978 do 1406+667	238,98	81,10

- Infrastructure is in excellent condition.
- River bank erosion protection ongoing at low water levels.
- Stone material of revetment is visible as well as vegetation above it. Revetment is continuous.

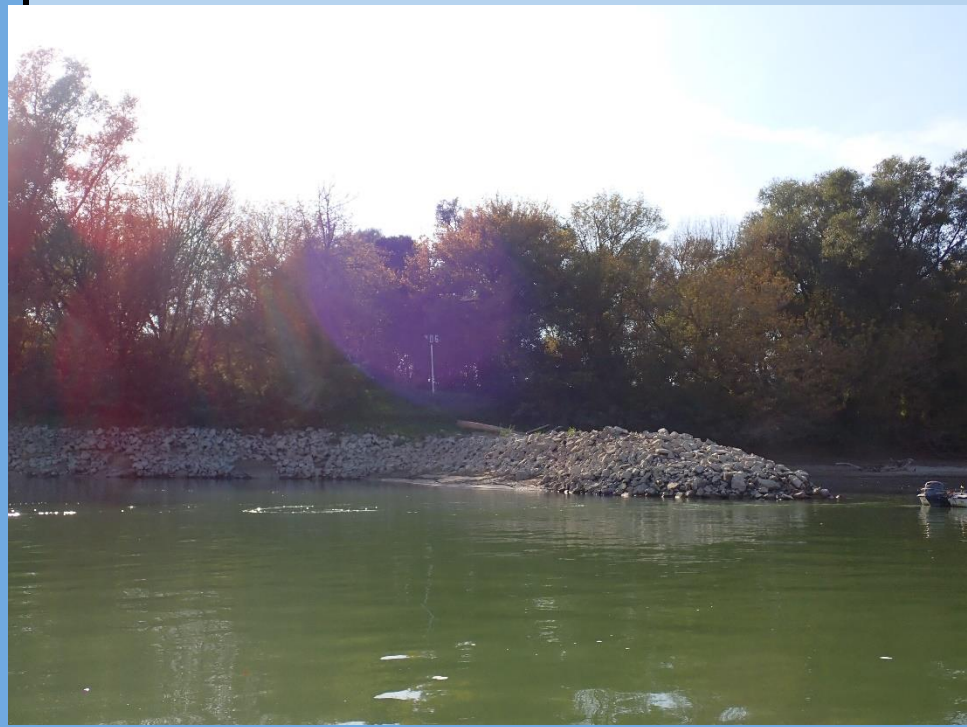
43. Right bank	Type:	Chainage (r.km)	Length (m)	Crown elevation (m.a.s.l.)
<b>1406-D1</b>	Groyne	1406+001	32,98	81,09

- Infrastructure is in excellent condition..
- Effect of material deposition ongoing (upstream, downstream).
- Stone material of groyne connection is visible. Newly built groyne.

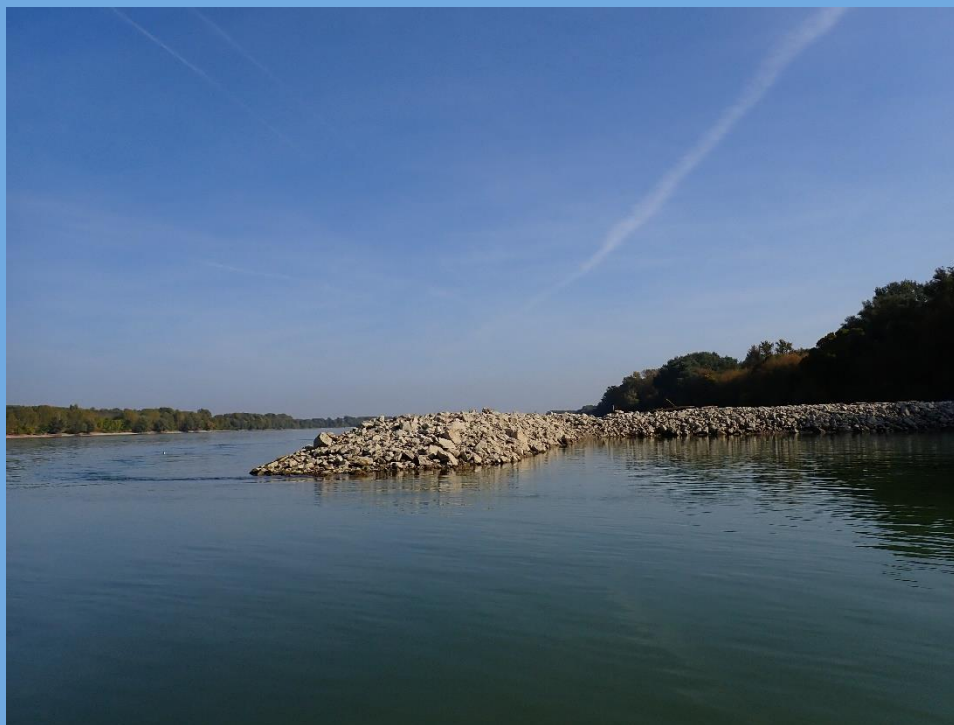
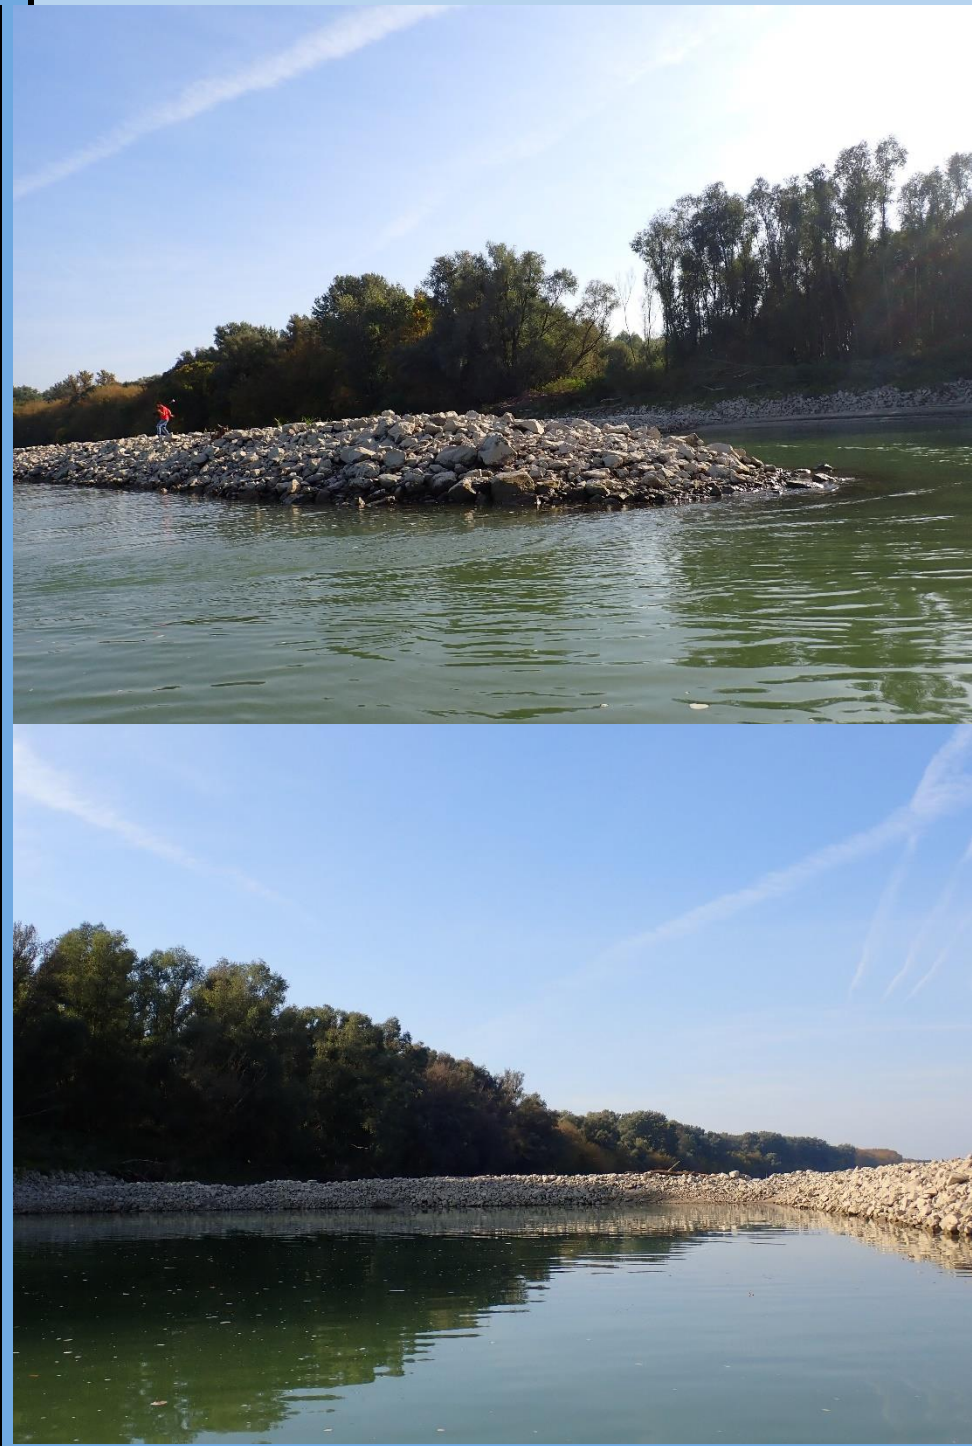
44. Right bank	Type:	Chainage (r.km)	Length (m)	Crown elevation (m.a.s.l.)
<b>1405-D2</b>	T-groyne	1405+691	93,24	79,77

- Infrastructure is in excellent condition.
- Effect of material deposition ongoing (upstream, downstream).
- T-groyne, stone material of groyne head and groyne connection is visible. Newly built groyne.

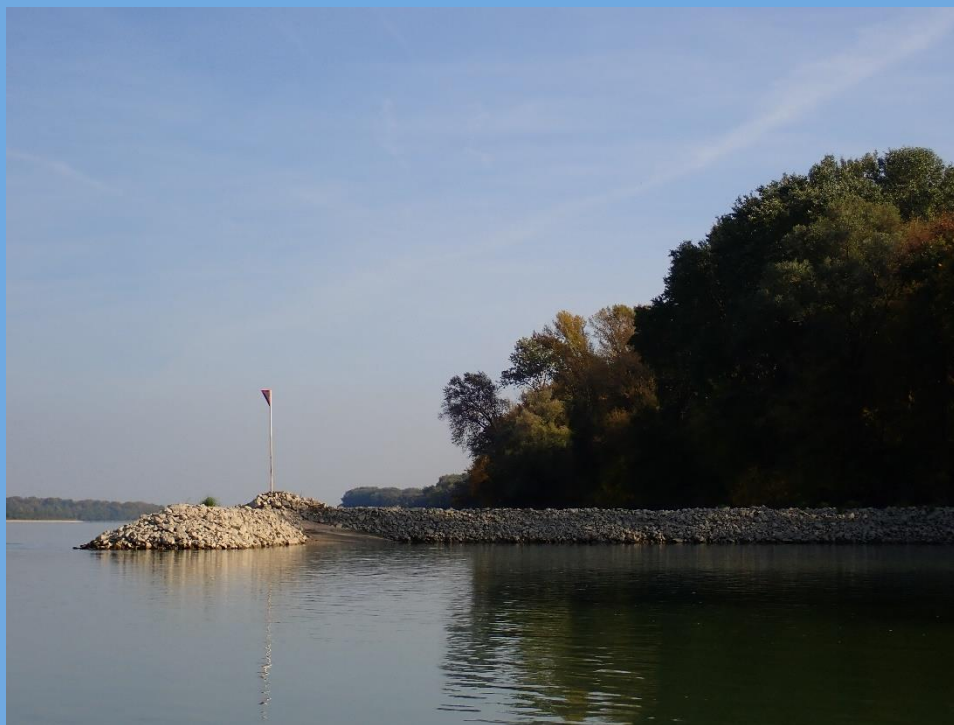
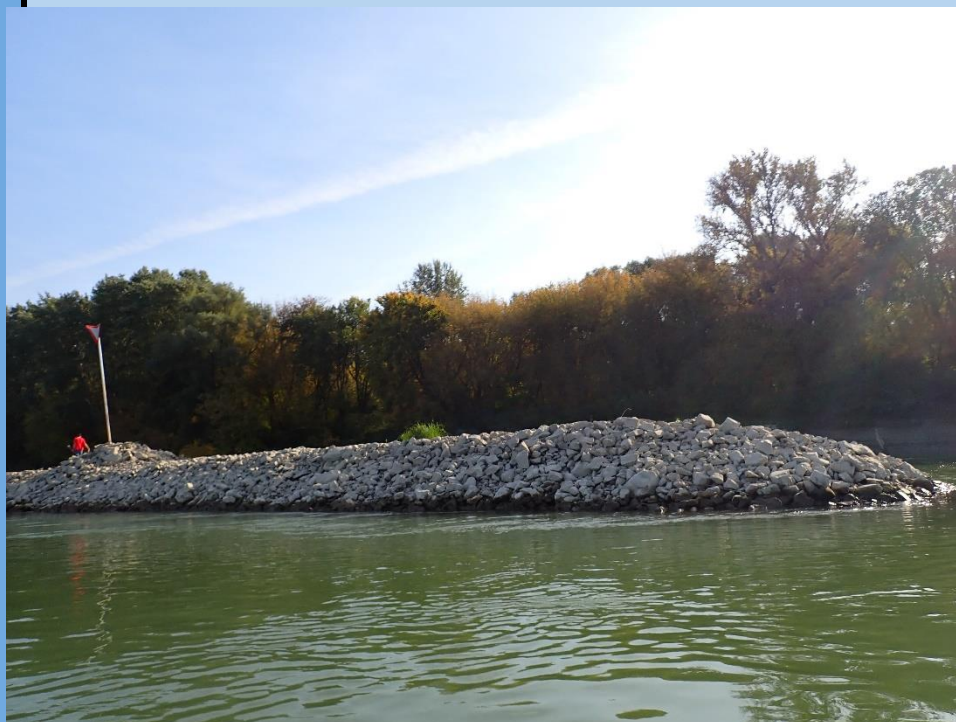
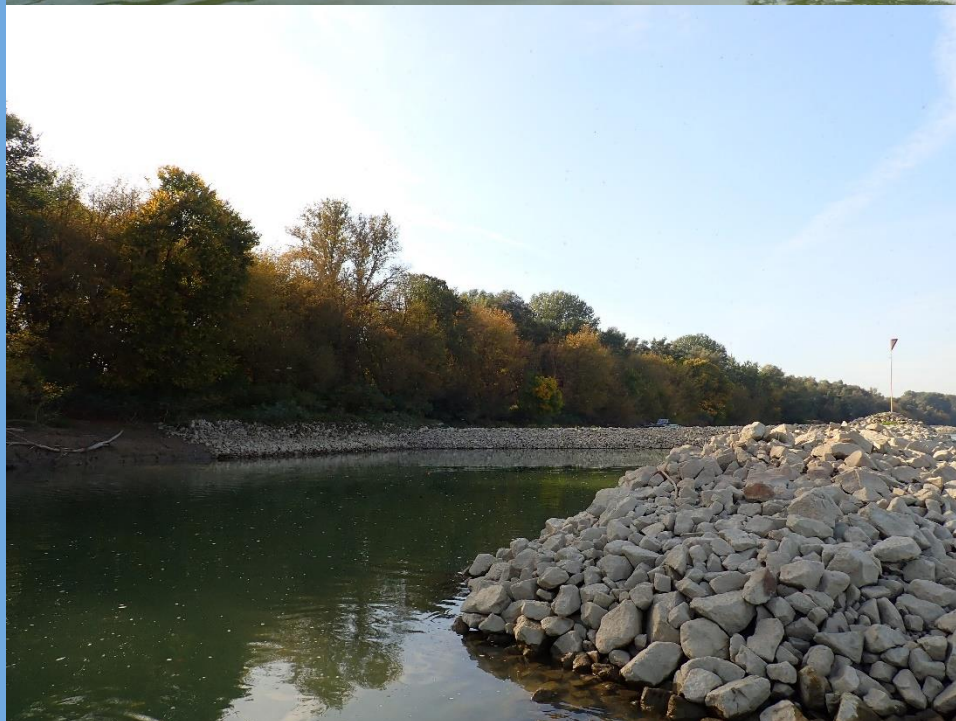
45. Right bank	Type:	Chainage (r.km)	Length (m)	Crown elevation (m.a.s.l.)
<b>1405-D1</b>	T-groyne	1405+383	93,25	81,38

- Infrastructure is in excellent condition.
- Effect of material deposition ongoing (upstream, downstream).
- T-groyne, stone material of groyne head and groyne connection is visible. Newly built groyne.

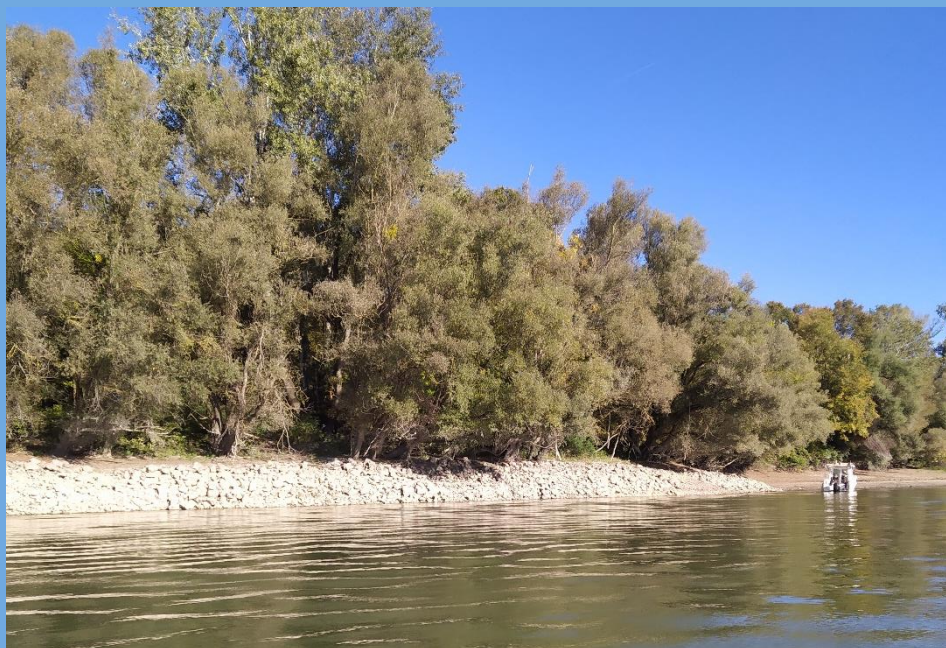
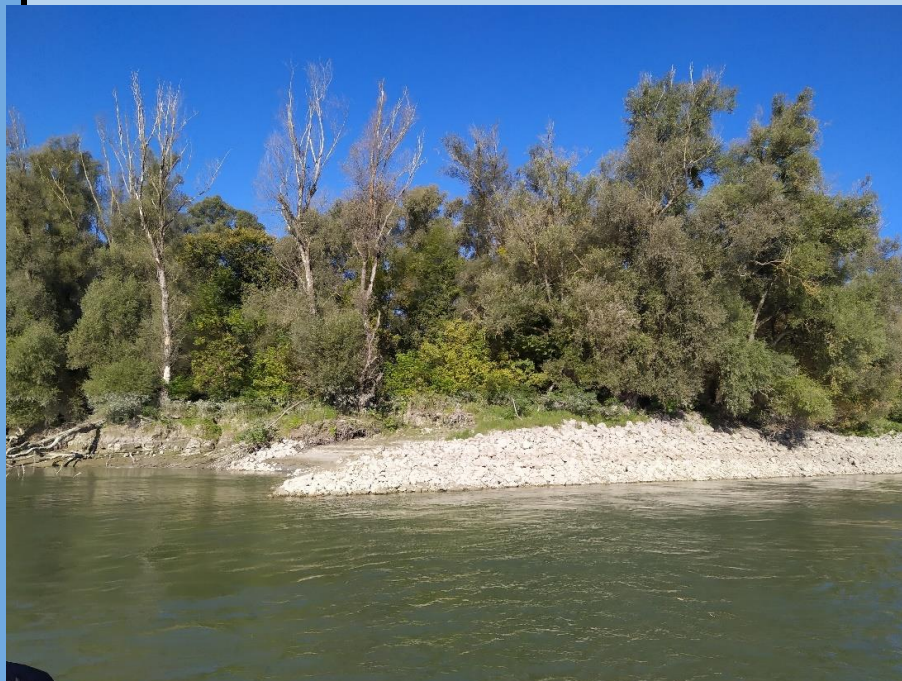
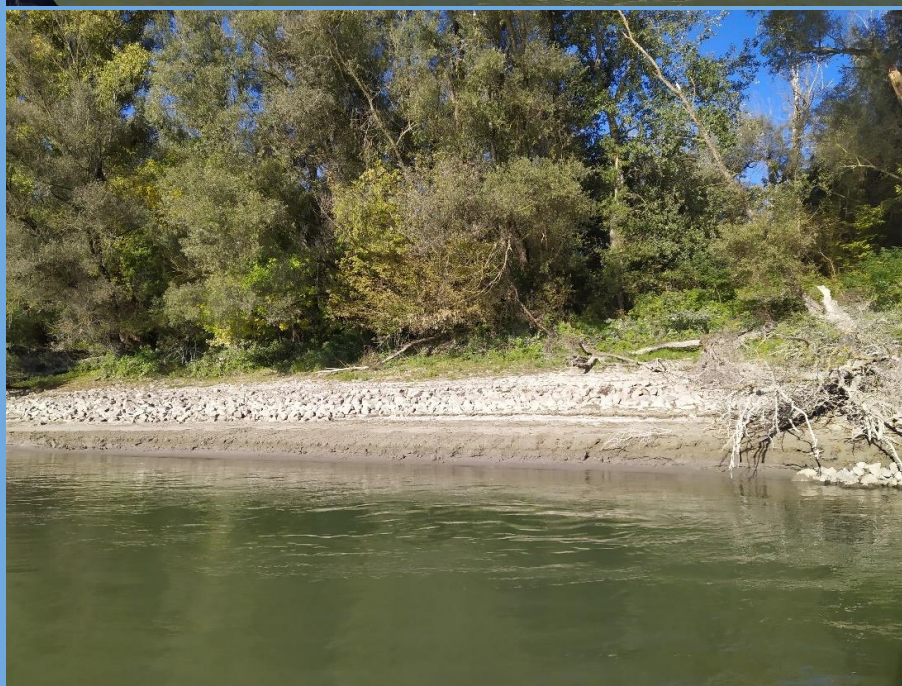
46. Right bank	Type:	Chainage (r.km)	Length (m)	Crown elevation (m.a.s.l.)
<b>1396-D1</b>	Revetment	1398+575 do 1396+740	1762,99	80,39

- Infrastructure is in good condition.
- River bank erosion protection ongoing at low water levels.
- Stone revetment above which is a stone river bank overgrown with plants and trees. A part of approx. 100 meters of the revetment has been washed away, no stone material is visible.

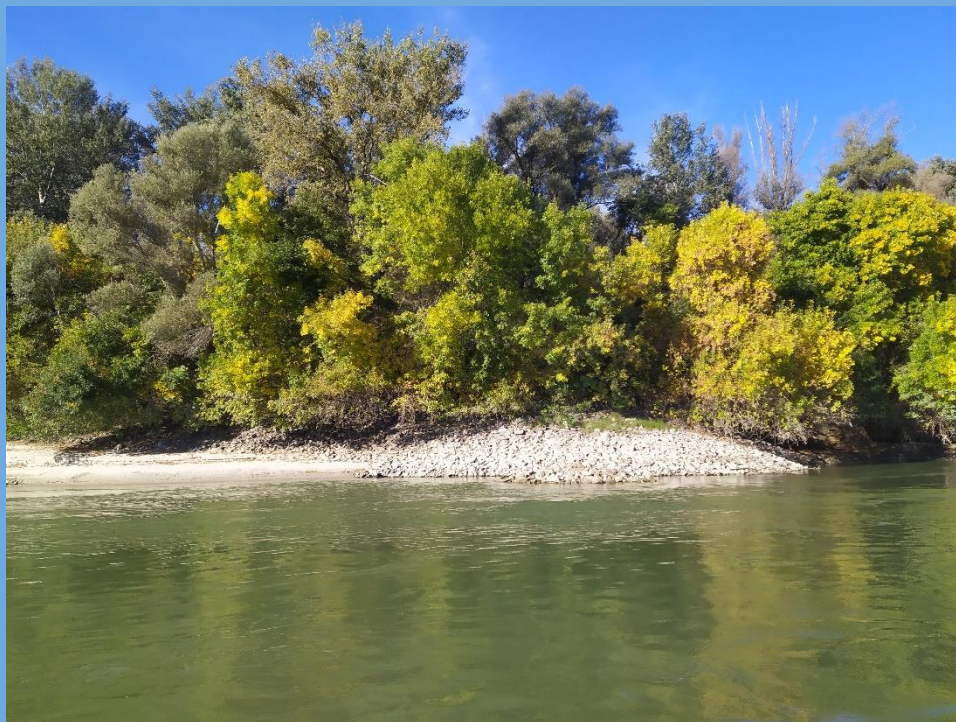
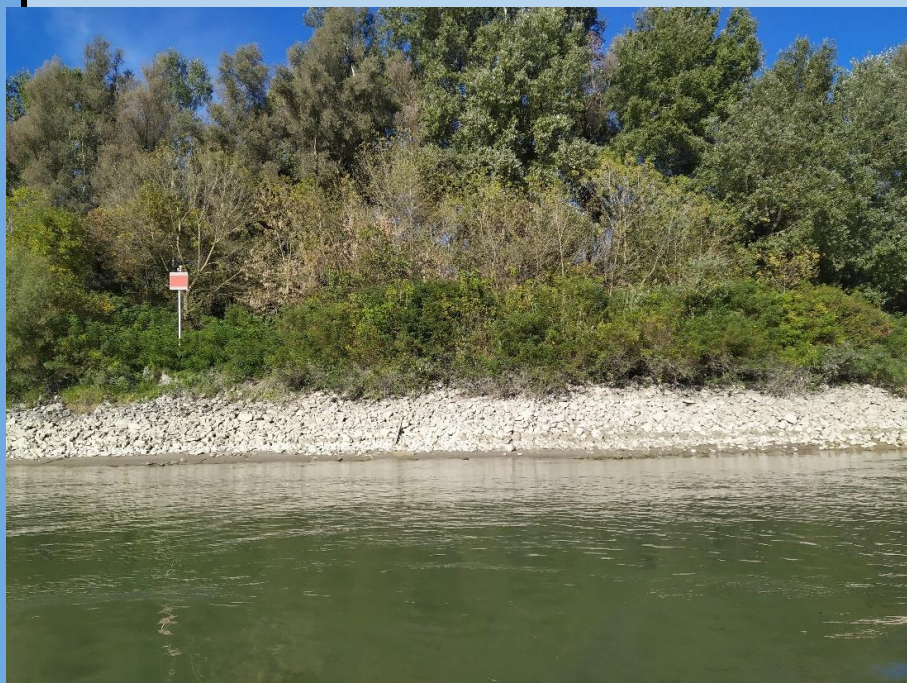
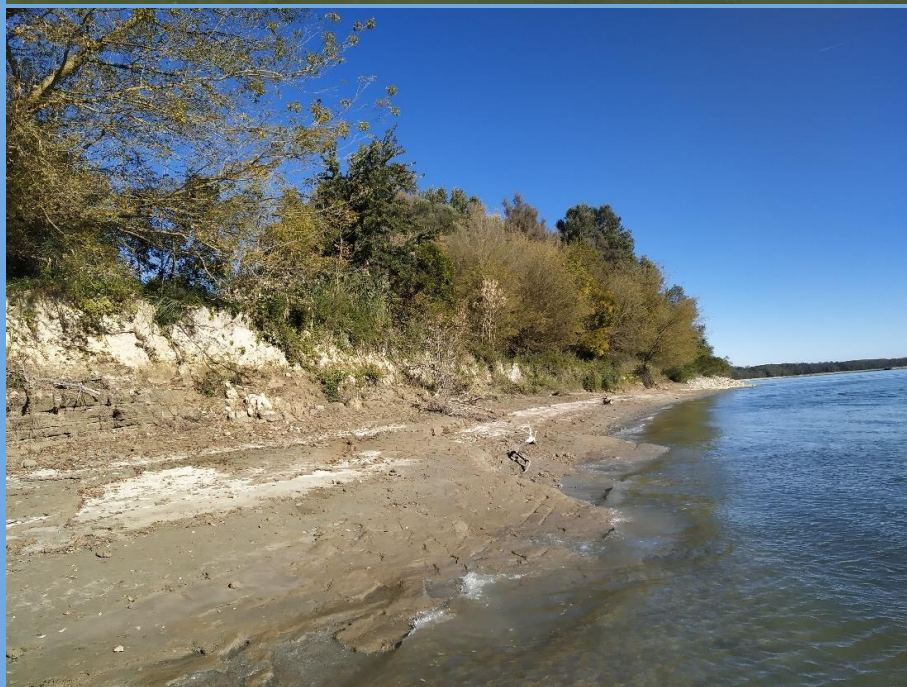
47. Right bank	Type:	Chainage (r.km)	Length (m)	Crown elevation (m.a.s.l.)
<b>1395-D1</b>	Imported fill	1396+614 do 1395+959	531,47	80,88

- Infrastructure is in satisfying condition.
- River bank protection from further erosion ongoing.
- Stone material on bevel of the river bank is visible, as well as vegetation above the stone material. At downstream part of landfill, stone material on bevel is not visible.

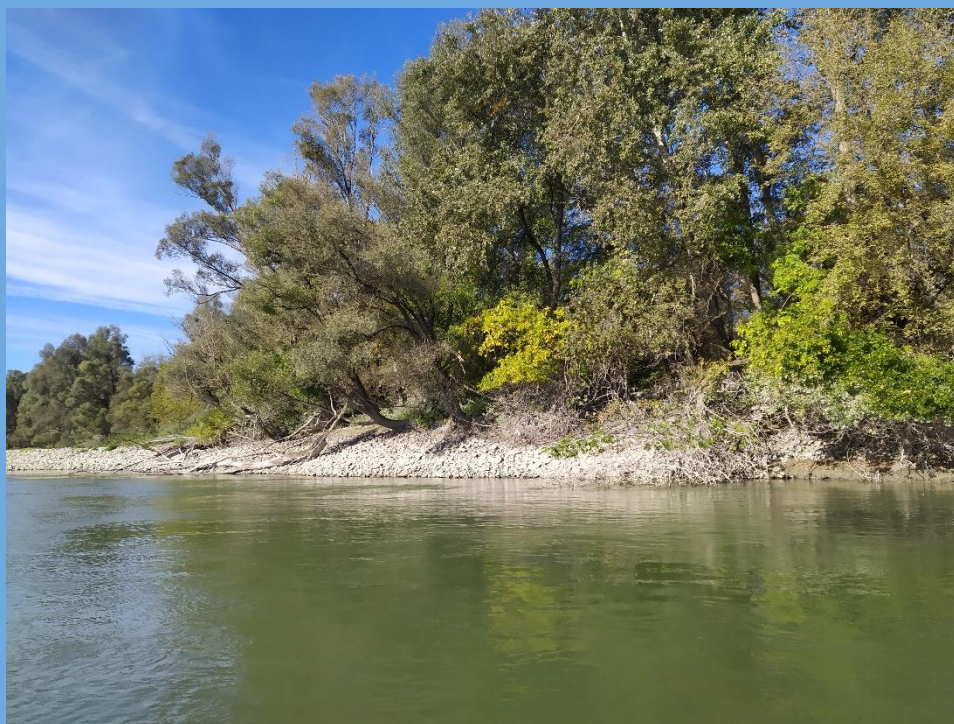
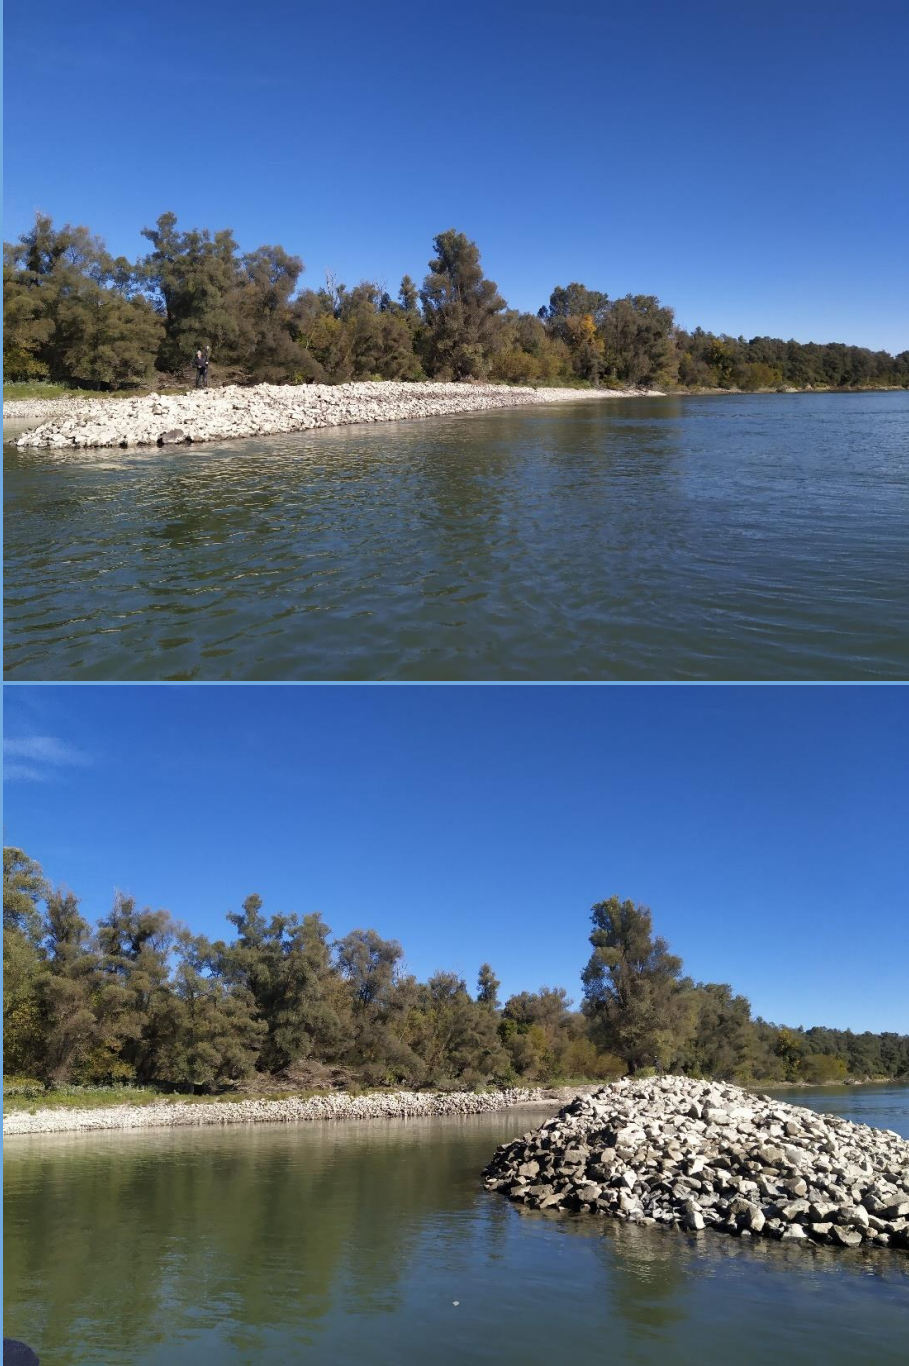
48. Right bank	Type:	Chainage (r.km)	Length (m)	Crown elevation (m.a.s.l.)
<b>1393-D3</b>	Parallel structure	1394+006 do 1393+640	389,24	80,38

- Infrastructure is in excellent condition.
- Effect of material deposition ongoing (downstream).
- Stone material of parallel structure is visible. A tree is present at junction of parallel and groyne 1393-D2.

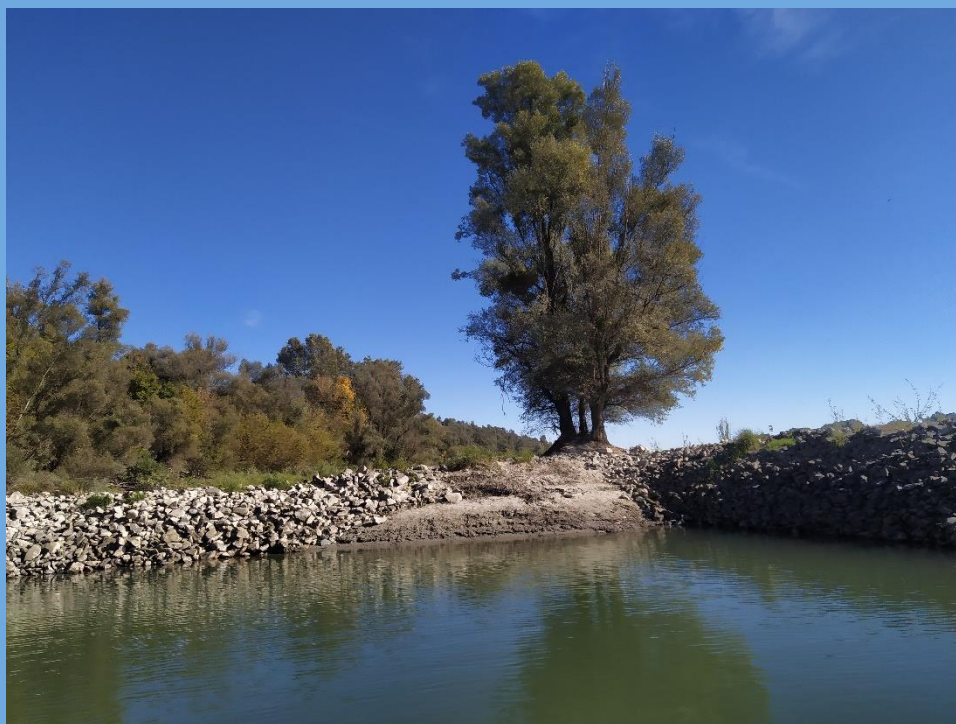
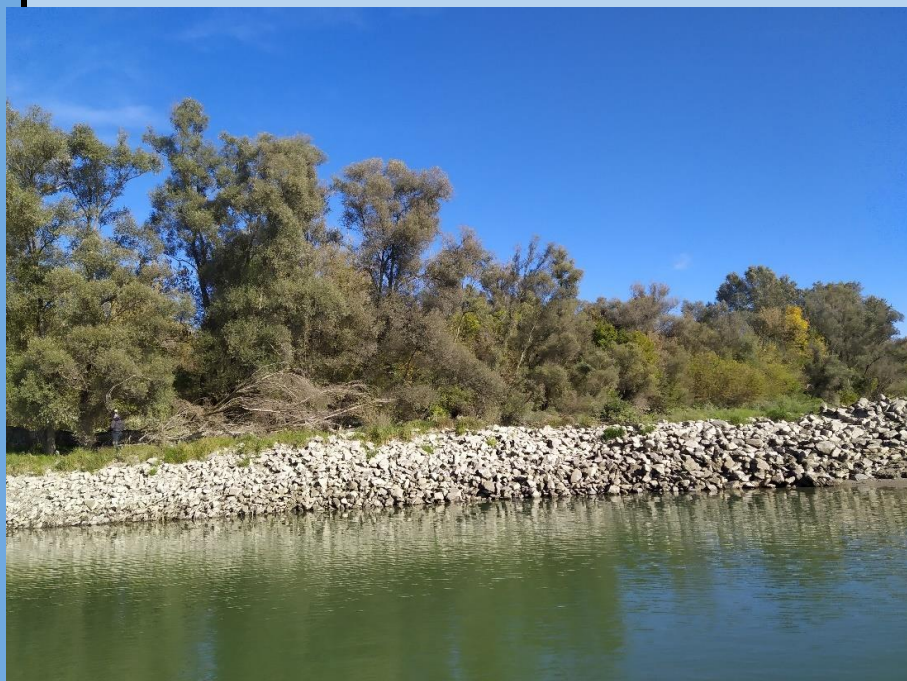
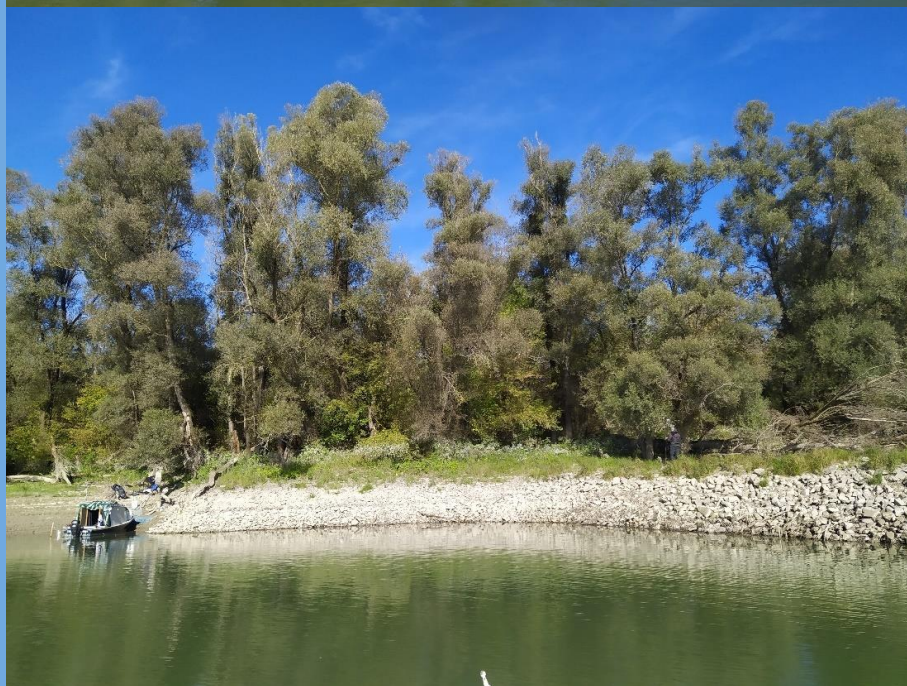
49. Right bank	Type:	Chainage (r.km)	Length (m)	Crown elevation (m.a.s.l.)
<b>1393-D2</b>	Groyne	1393+691	72,97	80,09

- Infrastructure is in good condition.
- Effect of material deposition ongoing (upstream, downstream).
- Groyne and the beginning of material deposition upstream and downstream of the groyne are visible. Downstream on the groyne, stone washout under the groyne crown is visible. Tree at the junction of the parallel 1393-D3 and the groyne is visible.
