**MONITORING OF HYDROLOGICAL, HYDRAULIC AND MORPHOLOGICAL CHARACTERISTICS OF THE DANUBE RIVER AND INVENTORY OF BIODIVERSITY COMPONENTS ON THE JOINT CROATIAN-SERBIAN SECTOR OF THE DANUBE RIVER**

**INVENTORY OF RIVER REGULATION INFRASTRUCTURE RELATED TO NAVIGATION**

**Project number:** I-2206/24

**LOCATION:** Danube river from rkm 1295,5 (Ilok) to rkm 1433,1  
(border with Hungary)

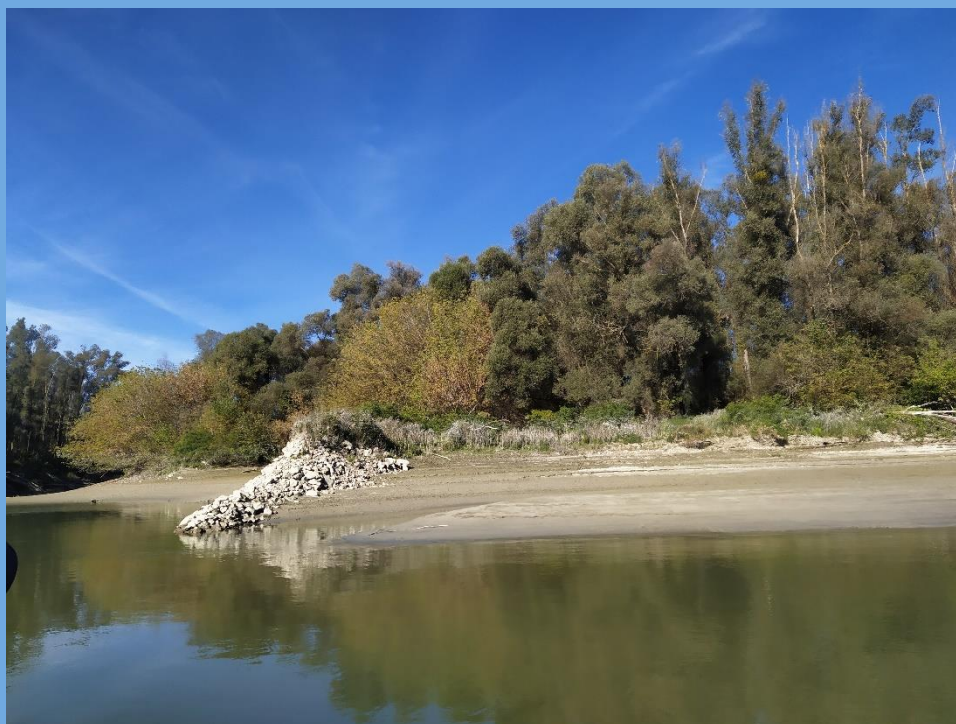
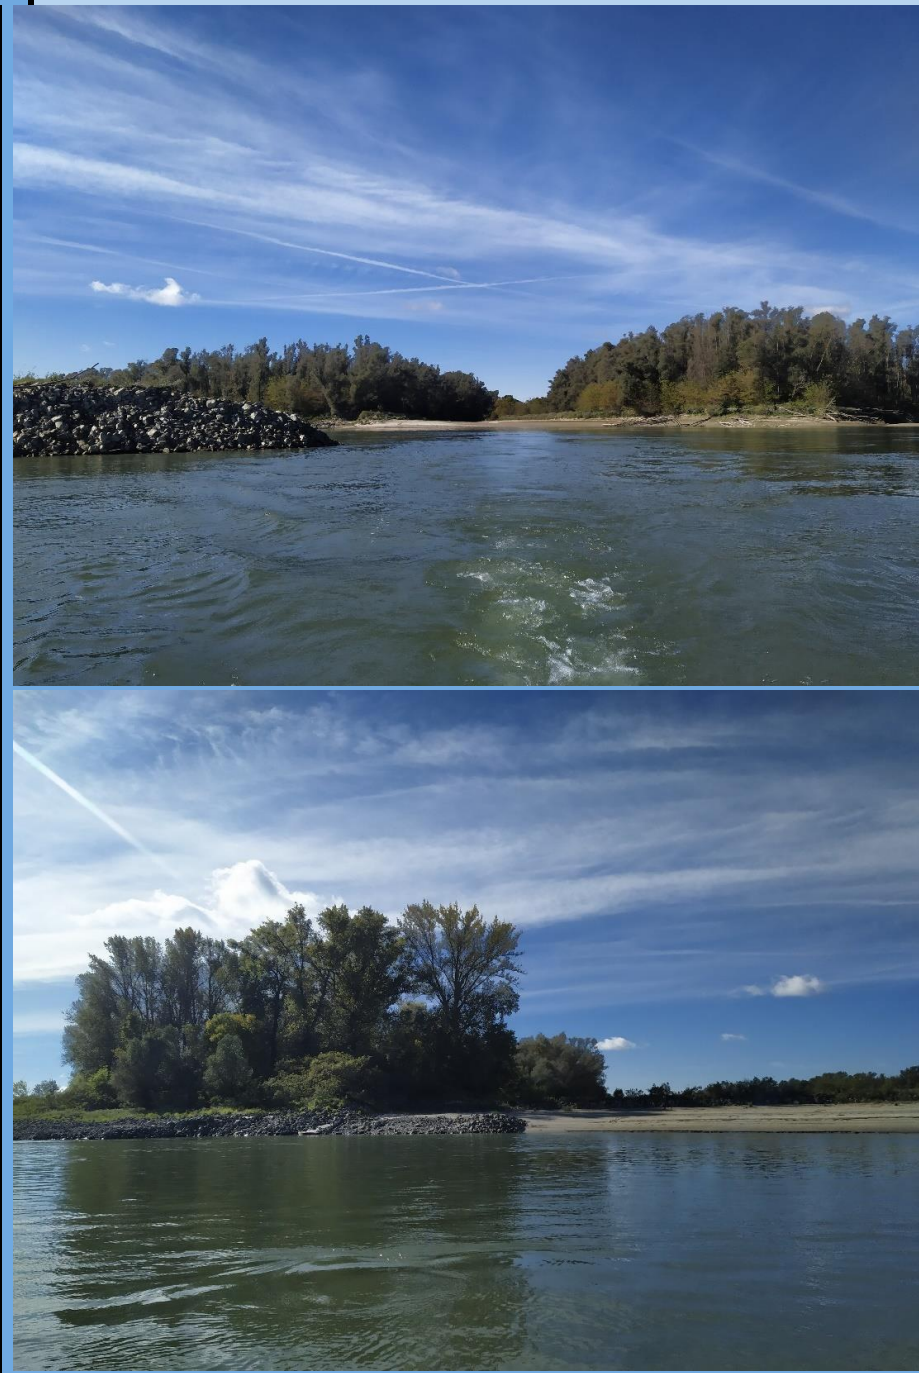
50. Right bank	Type:	Chainage (r.km)	Length (m)	Crown elevation (m.a.s.l.)
<b>1393-D1</b>	Barrier	1393+117	262,05	79,20

- Infrastructure is in bad condition.
- Barrier on backwater flow failed at low water level.
- Stone material of barrier is visible on both river banks. Barrier has irregular geometry. In the middle of the flow, the barrier is opened.

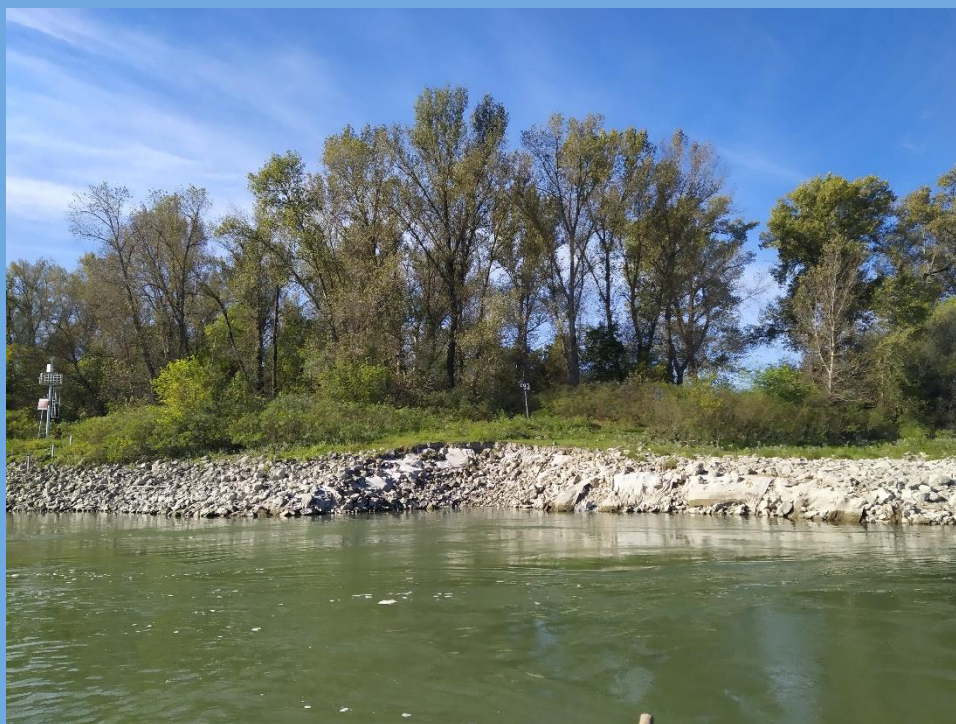
- Infrastructure is in bad condition.
- River bank erosion protection failed.
- Revetment is collapsed and the geotextile beneath the stone material is visible.

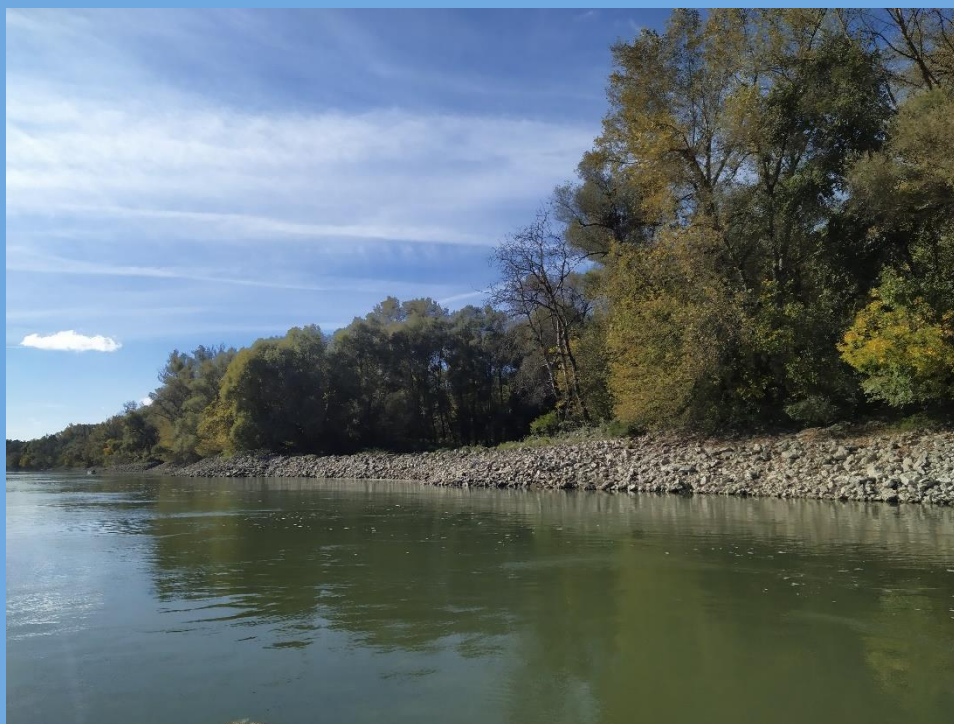
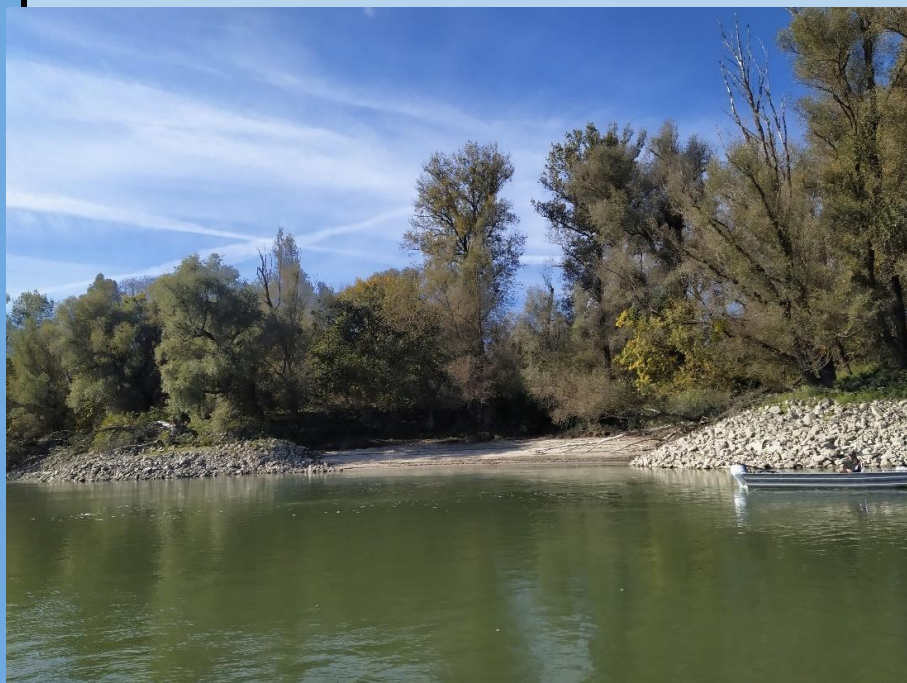
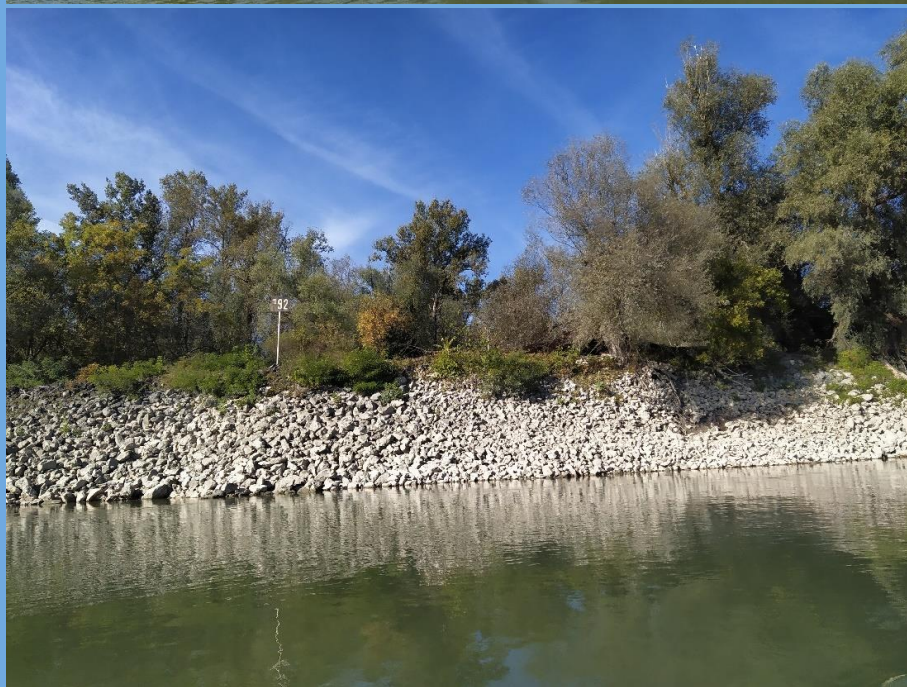
52. Right bank	Type:	Chainage (r.km)	Length (m)	Crown elevation (m.a.s.l.)
<b>1391-D2</b>	Revetment	1392+961 do 1391+991	704,65	83,23

- Infrastructure is in good condition.
- River bank erosion protection ongoing at medium water levels.
- Stone revetment. Above is a stone river bank overgrown with plants and trees. A rupture of revetment has been spotted in length around 20 meters.

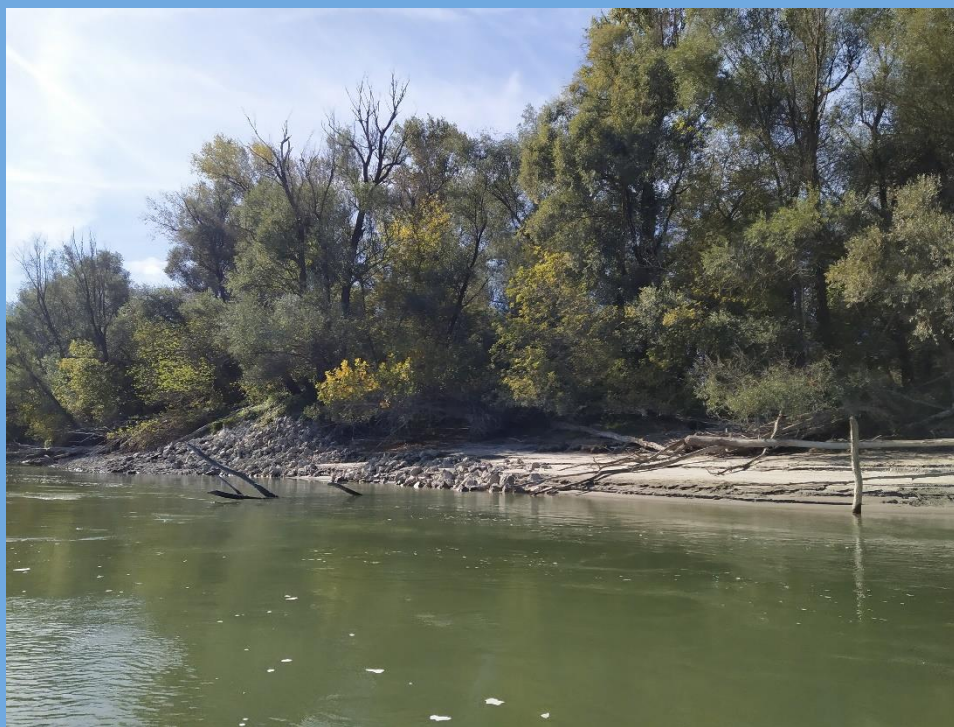
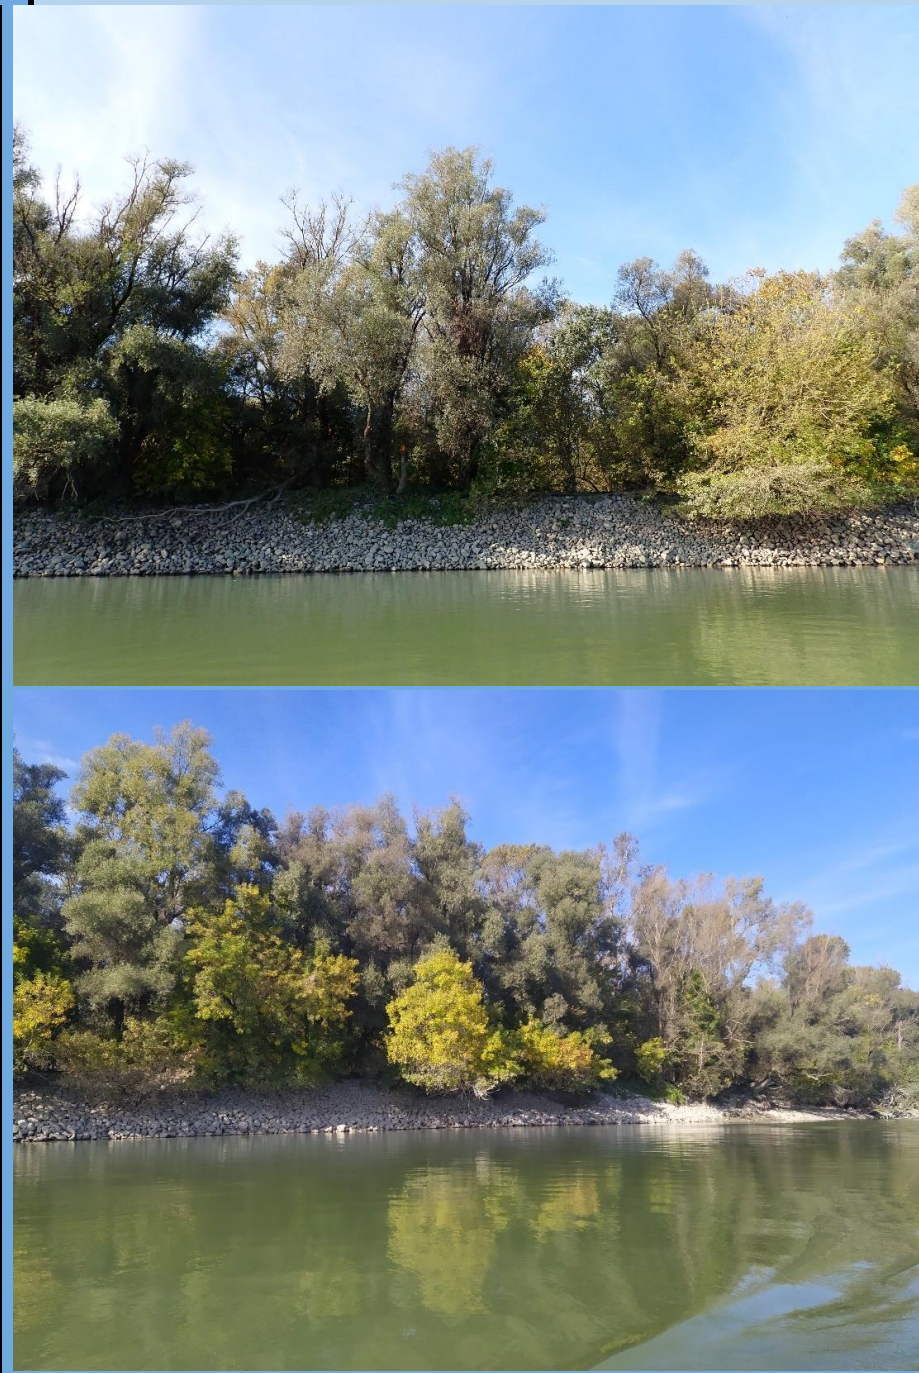
53. Right bank	Type:	Chainage (r.km)	Length (m)	Crown elevation (m.a.s.l.)
<b>1391-D1</b>	Parallel structure	1391+927 do 1391+716	278,02	81,96

- Infrastructure is in excellent condition.
- Effect of material deposition ongoing (upstream, downstream).
- Stone material of parallel structure on the bevel of the river bank is visible. Material deposition is spotted upstream and downstream of the parallel structure.

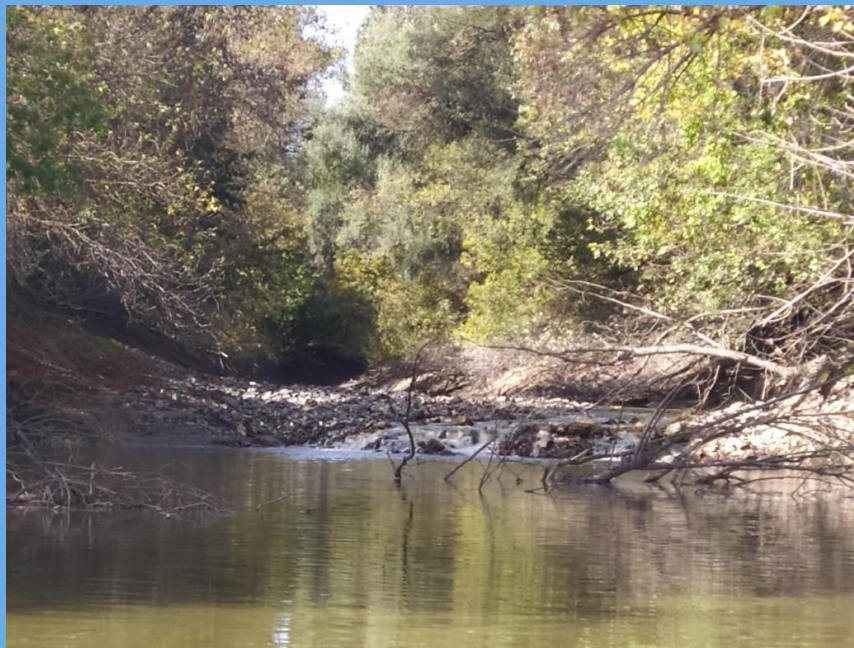
- Infrastructure is in good condition.
- Barrier on backwater flow finished at low water level.
- Barrier is covered with dirt and vegetation. Stone material of barrier is not visible.

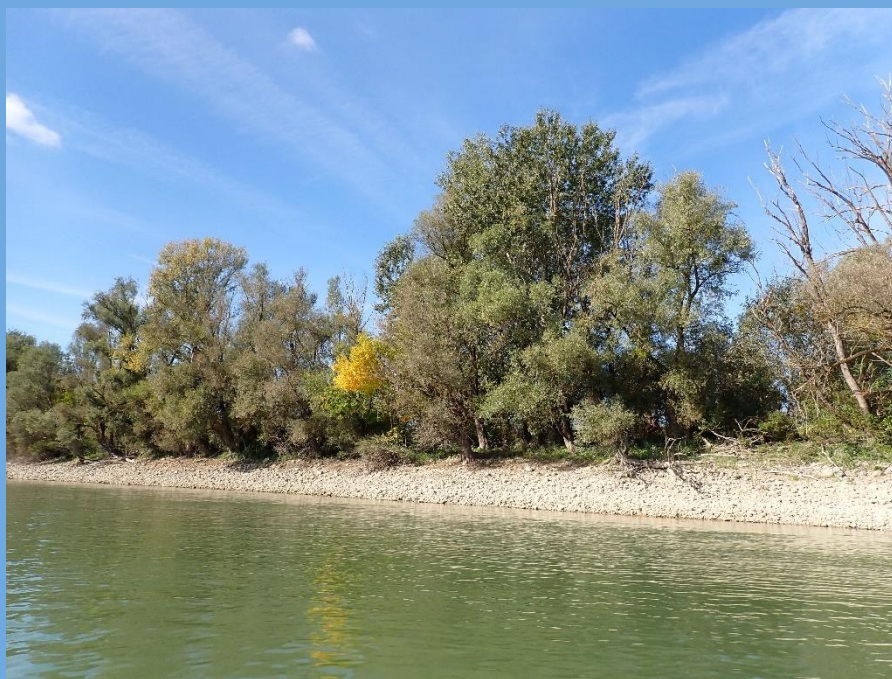
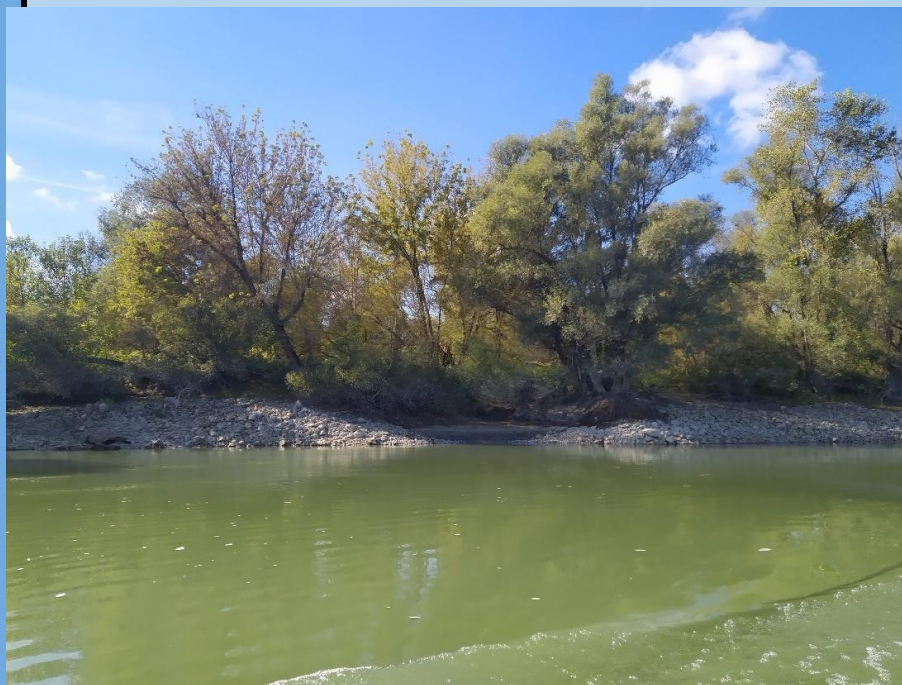
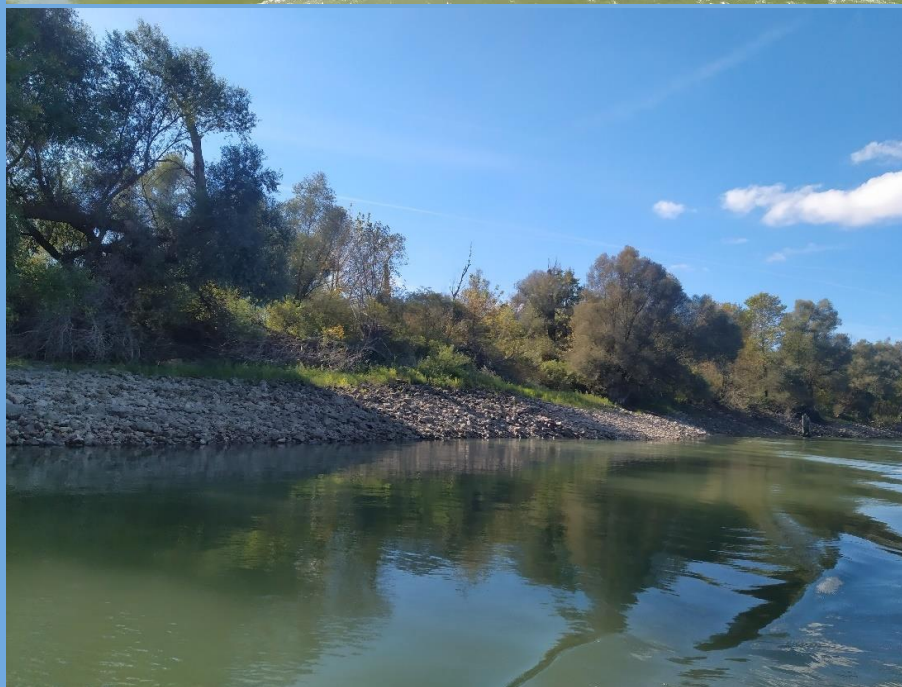
55. Right bank	Type:	Chainage (r.km)	Length (m)	Crown elevation (m.a.s.l.)
<b>1384-D2</b>	Revetment	1388+387 do 1384+468	4749,82	80,15

- Infrastructure is in good condition.
- River bank erosion protection ongoing at low water levels.
- Revetment starts at 300 meters upstream from the barrier 1387-D1. It continues after the barrier 1387-D1. Stone material of revetment is visible. Above the stone material vegetation is present. Landslide of revetment has been spotted at two locations.

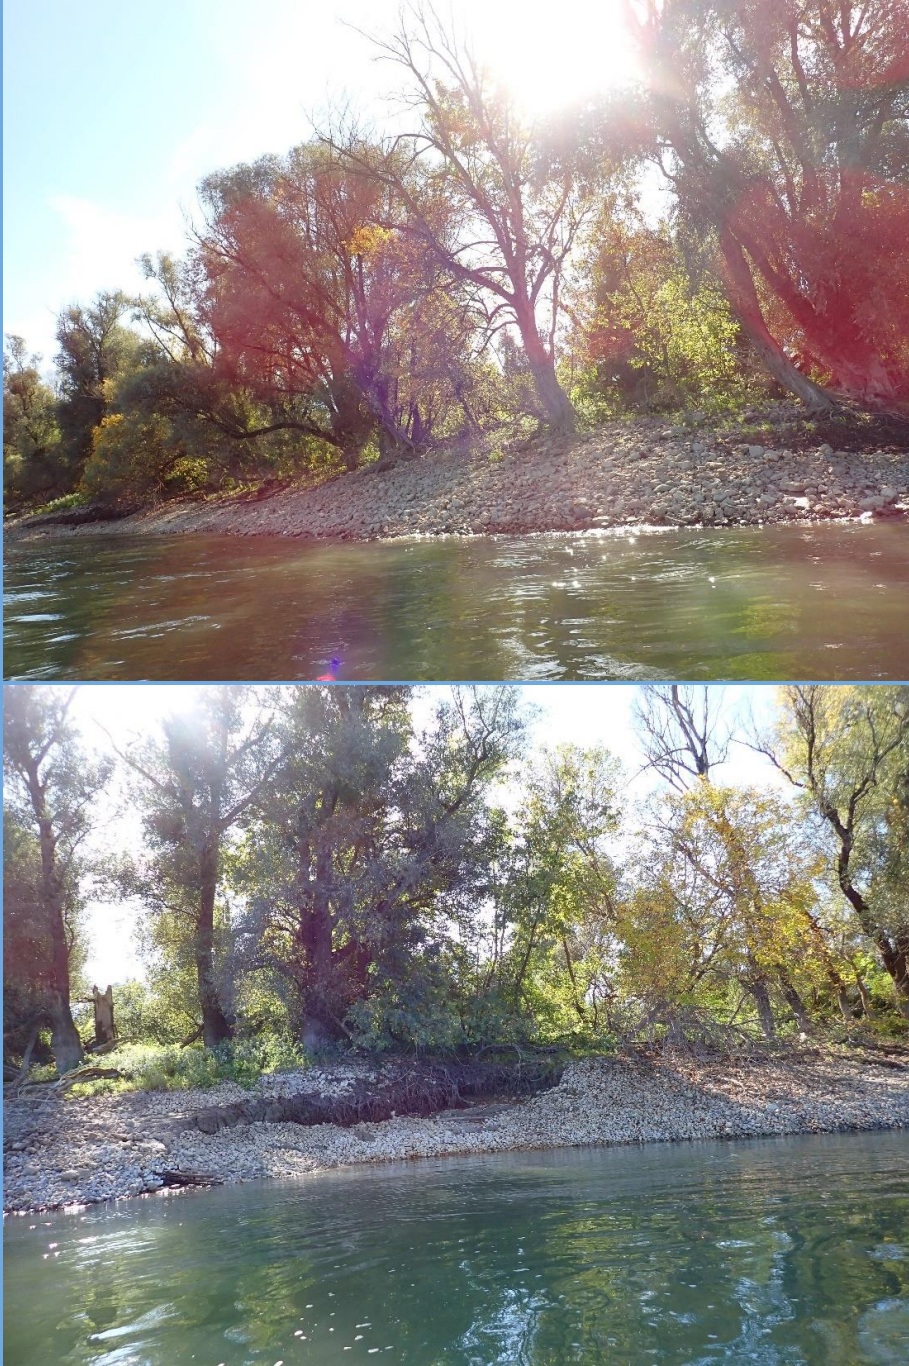
56. Right bank	Type:	Chainage (r.km)	Length (m)	Crown elevation (m.a.s.l.)
<b>1384-D1</b>	Revetment	1384+468 do 1384+283	270,14	80,41

- Infrastructure is in excellent condition.
- River bank erosion protection ongoing at low water levels.
- Stone material of revetment is visible. Above is a stone river bank overgrown with vegetation and trees.

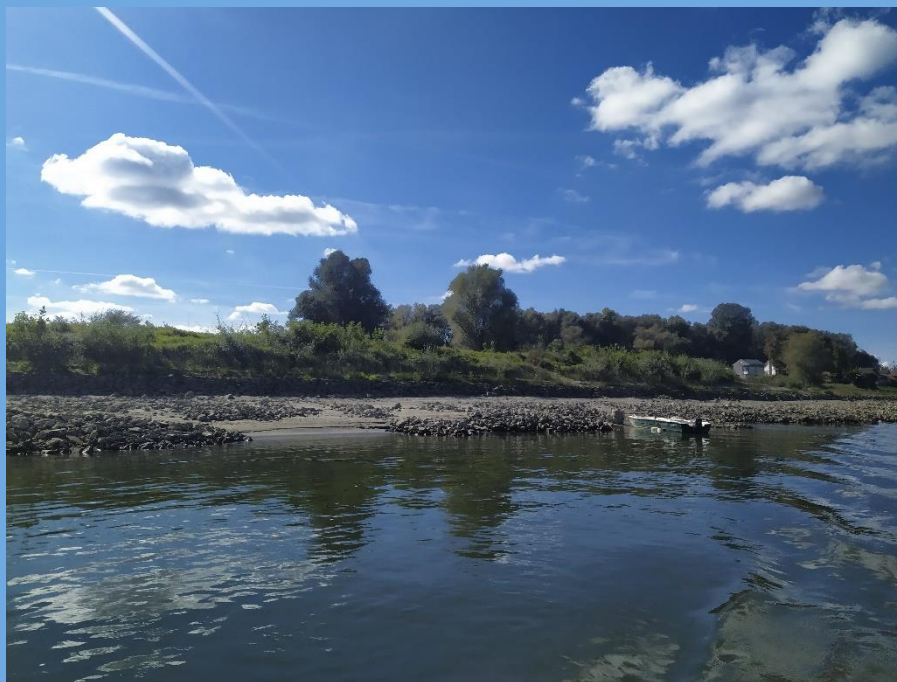
- Infrastructure is in satisfying condition..
- Effect of material deposition ongoing.
- Material deposit upstream and downstream of the groyne and stone material of groyne are visible.

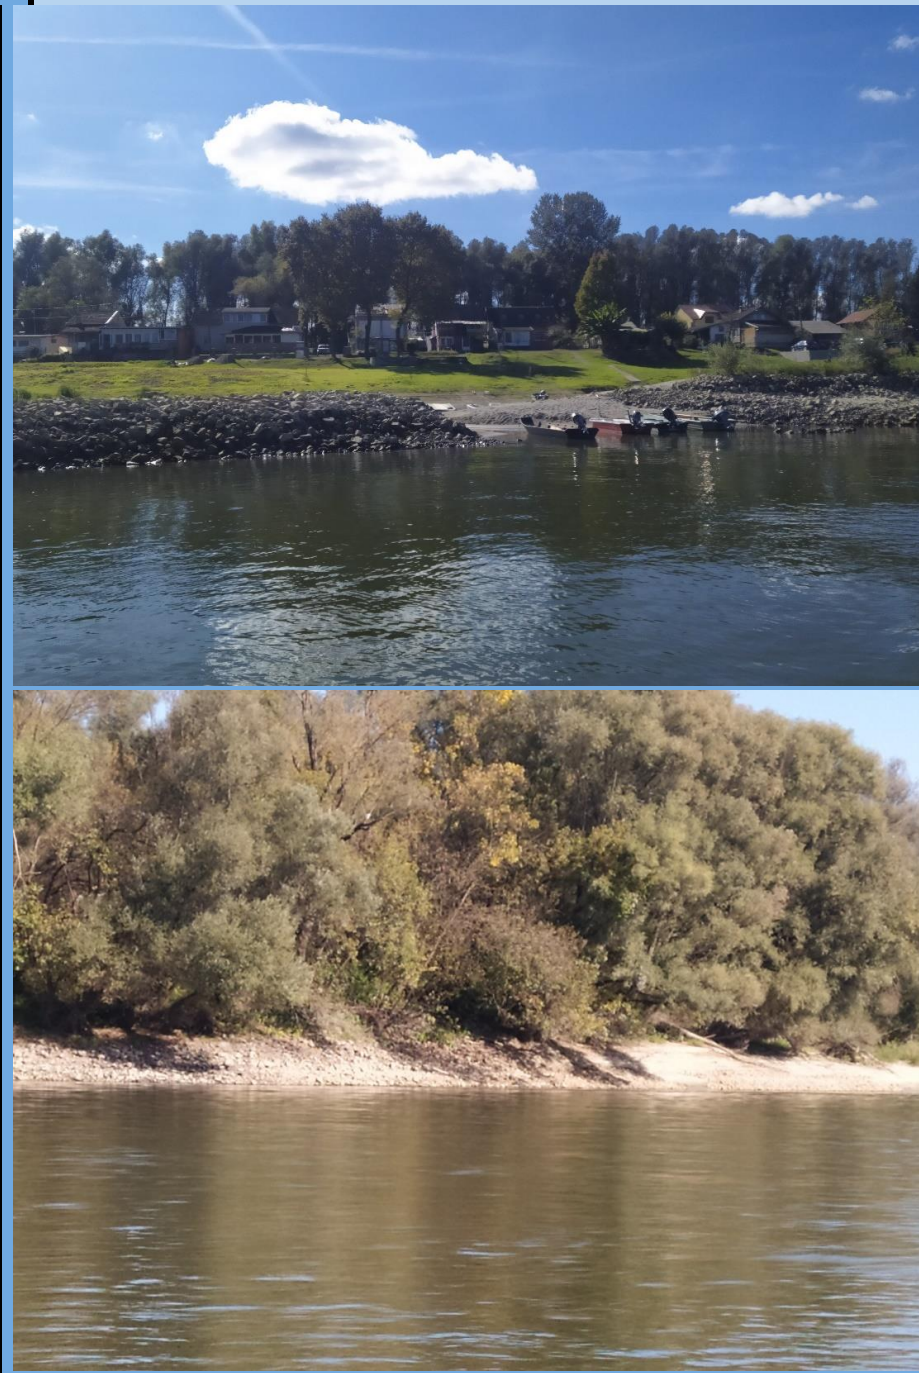
58. Right bank	Type:	Chainage (r.km)	Length (m)	Crown elevation (m.a.s.l.)
<b>1382-D1</b>	Parallel structure	1382+893 do 1382+209	919,15	80,04

- Infrastructure is in satisfying condition.
- Effect of material deposition ongoing (upstream, downstream).
- Near the settlement of Aljmaš, stone material of parallel structure is visible. Material deposition is present in the back of the parallel structure. Material deposition and vegetation overgrowth is present on the river bank.

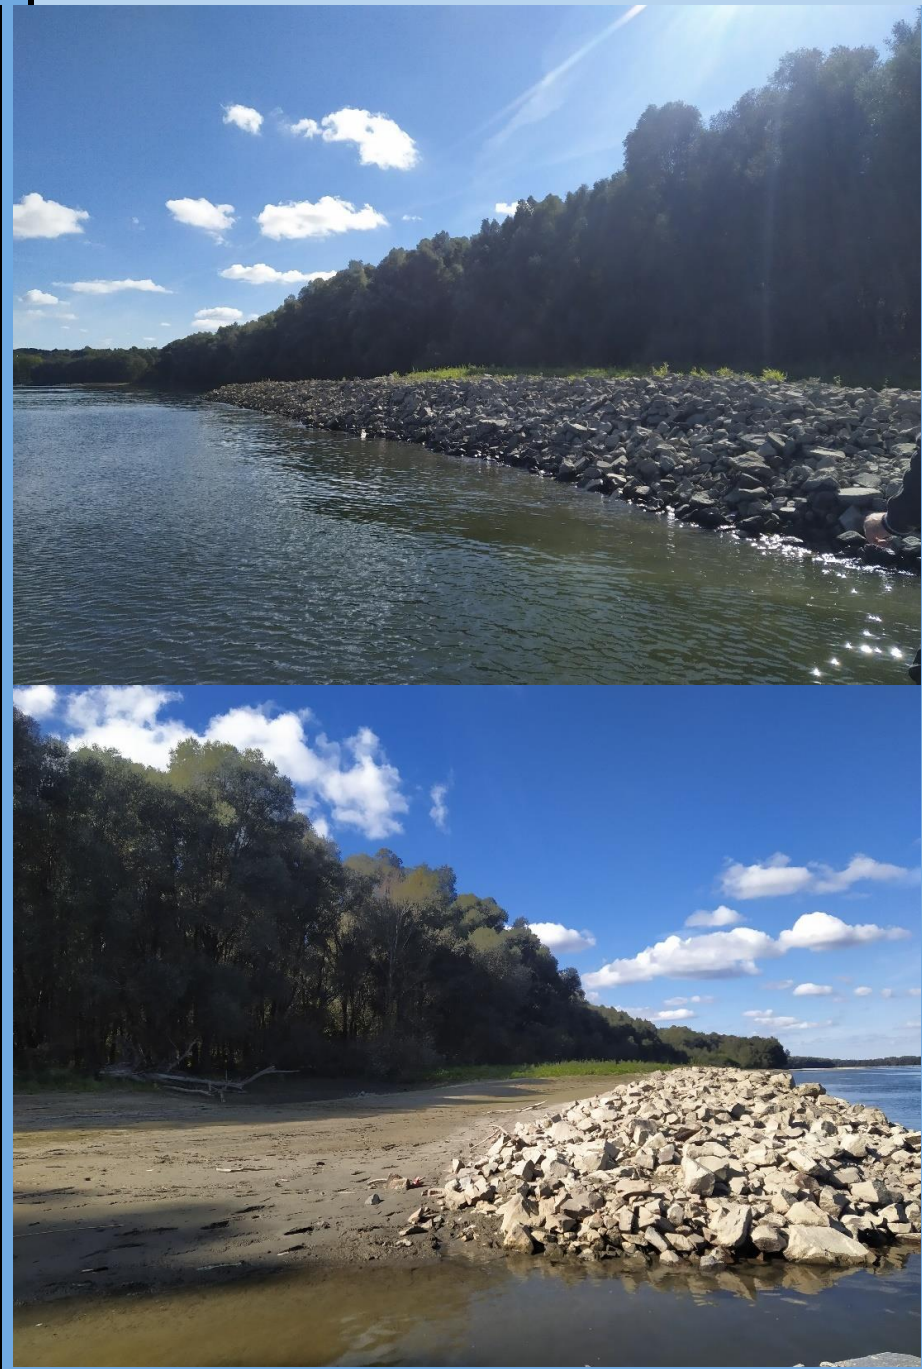
59. Right bank	Type:	Chainage (r.km)	Length (m)	Crown elevation (m.a.s.l.)
<b>1381-D1</b>	T-groyne	1381+381	85,31	79,62

- Infrastructure is in excellent condition.
- Effect of material deposition ongoing (upstream, downstream).
- Groyne head and groyne connection are visible. Sand deposit upstream and downstream of the groyne.

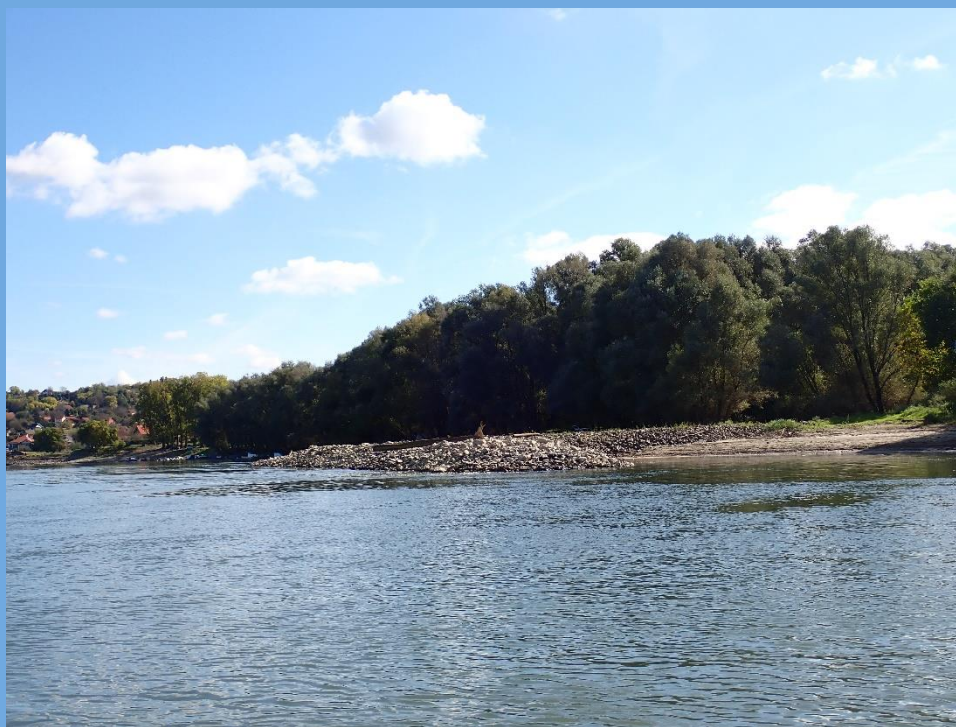
- Infrastructure is in good condition.
- Effect of material deposition ongoing (upstream, downstream).
- Groyne head and groyne connection are visible. The beginning of material deposition upstream and downstream of the groyne is visible. Downstream on the groyne connection, stone washout under the groyne crown is visible.

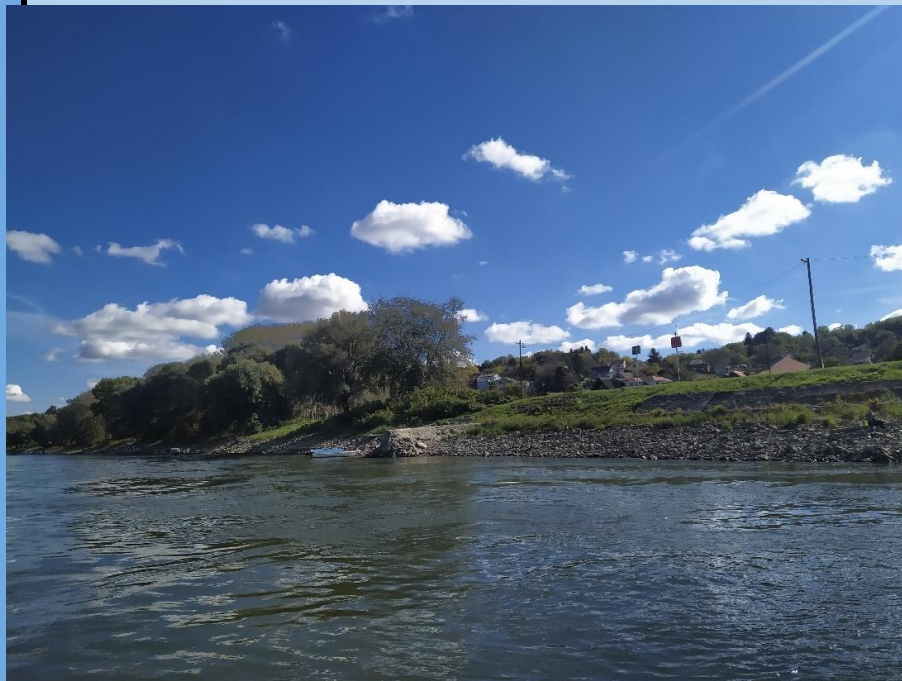
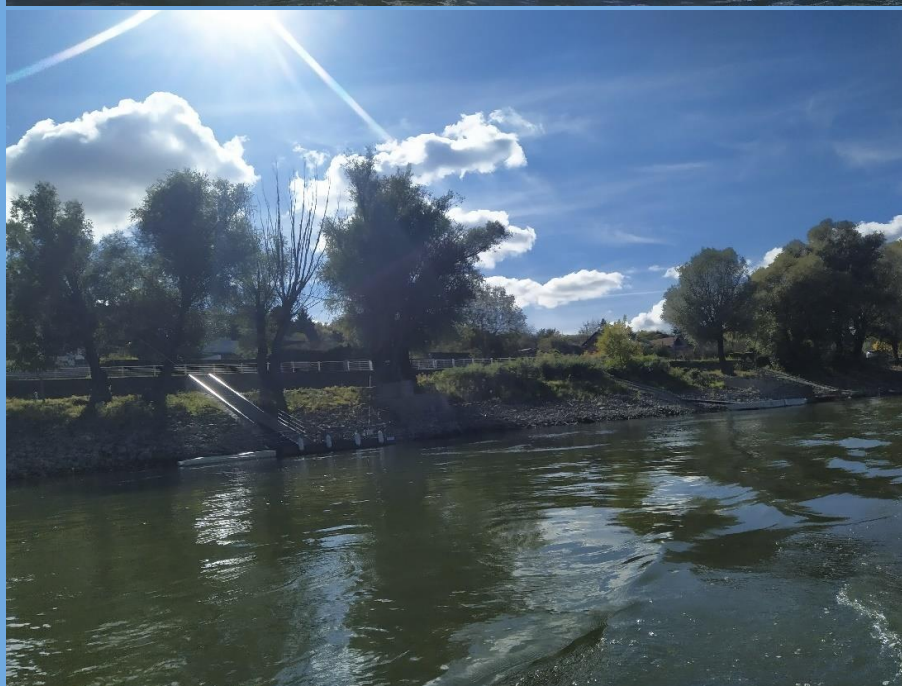
61. Right bank	Type:	Chainage (r.km)	Length (m)	Crown elevation (m.a.s.l.)
<b>1379-D1</b>	Revetment	1380+357 do 1379+983	361,37	80,68

- Infrastructure is in good condition.
- River bank erosion protection ongoing at medium water levels.
- Stone revetment upstream and downstream of passenger wharf Aljmaš is present. Near the mentioned wharf there is a city-type revetment. Concrete stairs along the bevel of the revetment are present.

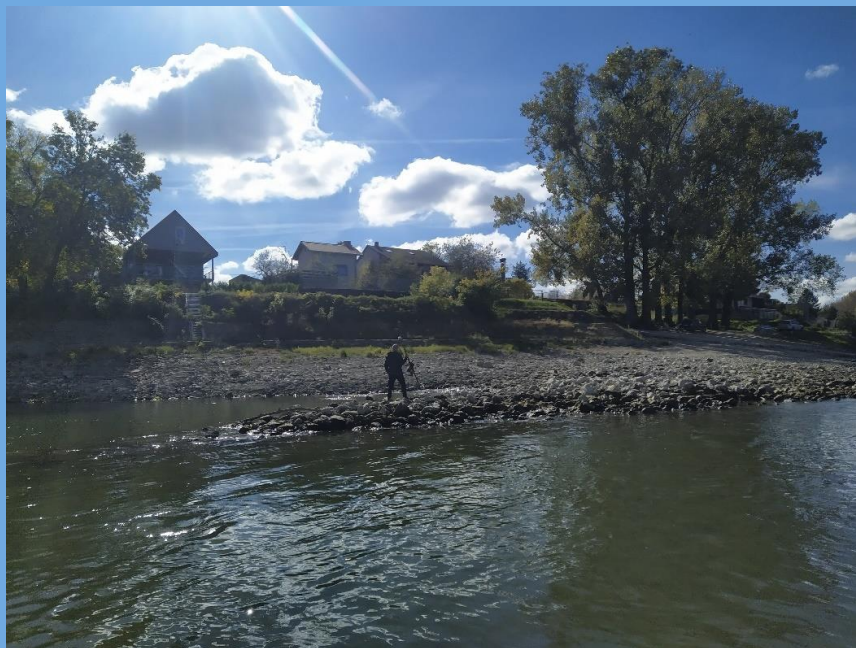
- Infrastructure is in bad condition..
- Effect of material deposition failed.
- Stone material of groyne is visible at low water levels upstream of the revetment 1379-D1.

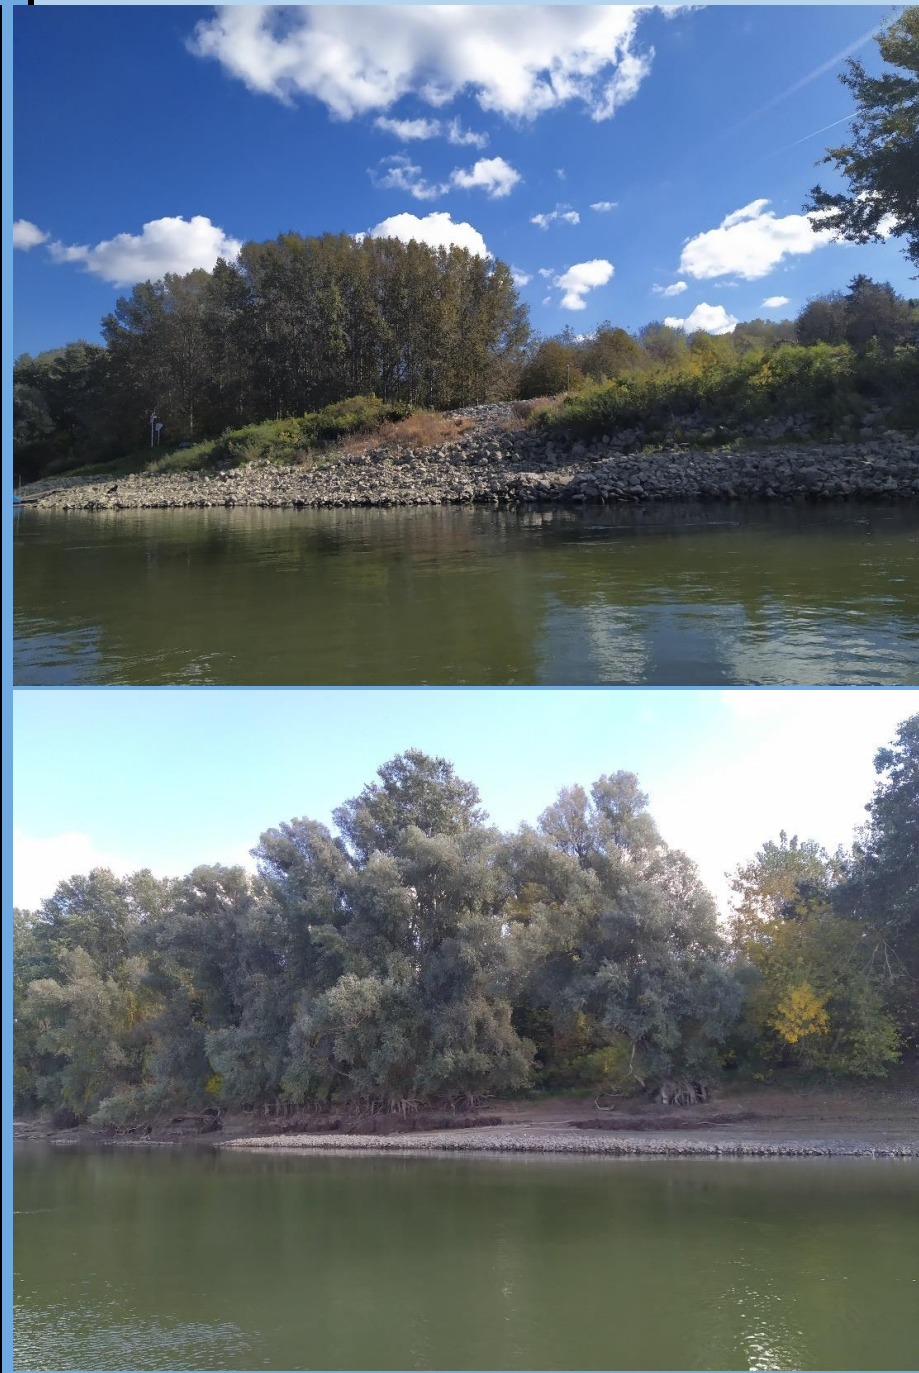
63. Right bank	Type:	Chainage (r.km)	Length (m)	Crown elevation (m.a.s.l.)
<b>1377-D1</b>	Revetment	1379+983 do 1377+528	2705,45	80,60

- Infrastructure is in bad/ satisfying condition.
- River bank erosion protection ongoing at medium water levels.
- Stone material of revetment on the bevel is visible. It protects the river bank of the Aljmaš settlement.

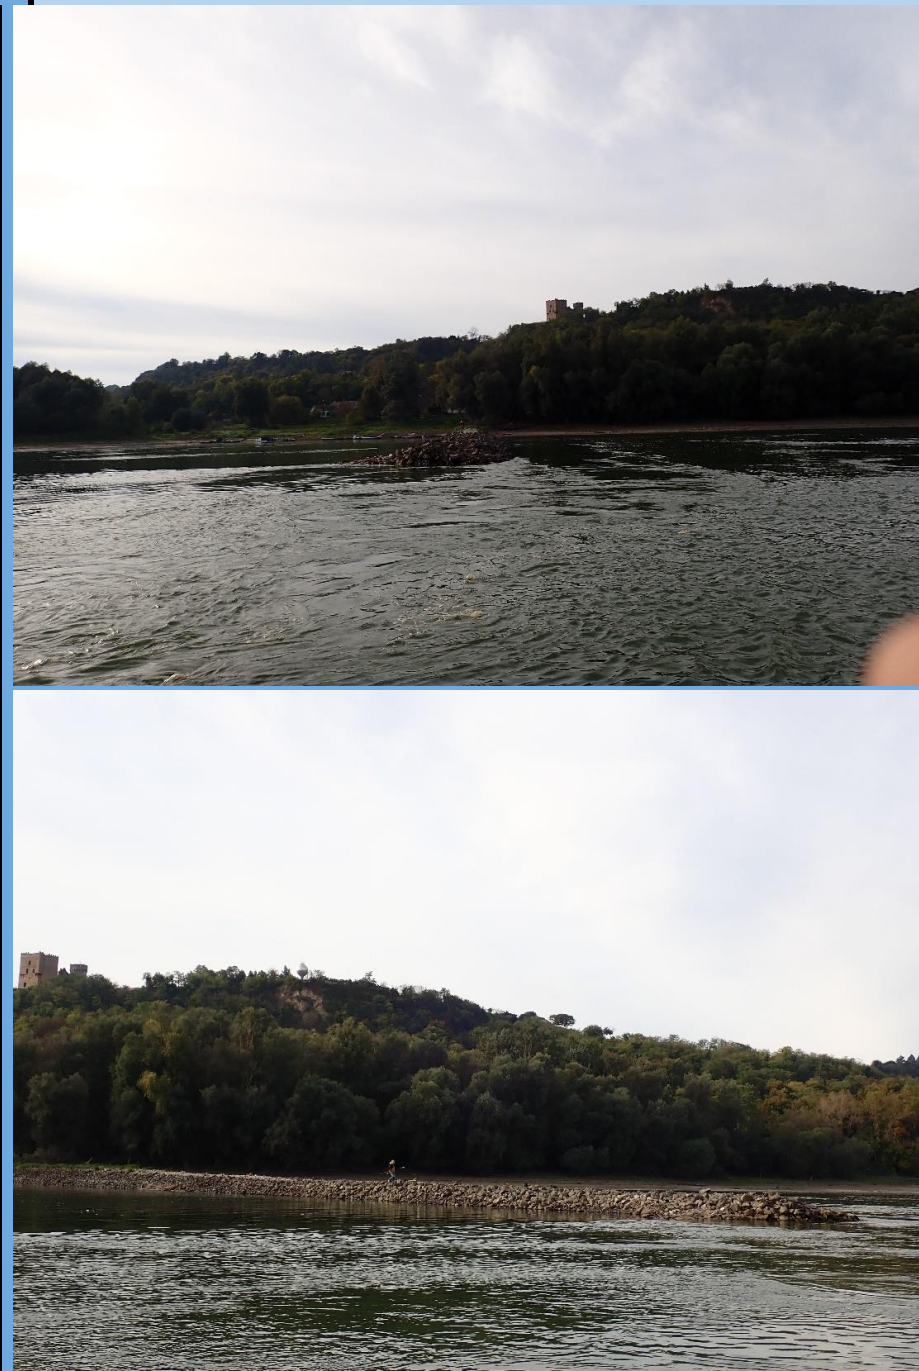
64. Right bank	Type:	Chainage (r.km)	Length (m)	Crown elevation (m.a.s.l.)
<b>1368-D1</b>	Groyne	1368+237	138,31	78,06

- Infrastructure is in excellent condition.
- Effect of material deposition ongoing (upstream, downstream).
- Groyne and the beginning of material deposition upstream and downstream of the groyne are visible.

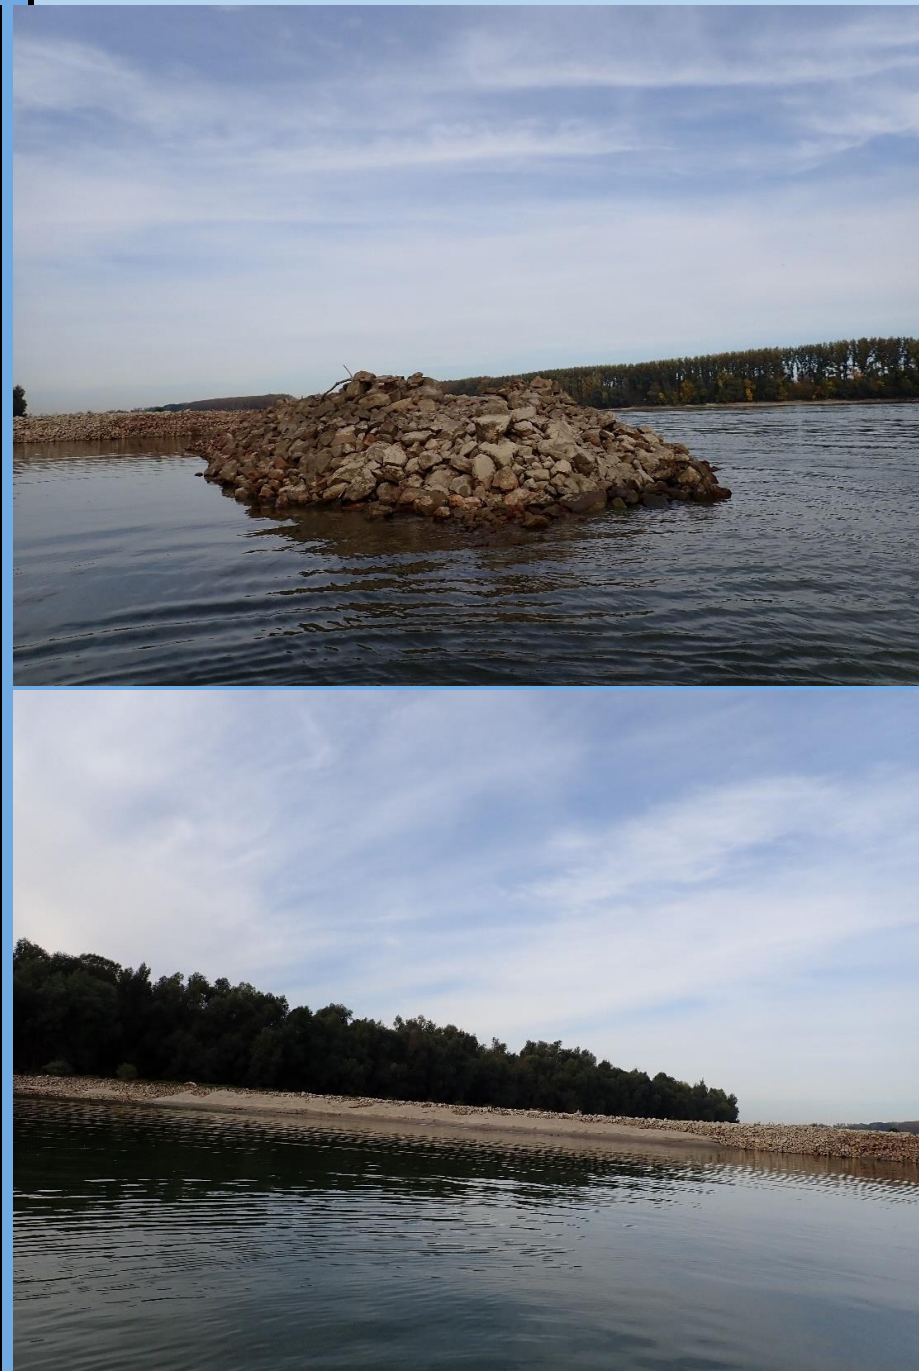
65. Right bank	Type:	Chainage (r.km)	Length (m)	Crown elevation (m.a.s.l.)
<b>1367-D2</b>	T-groyne	1367+663	83,84	78,68

- Infrastructure is in good condition.
- Effect of material deposition ongoing (upstream, downstream).
- Groyne head and groyne connection are visible. Material deposition upstream and downstream of the groyne is visible. Upstream on the groyne connection, stone washout under the groyne crown connection is visible.

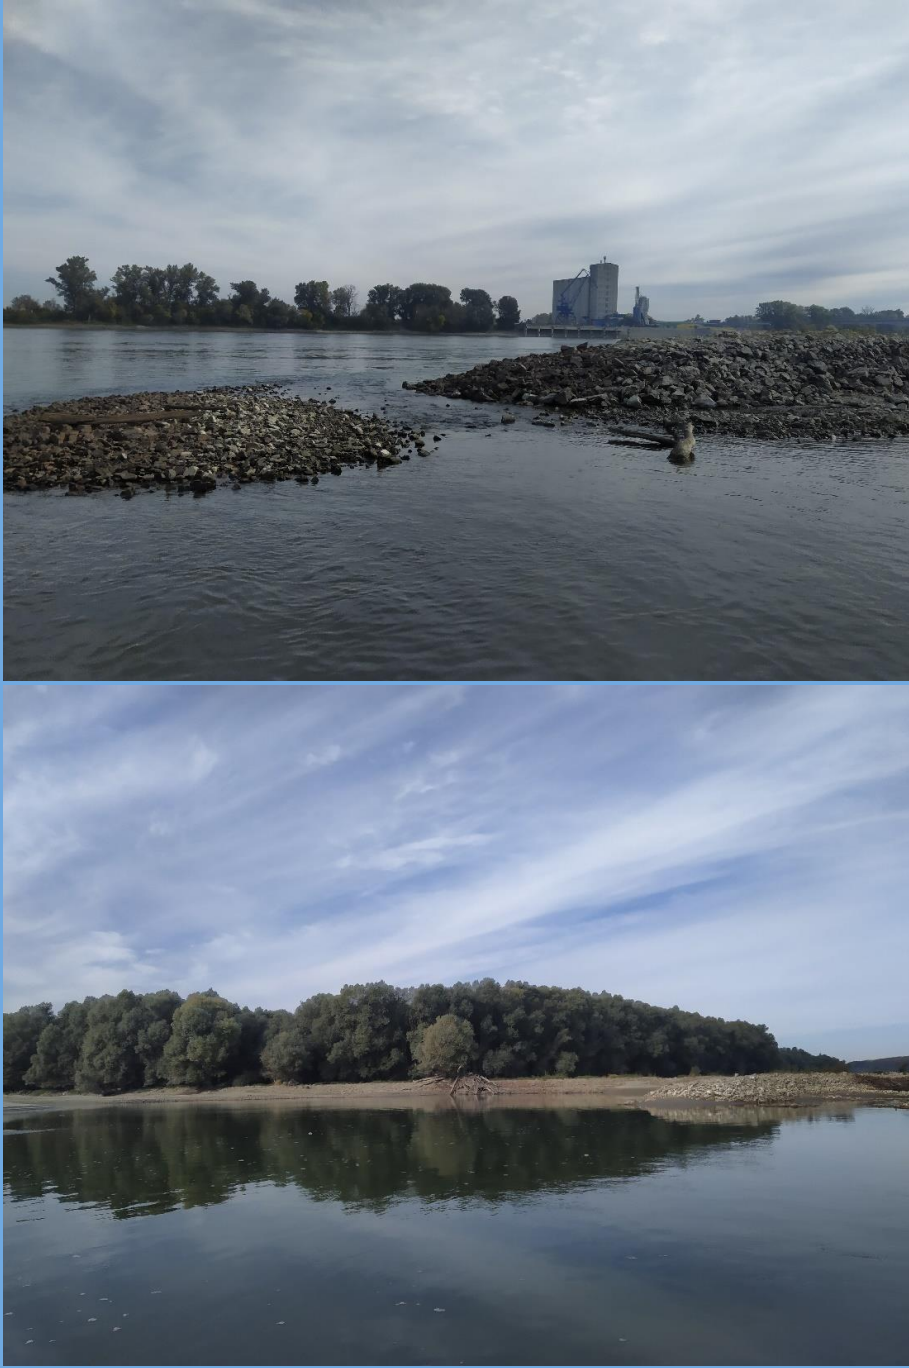
66. Right bank	Type:	Chainage (r.km)	Length (m)	Crown elevation (m.a.s.l.)
<b>1367-D1</b>	T-groyne	1367+218	90,26	78,40

- Infrastructure is in satisfying condition.
- Effect of material deposition ongoing (upstream, downstream).
- Collapsed part of the groyne head and material deposit upstream and downstream of the groyne are visible. Downstream and upstream on the groyne connection, stone washout under the groyne crown connection is visible.

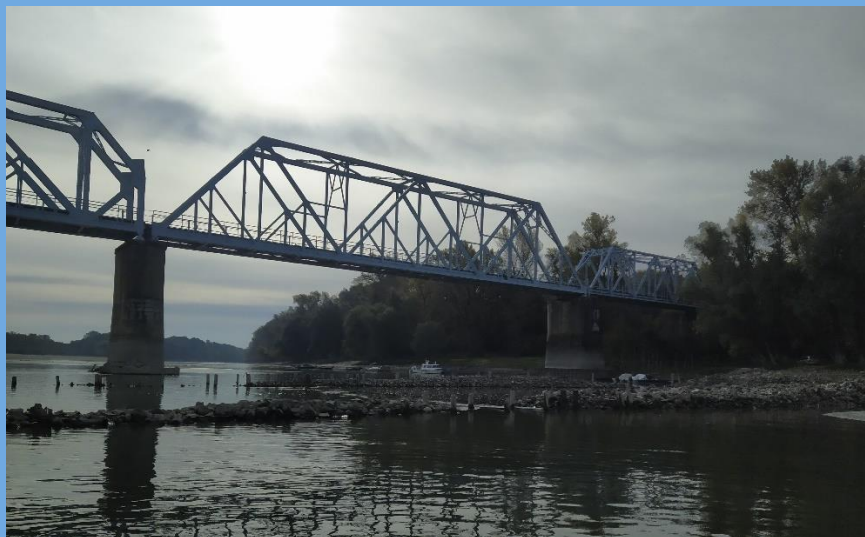
- Infrastructure is in bad condition.
- Effect of material deposition failed.
- Stone material of groyne connection is visible. Sand deposit upstream of the groyne. Between the road and railway bridge near the settlement of Erdut.
