**MONITORING OF HYDROLOGICAL, HYDRAULIC AND MORPHOLOGICAL CHARACTERISTICS OF THE DANUBE RIVER AND INVENTORY OF BIODIVERSITY COMPONENTS ON THE JOINT CROATIAN-SERBIAN SECTOR OF THE DANUBE RIVER**

**INVENTORY OF RIVER REGULATION INFRASTRUCTURE RELATED TO NAVIGATION**

**Project number:** I-2206/24

**LOCATION:** Danube river from rkm 1295,5 (Ilok) to rkm 1433,1  
(border with Hungary)

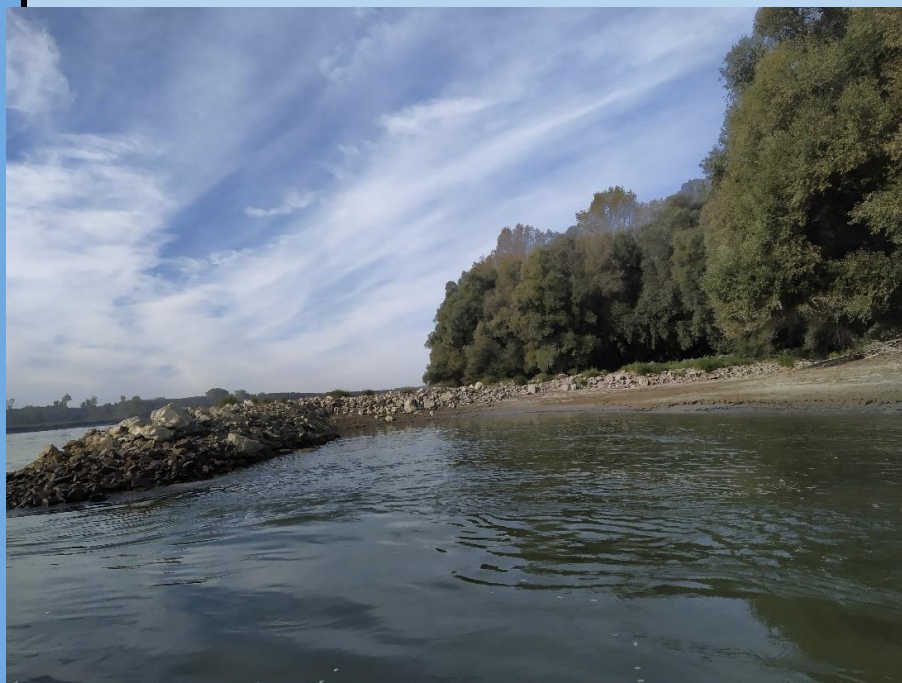
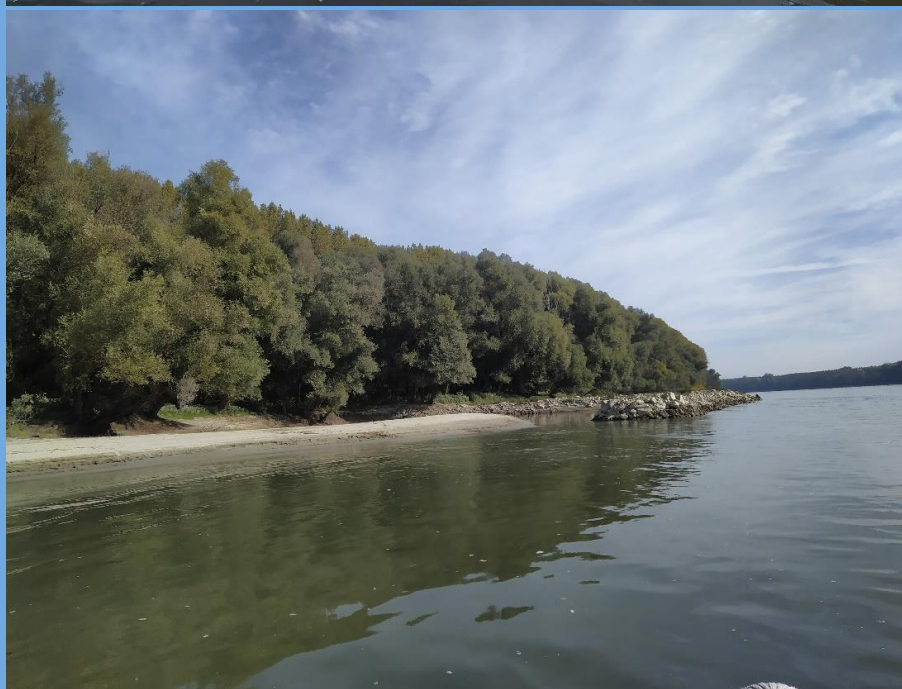
68. Right bank	Type:	Chainage (r.km)	Length (m)	Crown elevation (m.a.s.l.)
<b>1360-D3</b>	T-groyne	1360+958	81,71	78,59

- Infrastructure is in excellent condition.
- Effect of material deposition ongoing (upstream, downstream).
- Groyne head and groyne connection are visible. The beginning of material deposition on the river bank downstream of the groyne, upstream still in the function of material deposition.

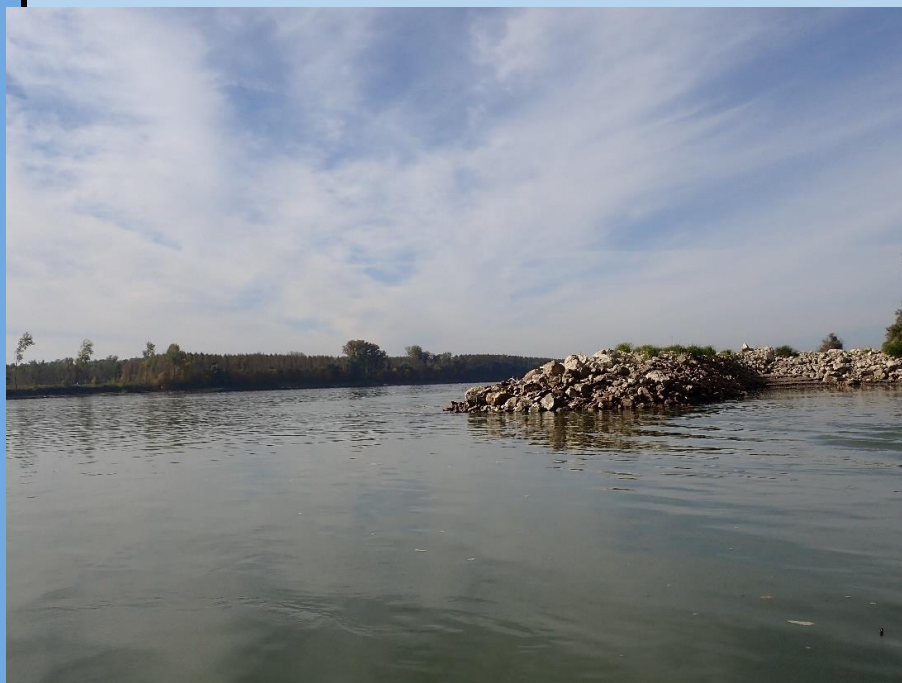
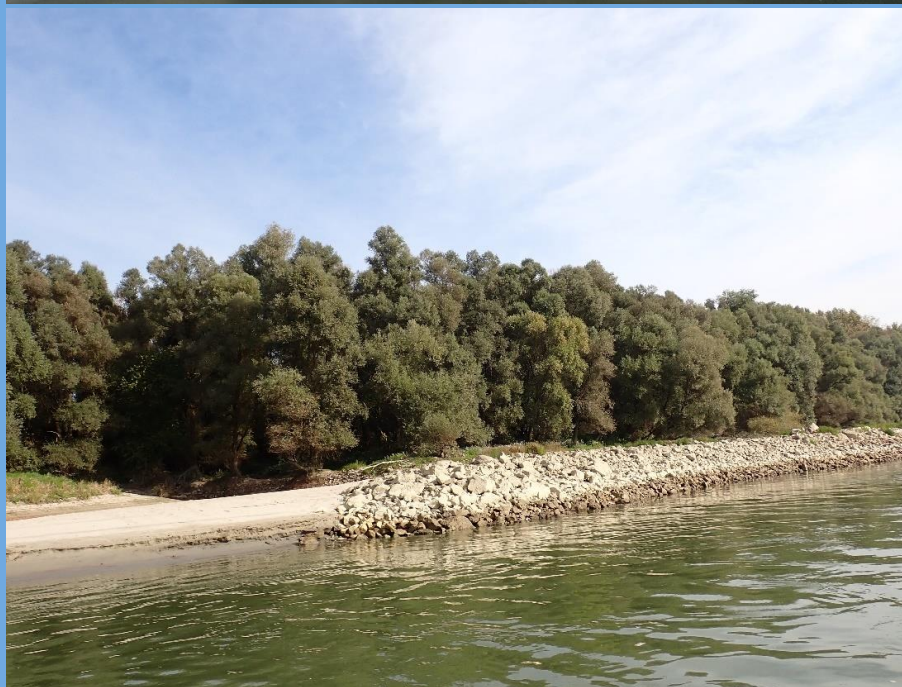
69. Right bank	Type:	Chainage (r.km)	Length (m)	Crown elevation (m.a.s.l.)
<b>1360-D2</b>	T-groyne	1360+539	79,89	78,53

- Infrastructure is in excellent condition.
- Effect of material deposition ongoing (upstream, downstream).
- Groyne head and groyne connection are visible. The beginning of material deposition on the river bank upstream of the groyne, downstream deposited with sand.

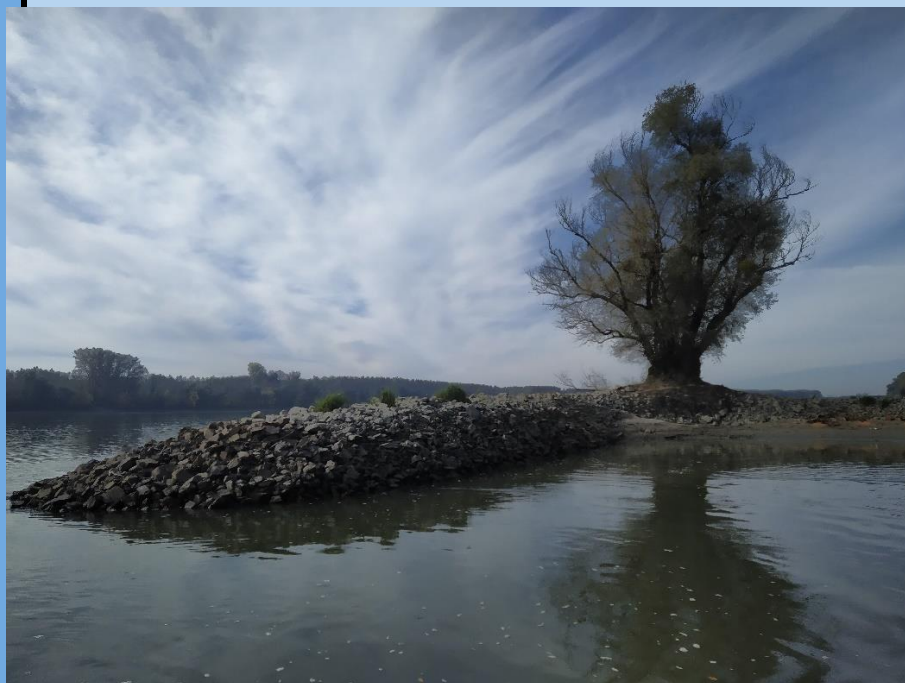
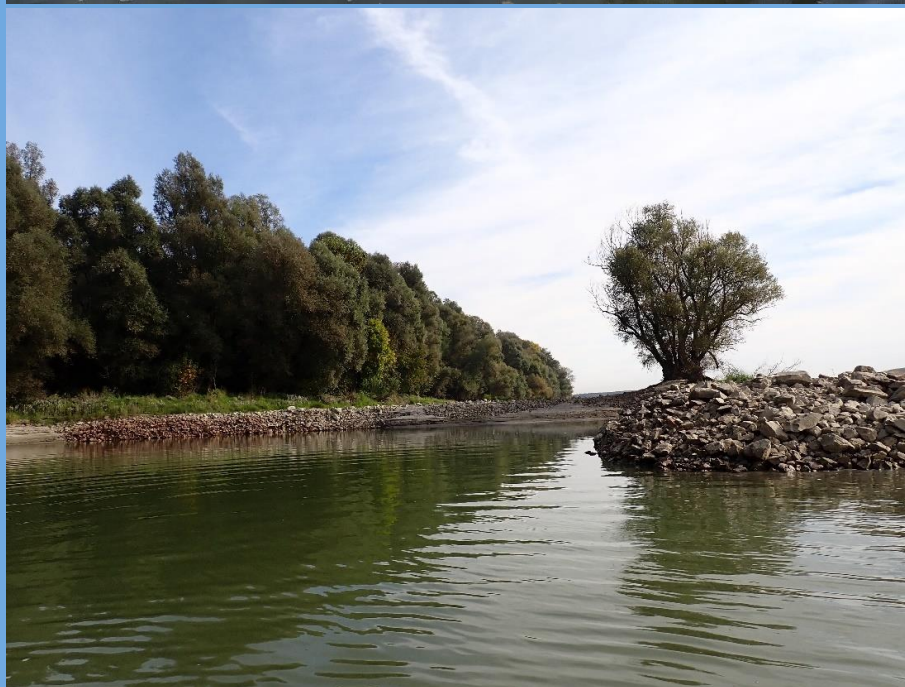
70. Right bank	Type:	Chainage (r.km)	Length (m)	Crown elevation (m.a.s.l.)
<b>1360-D1</b>	T-groyne	1360+130	81,88	79,18

- Infrastructure is in good condition.
- Effect of material deposition ongoing (upstream, downstream).
- Material deposit upstream and downstream of the groyne is visible. Downstream on the groyne connection, stone washout under the groyne crown connection is visible. Tree at the junction of the groyne head and groyne connection is visible.

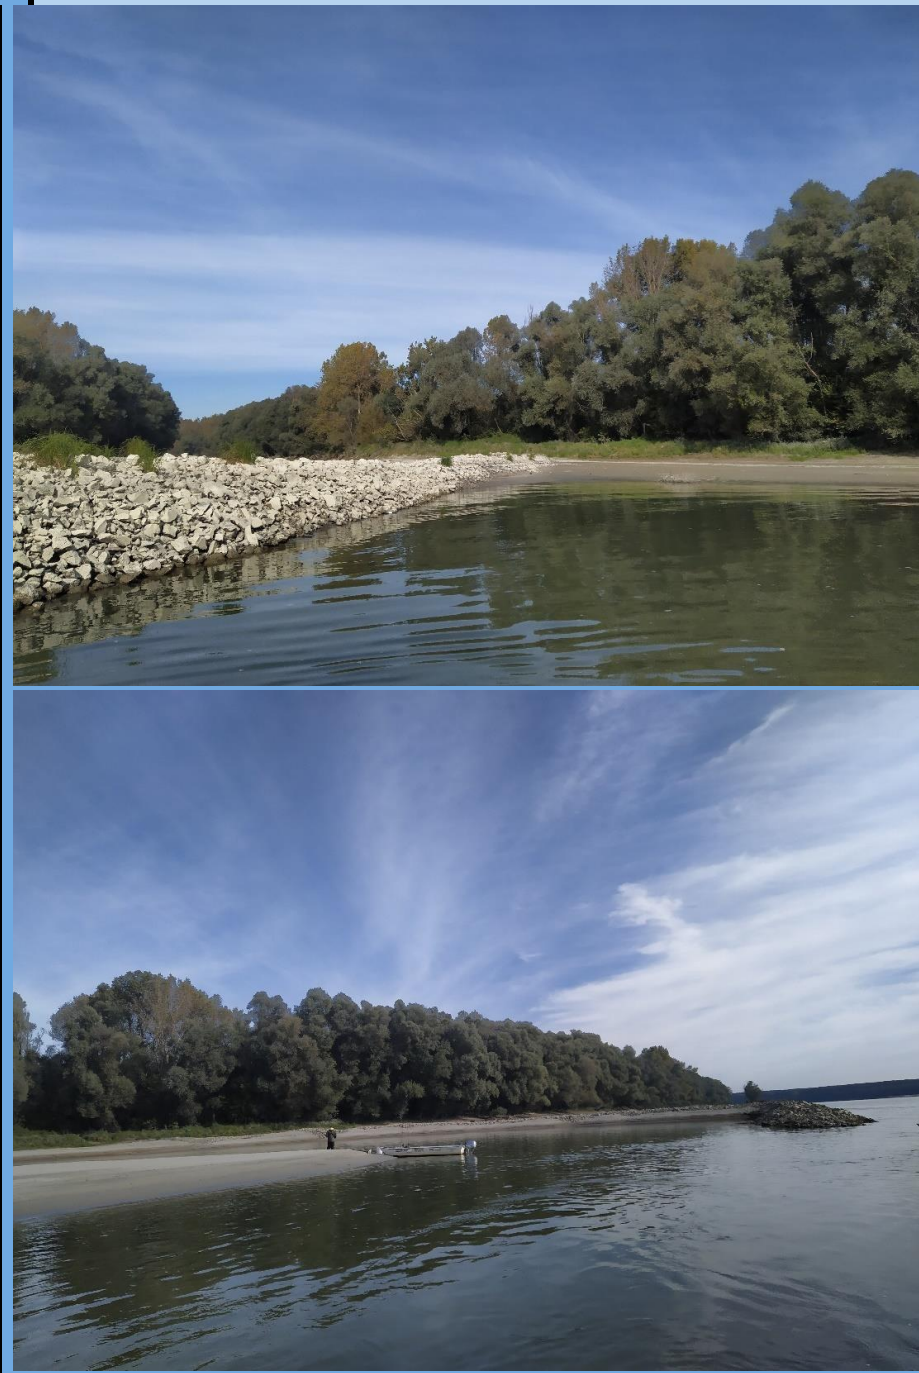
71. Right bank	Type:	Chainage (r.km)	Length (m)	Crown elevation (m.a.s.l.)
<b>1359-D1</b>	T-groyne	1359+714	81,62	78,56

- Infrastructure is in good condition.
- Effect of material deposition ongoing (upstream, downstream).
- Material deposit upstream and downstream of the groyne is visible. Downstream on the groyne connection, stone washout under the groyne crown connection is visible.

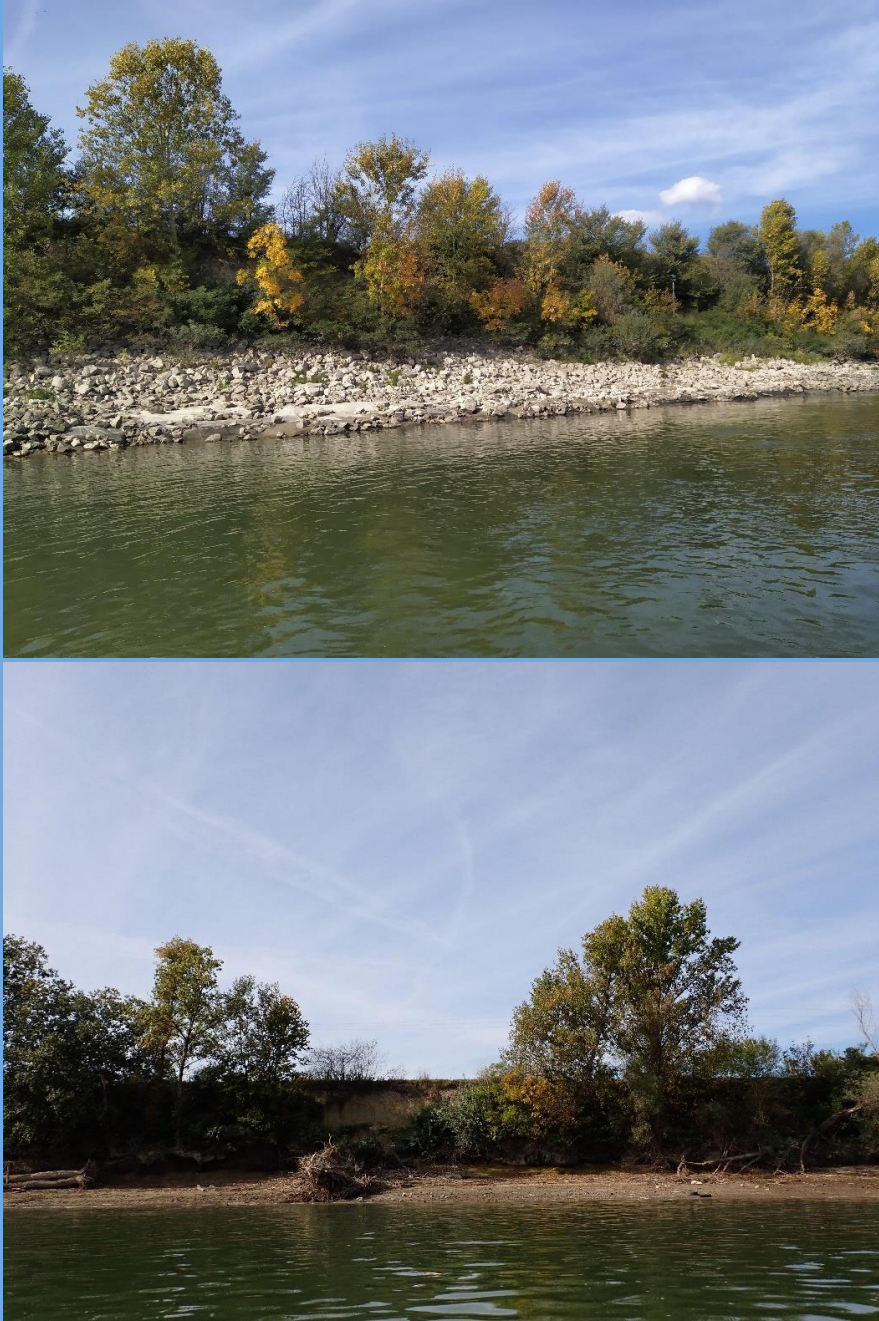
72. Right bank	Type:	Chainage (r.km)	Length (m)	Toe elevation (m.a.s.l.)
<b>1351-D1</b>	Revetment	1355+788 do 1351+922	3329,39	76,55

- Infrastructure is in satisfying condition.
- River bank erosion protection ongoing at high water levels in settlement Dalj. Upstream from the settlement river bank erosion protection ongoing at low water levels.
- Revetment near the settlement of Dalj has steep bevel and irregular geometry, it is overgrown with vegetation and is city-type revetment. Downstream of the Dalj canal there is a stone revetment. Stone material is visible at low water levels and vegetation above it is visible. Last 500 m river bank erosion behind revetment present.

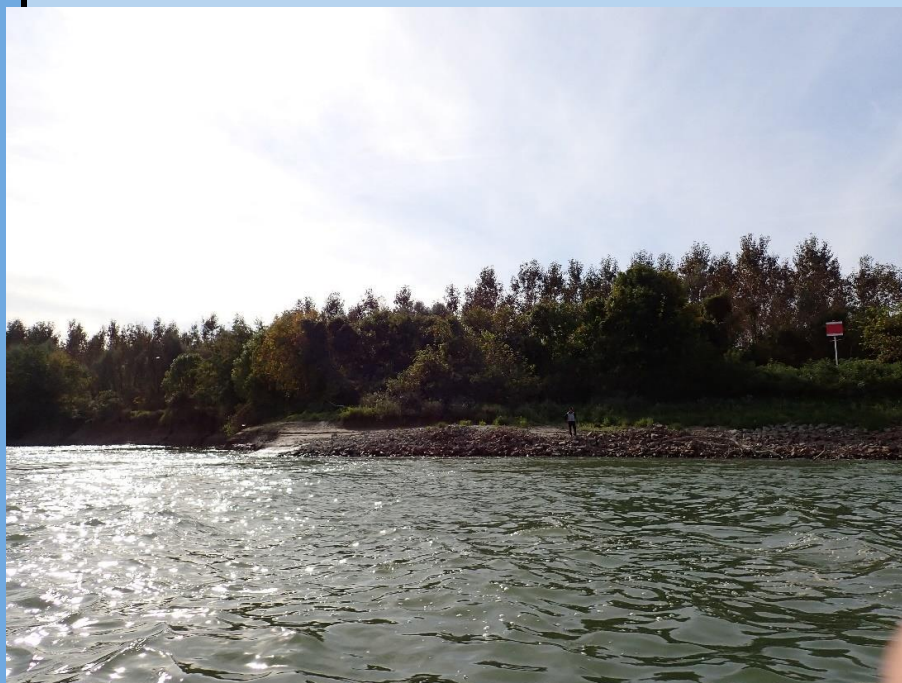
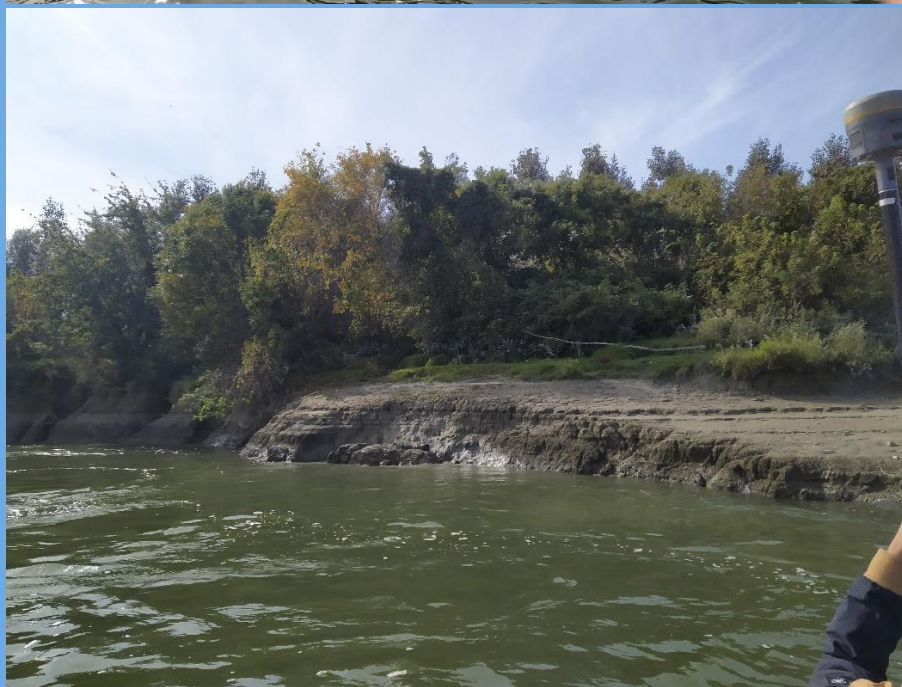
73. Right bank	Type:	Chainage (r.km)	Length (m)	Crown elevation (m.a.s.l.)
<b>1347-D2</b>	Revetment	1349+617 do 1347+712	2202,23	76,56

- Infrastructure is in satisfying condition.
- River bank erosion protection ongoing at low water levels.
- Start of revetment is 800 meters upstream from the rkm 1349. Stone material of revetment is visible. Above is a stone river bank overgrown with plants and trees.

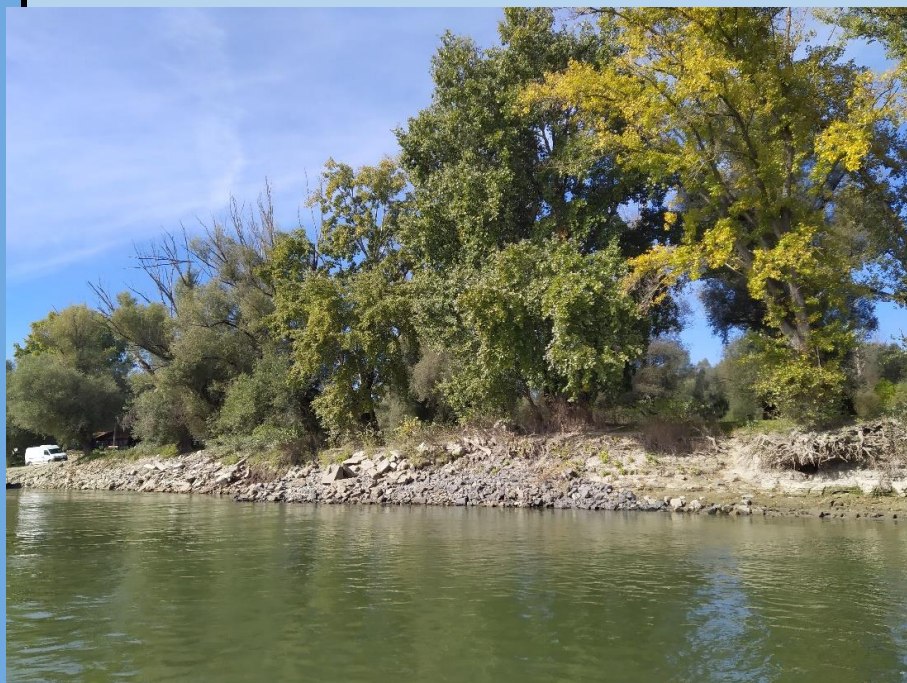
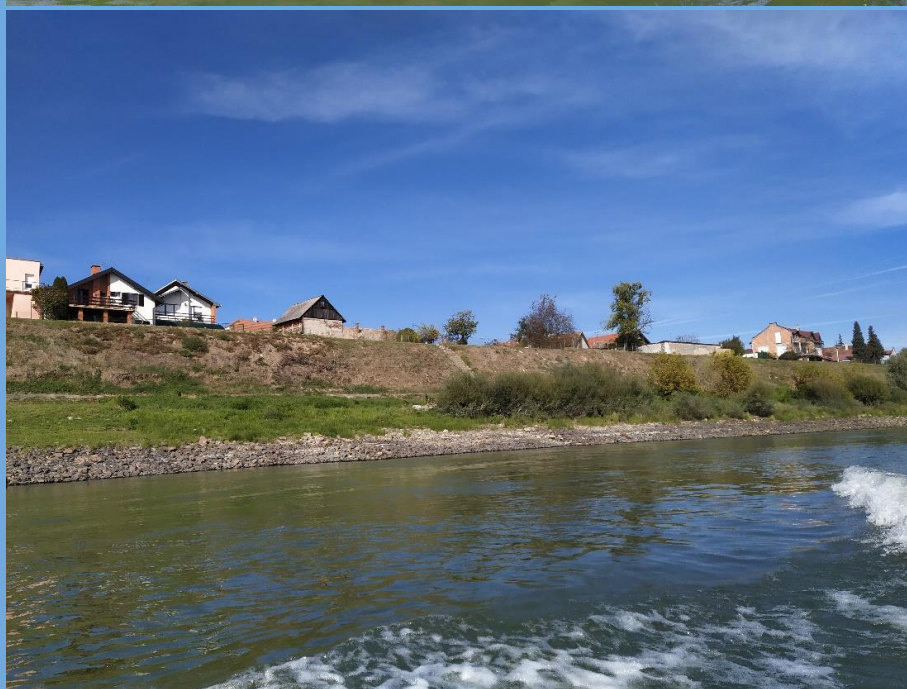
75. Right bank	Type:	Chainage (r.km)	Length (m)	Crown elevation (m.a.s.l.)
<b>1337-D1</b>	Revetment	1340+795 do 1337+499	2545,59	76,05 78,97

- Infrastructure is in good condition.
- River bank protection from erosion ongoing at low and high water levels.
- Stone revetment. It protects the river bank at low water levels. Downstream of the rkm 1338, city-type revetment protects the river bank from high water levels.

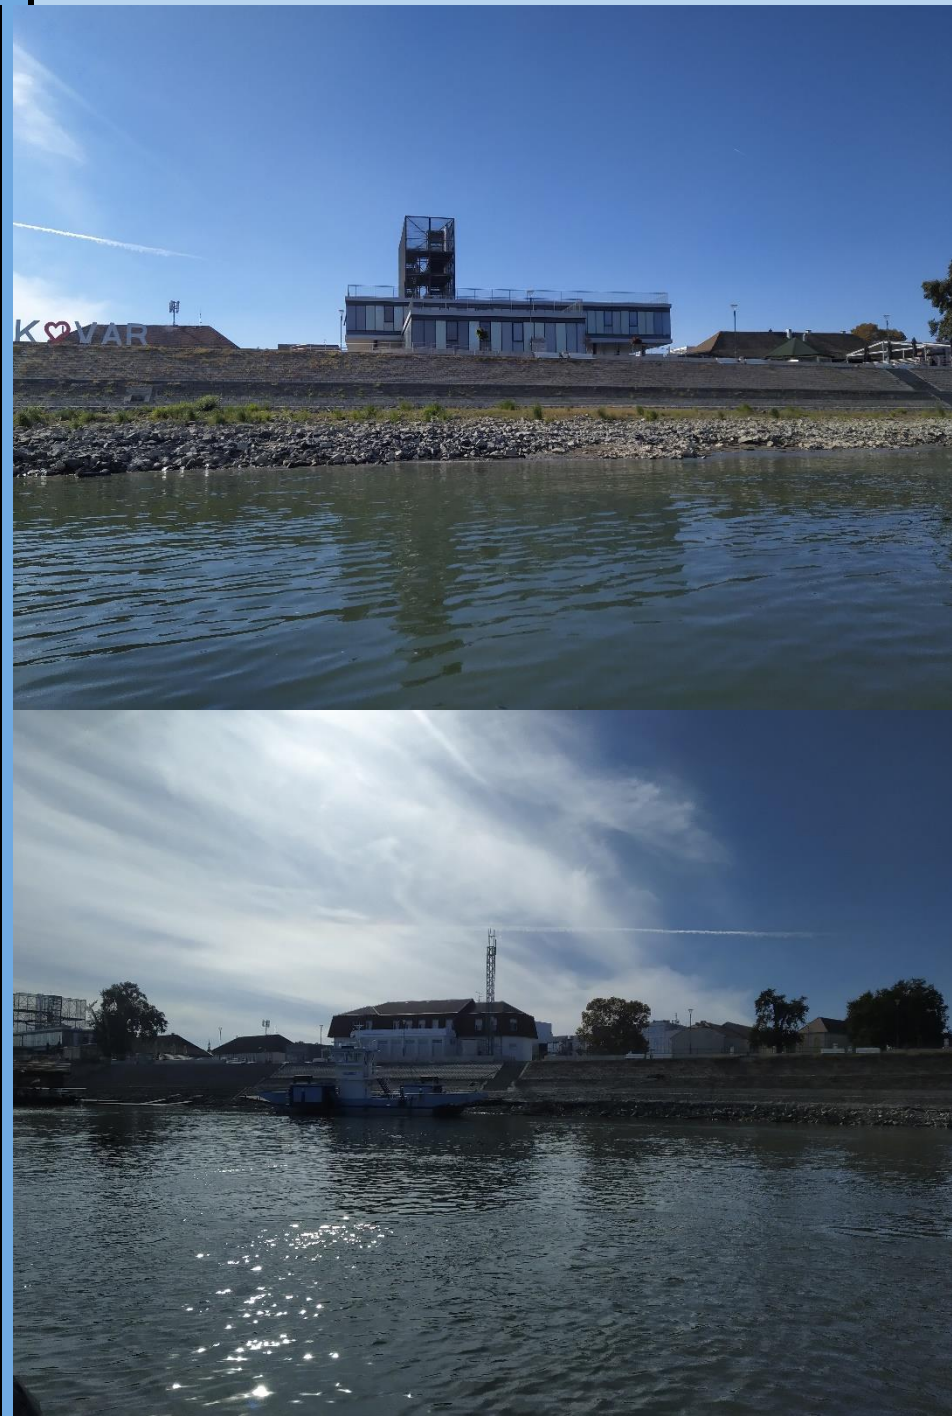
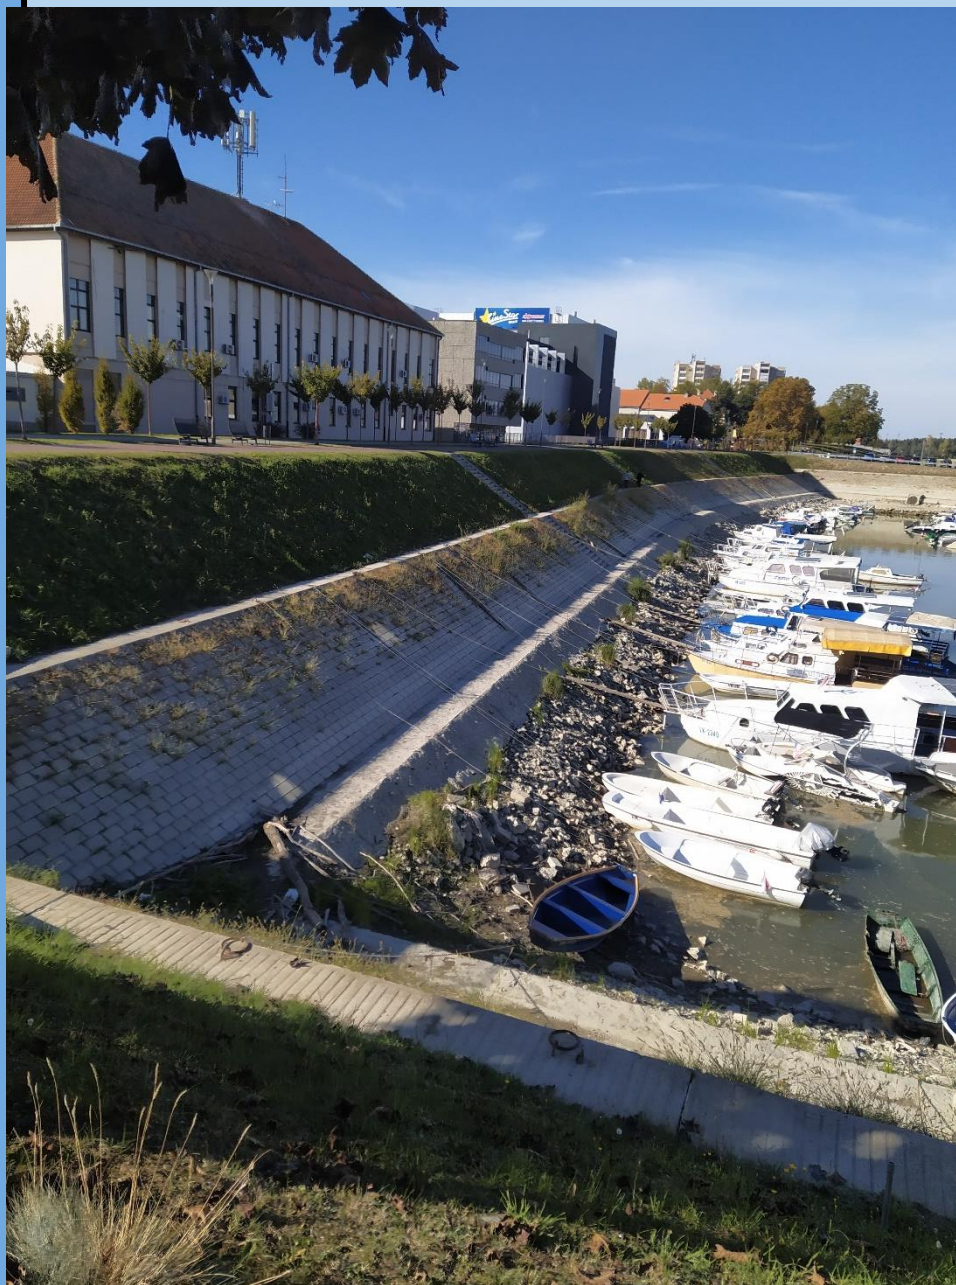
77. Right bank	Type:	Chainage (r.km)	Length (m)	Crown elevation (m.a.s.l.)
<b>1333-D1</b>	Revetment	1334+739 do 1333+113	998,31	83,40

- Infrastructure is in excellent condition.
- River bank erosion protection ongoing at high water levels.
- City-type revetment. It extends from the revetment 1334-D1 to the confluence of Vuka river and includes the revetment "Otok Športova".

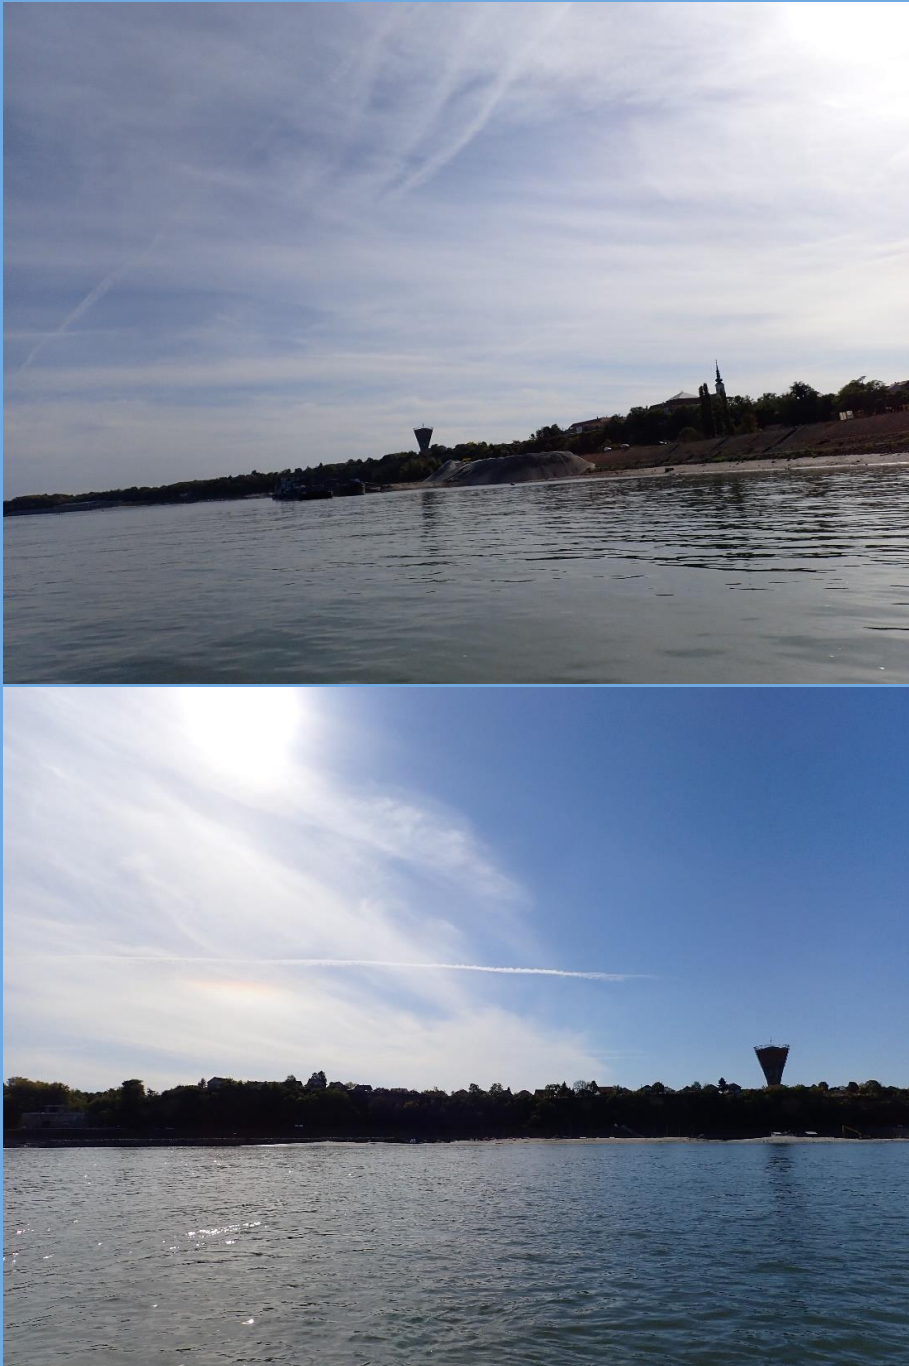
78. Right bank	Type:	Chainage (r.km)	Length (m)	Crown elevation (m.a.s.l.)
<b>1330-D1</b>	Revetment	1333+025 do 1330+932	3817,44	84,10

- Infrastructure is in excellent condition.
- River bank erosion protection ongoing at high water levels. The revetment of passenger wharf of Vukovar. It is under construction in the area of the city of Vukovar, from rkm 1333 (confluence of Vuka river) to rkm 1331 (waste water treatment device).

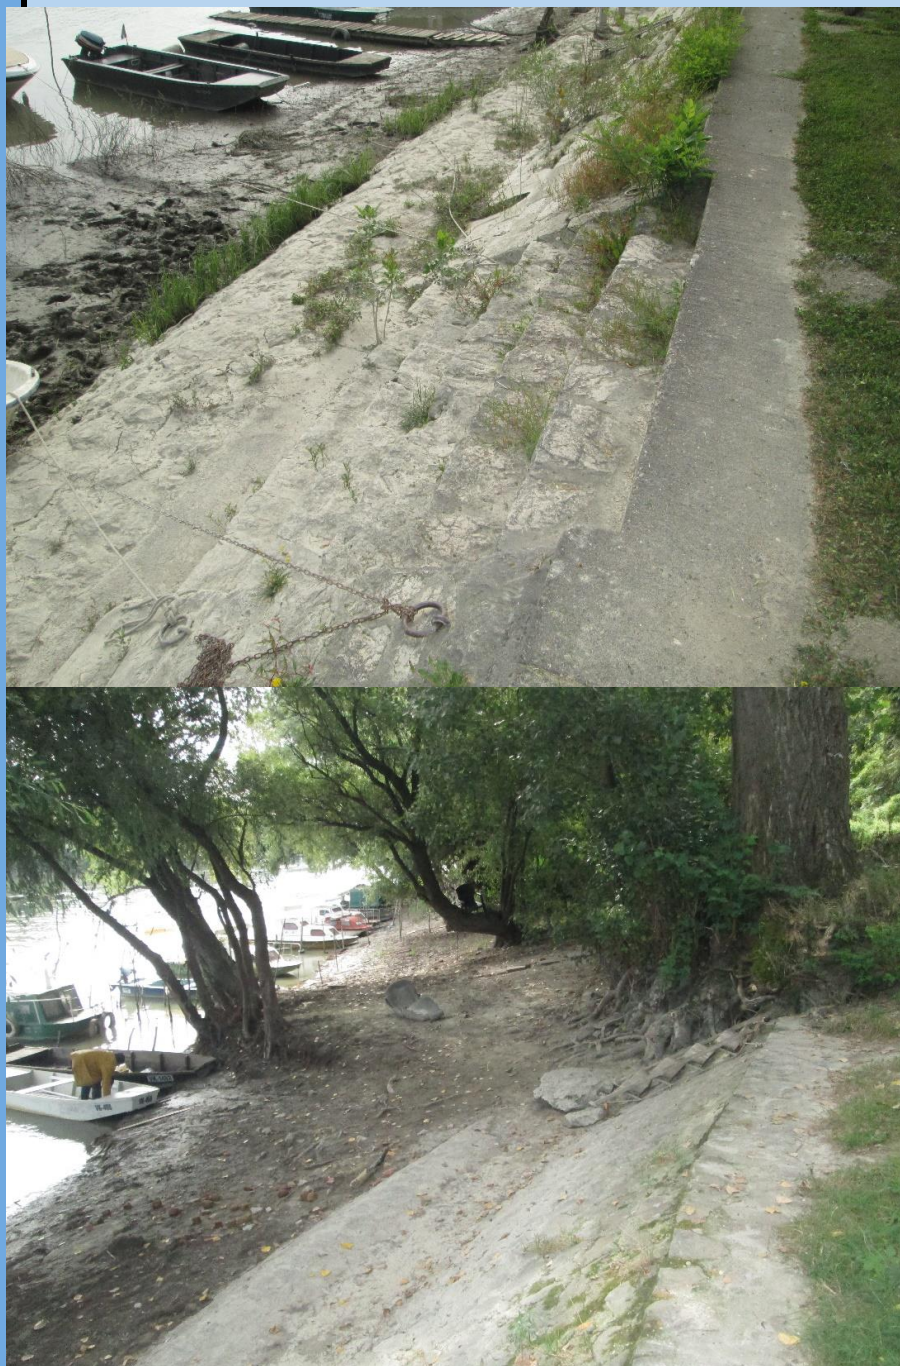
79. Right bank	Type:	Chainage (r.km)	Length (m)	Crown elevation (m.a.s.l.)
<b>1328-D1</b>	Revetment	1328+550 do 1328+415	180,05	79,90

- Infrastructure is in good condition.
- River bank erosion protection ongoing at medium water levels.
- City-type revetment to crown elevation of 80.15 m.a.s.l. The revetment of passenger wharf of Vučedol.

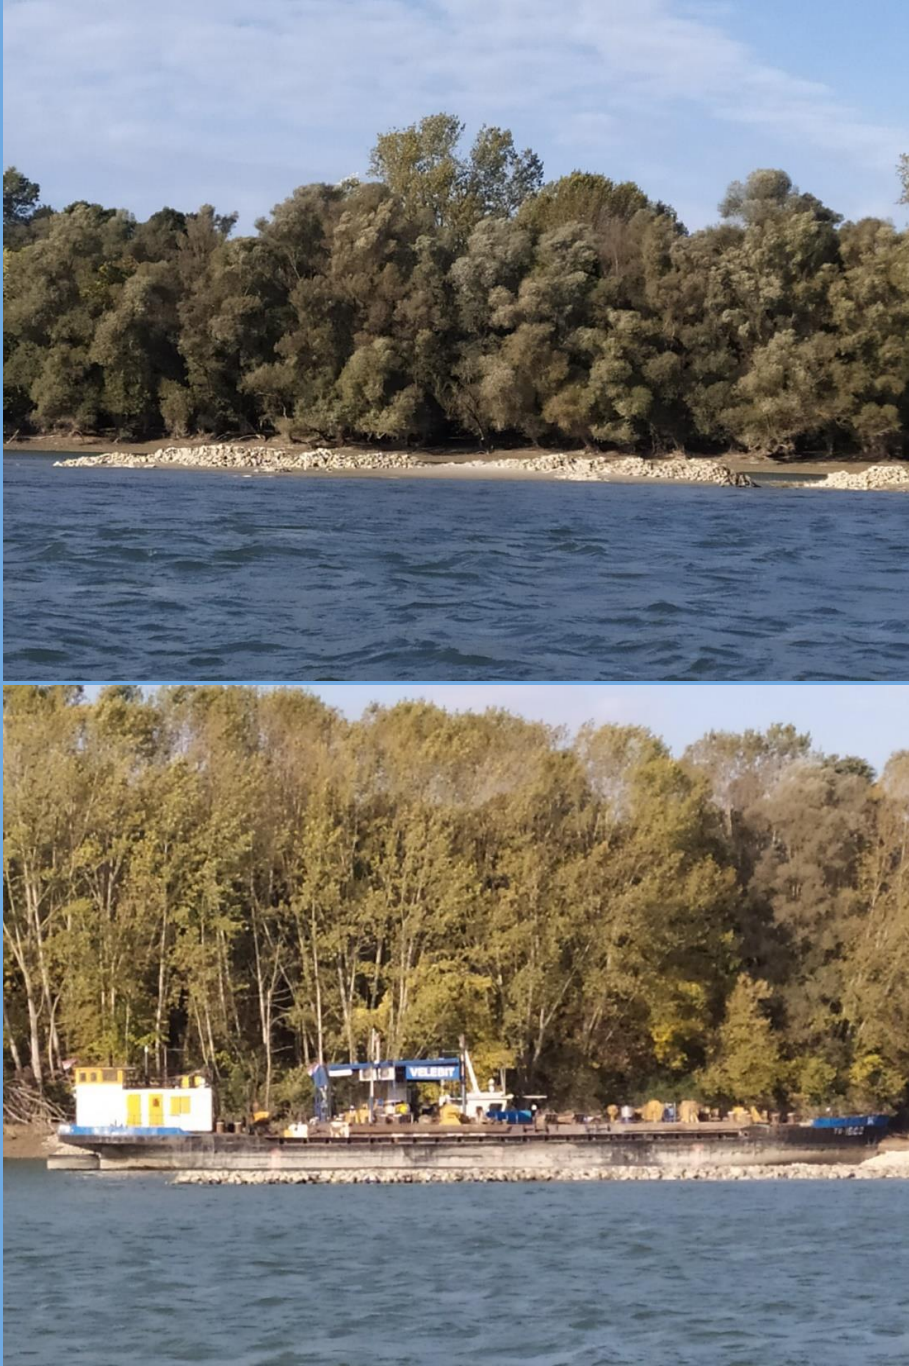
80. Right bank	Type:	Chainage (r.km)	Length (m)	Crown elevation (m.a.s.l.)
<b>1322-D2</b>	Parallel structure	1323+927 do 1322+971	1061,26	76,08

- Infrastructure is in excellent condition.
- Effect of material deposition ongoing (upstream, downstream).
- Newly built. Stone material of parallel structure and groyne are visible.

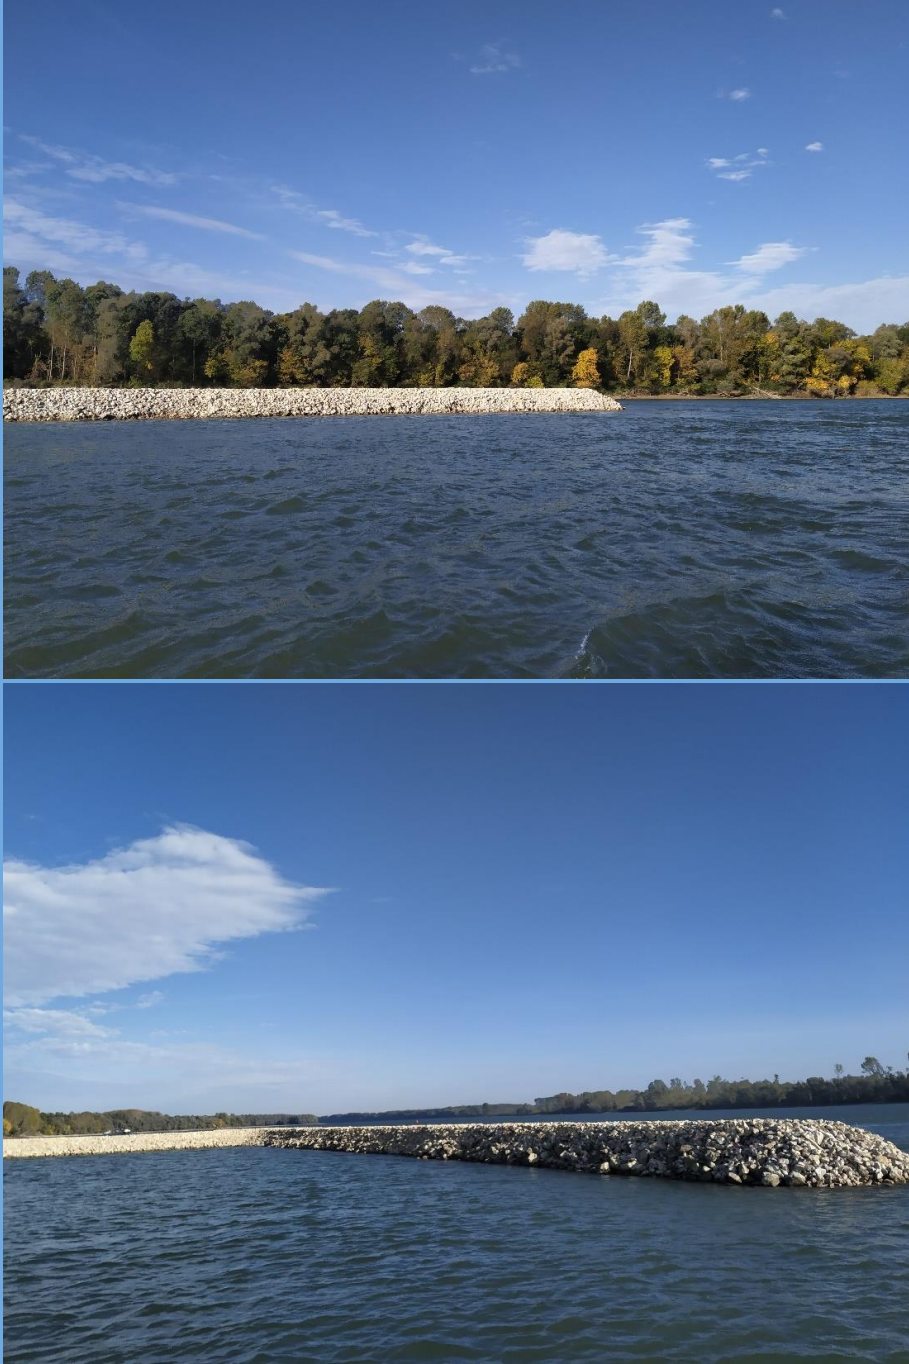
81. Right bank	Type:	Chainage (r.km)	Length (m)	Crown elevation (m.a.s.l.)
<b>1322-D1</b>	T-groyne	1322+450	90,04	77,01

- Infrastructure is in excellent condition..
- Effect of material deposition ongoing (upstream, downstream).
- Newly built. Stone material of groyne connection and groyne head is visible.

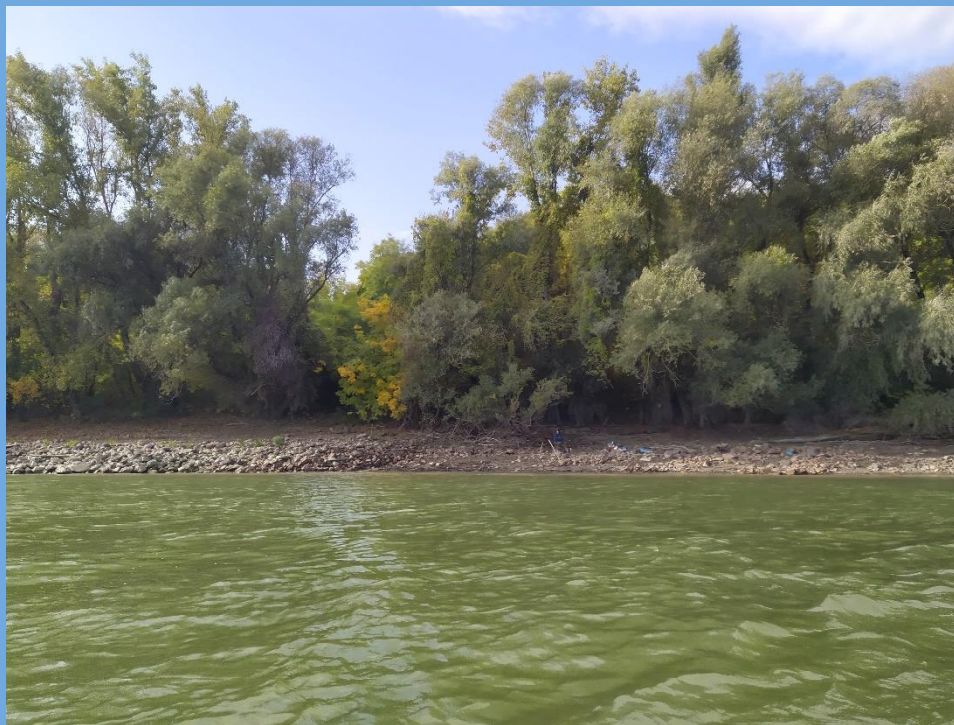
82. Right bank	Type:	Chainage (r.km)	Length (m)	Crown elevation (m.a.s.l.)
<b>1321-D1</b>	T-groyne	1321+960	89,98	76,99

- Infrastructure is in excellent condition..
- Effect of material deposition ongoing (upstream, downstream).
- Newly built. Stone material of groyne connection and groyne head is visible.

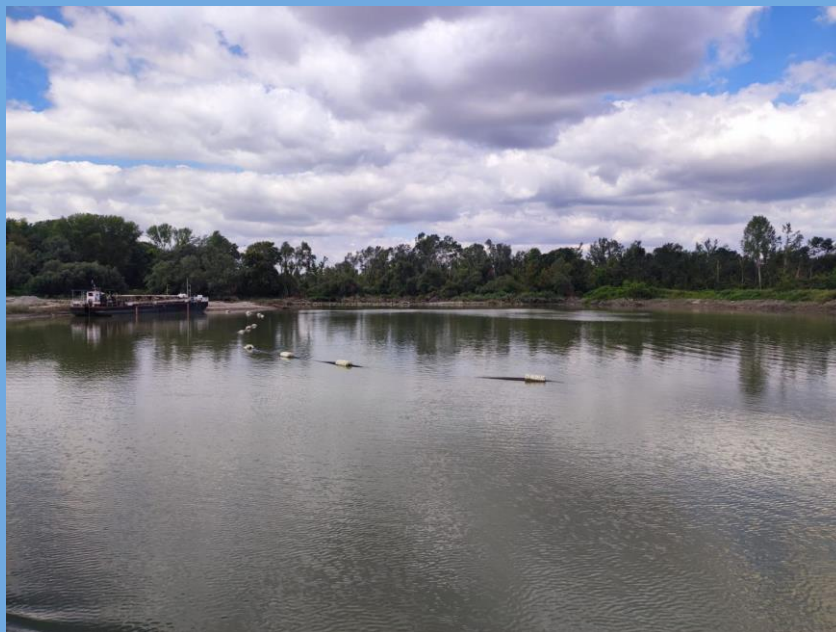
83. Right bank	Type:	Chainage (r.km)	Length (m)	Crown elevation (m.a.s.l.)
<b>1318-D1</b>	Revetment	1318+669 do 1318+577	118,34	75,35

- Infrastructure is in bad condition..
- River bank erosion protection failed.
- Stone material of the revetment is visible at low water levels.

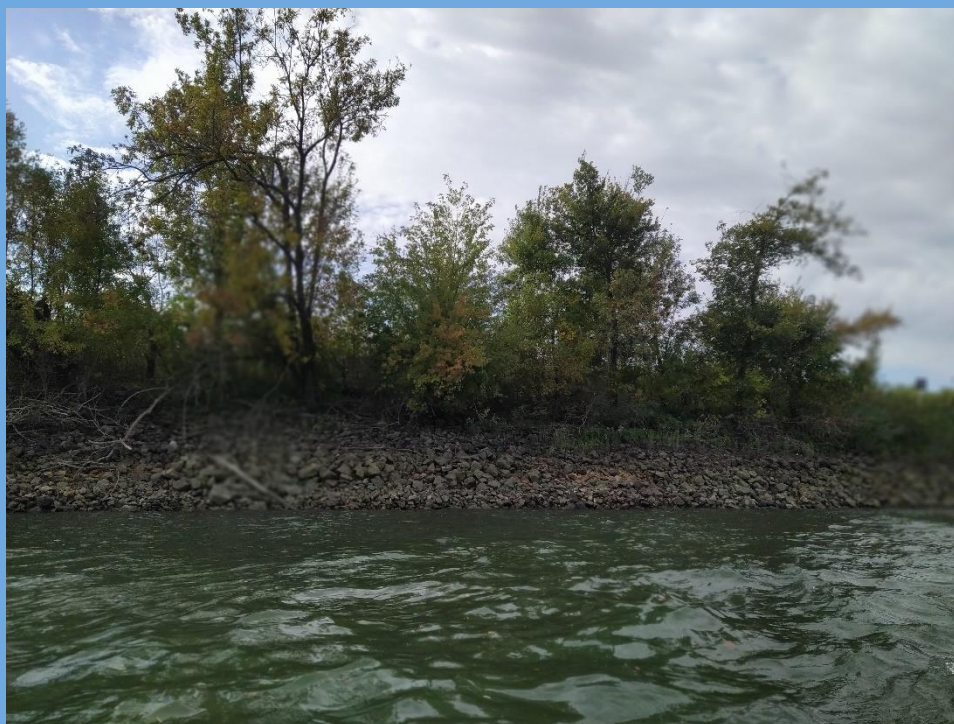
- Infrastructure is in good condition..
- Barrier on backwater flow finished at low water level.
- Barrier is not visible from the river side.

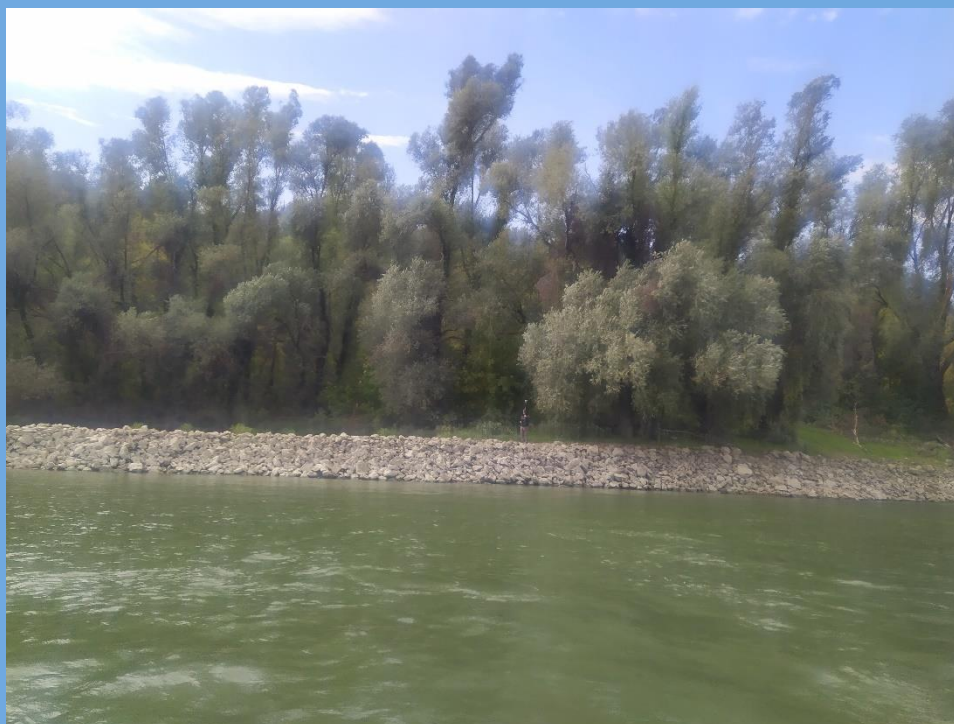
85. Right bank	Type:	Chainage (r.km)	Length (m)	Crown elevation (m.a.s.l.)
<b>1309-D1</b>	Revetment	1313+676 do 1309+502	3993,84	74,95

- Infrastructure is in satisfying condition..
- River bank erosion protection ongoing at low water levels.
- Stone material of the revetment is visible at low water levels. Collapsed vegetation on the bevel.

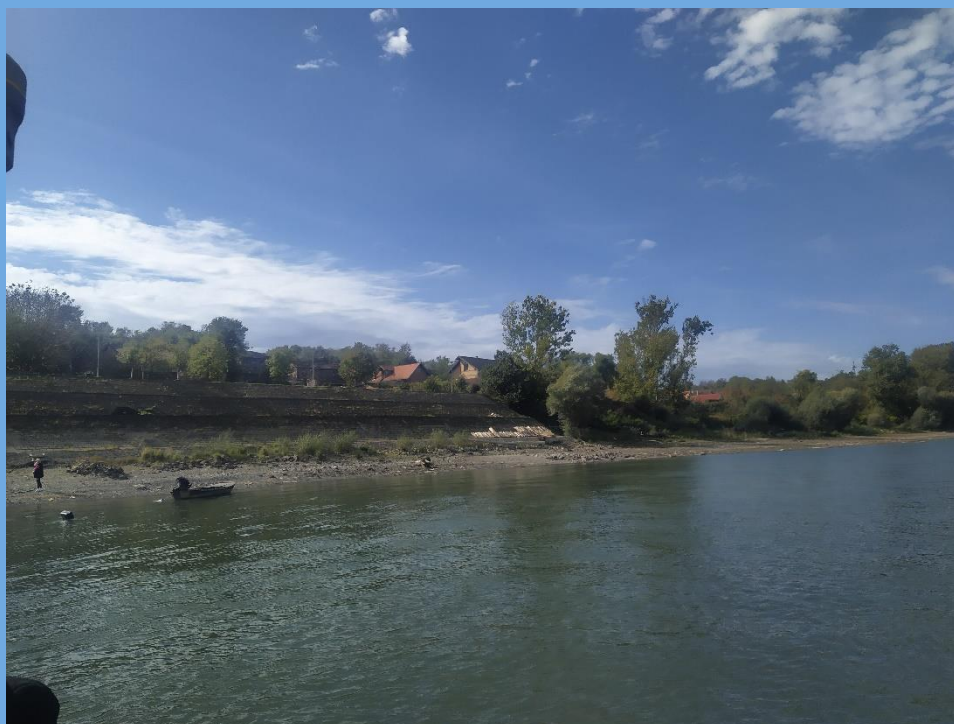
86. Right bank	Type:	Chainage (r.km)	Length (m)	Crown elevation (m.a.s.l.)
<b>1307-D1</b>	Parallel structure	1309+502 do 1307+954	1646,34	76,34

- Infrastructure is in good condition..
- Effect of material deposition ongoing (upstream, downstream).
- Parallel structure continues on a revetment 1309-D1. Stone material of the parallel and two groynes vertical to it are visible. Material deposition on the river bank is spotted in the back of the parallel structure.

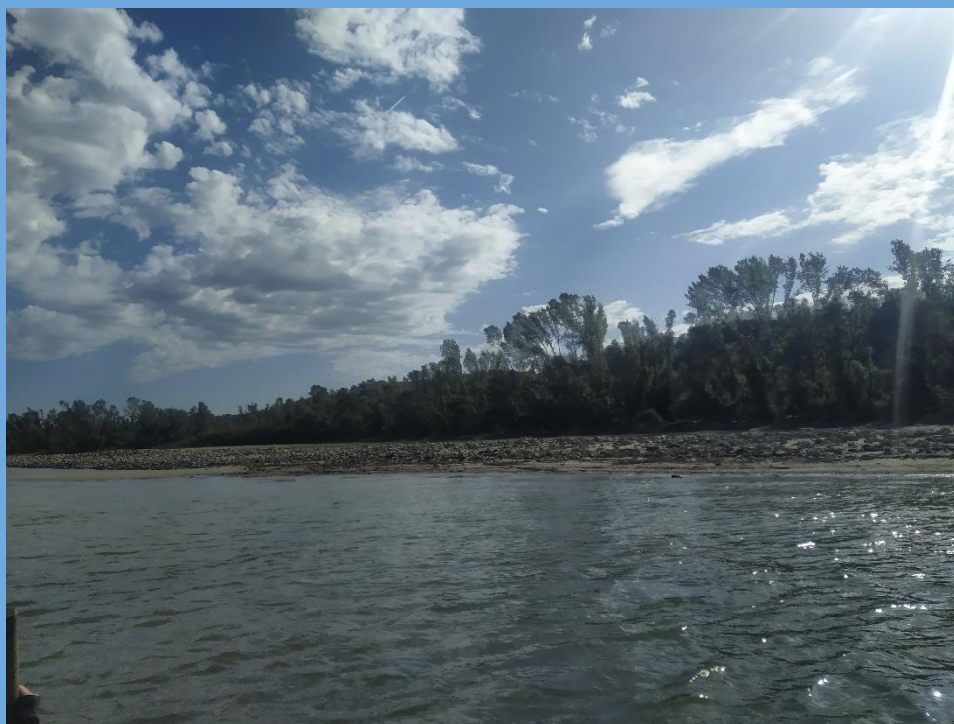
- Infrastructure is in excellent condition..
- River bank erosion protection ongoing at high water levels.
- City-type revetment of Šarengrad settlement.

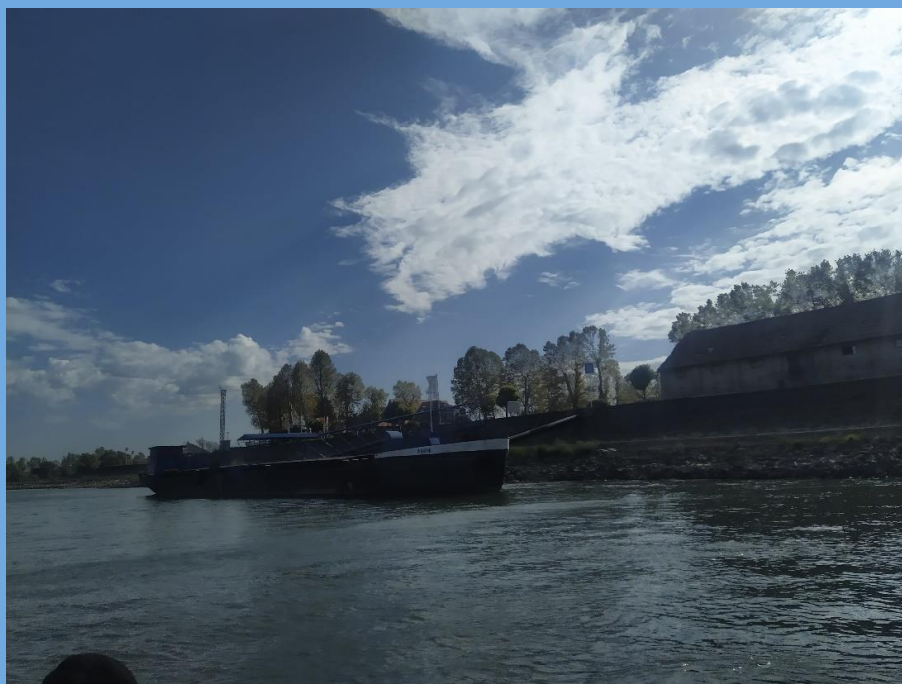
88. Right bank	Type:	Chainage (r.km)	Length (m)	Crown elevation (m.a.s.l.)
<b>1299-D1</b>	Parallel structure	1300+668 do 1299+105	1790,95	73,77

- Infrastructure is in satisfying condition..
- Effect of material deposition ongoing (downstream).
- Stone material of parallel structure is visible. Material deposition on the river bank is spotted in the back of the parallel structure. Parts of the stone material are collapsed and have irregular geometry.
