**MONITORING OF HYDROLOGICAL, HYDRAULIC AND MORPHOLOGICAL CHARACTERISTICS OF THE DANUBE RIVER AND INVENTORY OF BIODIVERSITY COMPONENTS ON THE JOINT CROATIAN-SERBIAN SECTOR OF THE DANUBE RIVER**

**INVENTORY OF RIVER REGULATION INFRASTRUCTURE RELATED TO NAVIGATION**

**Project number:** I-2206/24

**LOCATION:** Danube river from rkm 1295,5 (Ilok) to rkm 1433,1  
(border with Hungary)

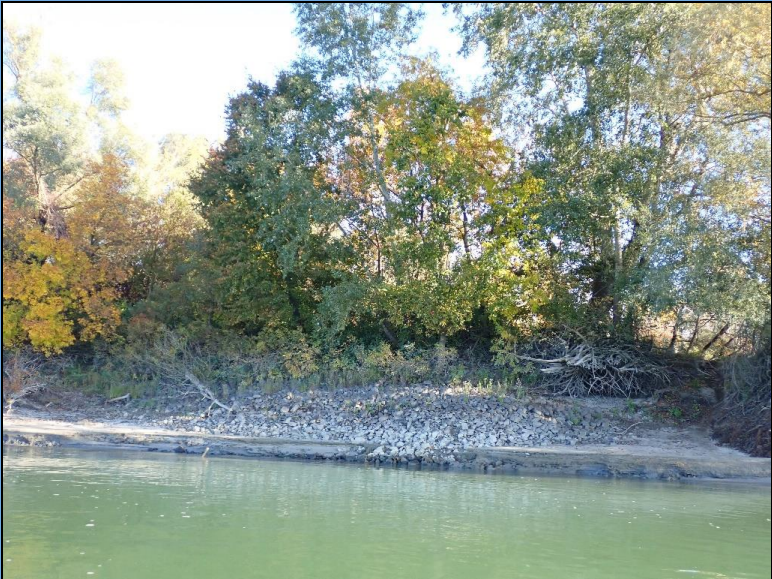
89. Right bank	Type:	Chainage (r.km)	Length (m)	Crown and toe elevation (m.a.s.l.)
<b>1295-D1</b>	Revetment	1299+105 do 1295+350	3789,17	80,07 crown 73,93 toe

- Infrastructure is in excellent/good condition..
- River bank protection from erosion ongoing at low and high water levels. Effect of material deposition ongoing (downstream).
- City-type revetment at the wharf of Ilok protects the river bank from the high waters. Downstream of the wharf, stone revetment and parallel structure are in function of river bank protection from the erosion during low water levels. Downstream of the bridge, vertical river bank is under construction.

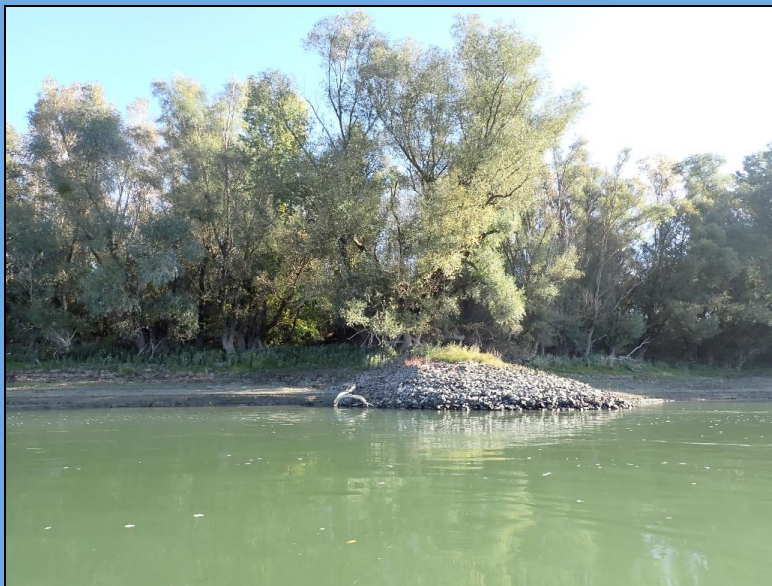
- Infrastructure is in satisfying condition.
- Effect of material deposition finished (upstream, downstream).
- Groyne material and effect of material deposition upstream and downstream visible.

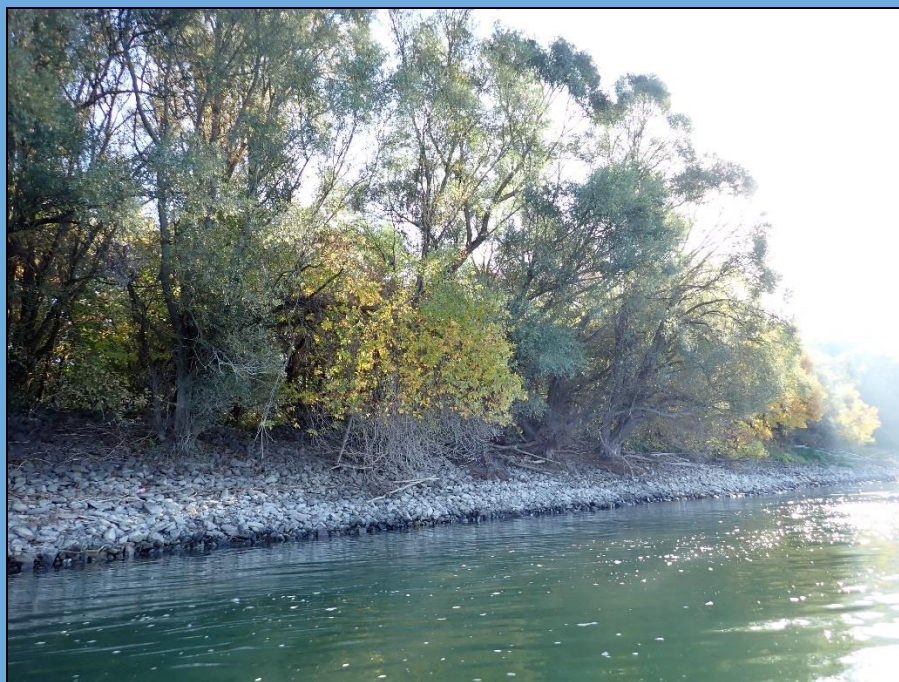
- Infrastructure is in good condition.
- Effect of material deposition ongoing (upstream, downstream).
- Groyne material and effect of material deposition upstream and downstream visible, vegetation present on the beginning of the infrastructure.

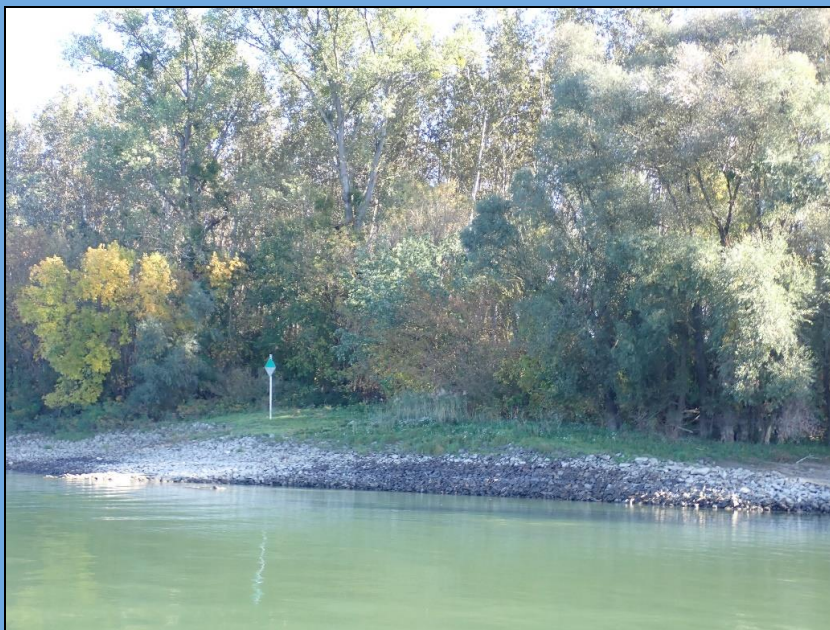
3. Left bank	Type:	Chainage (r.km)	Length (m)	Crown elevation (m.a.s.l.)
<b>1430-L4</b>	Revetment	1432+360 do 1430+378	2152,14 m	82,76

- Infrastructure is in good condition.
- River bank erosion protection ongoing at low water levels.
- Stone revetment. Revetment material visible. Above crown revetment vegetation and trees present. Approx 30 m of revetment material not visible.

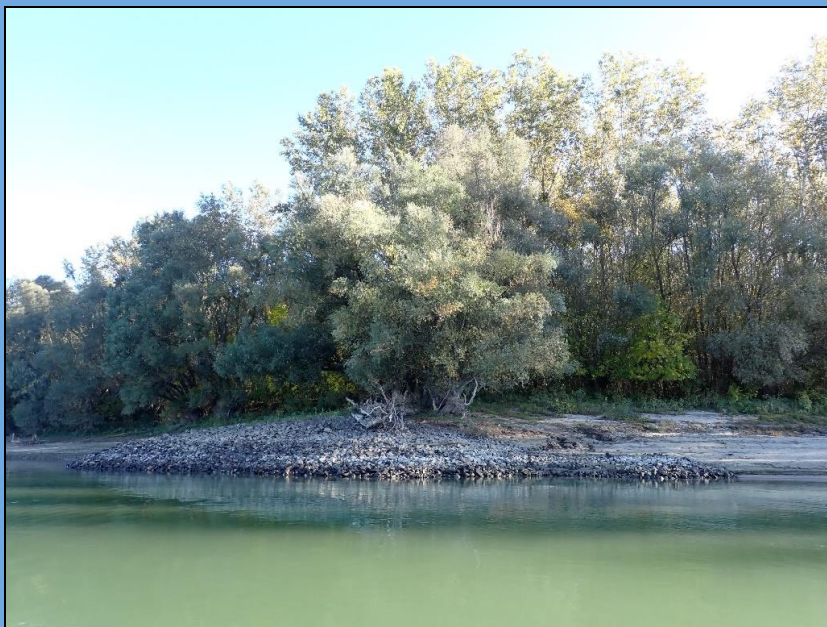
- Infrastructure is in good condition.
- River bank erosion protection ongoing at low water levels.
- River bank ingrown with revetment. Effect of material deposition visible (upstream and downstream).

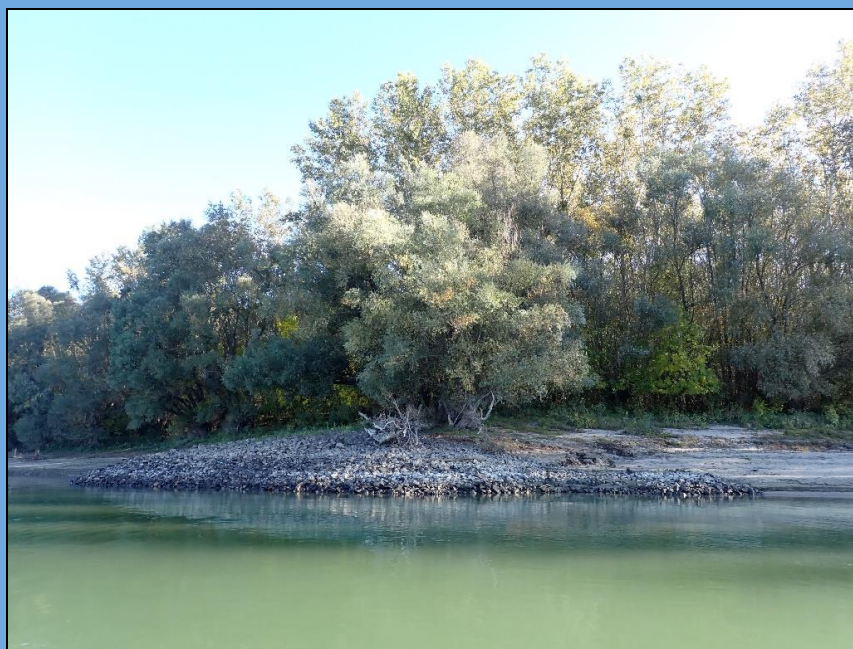
- Infrastructure is in good condition.
- Effect of material deposition ongoing (upstream, downstream).
- Material on the groyne head and effect of material deposition upstream and downstream visible, vegetation present on the beginning of the infrastructure.

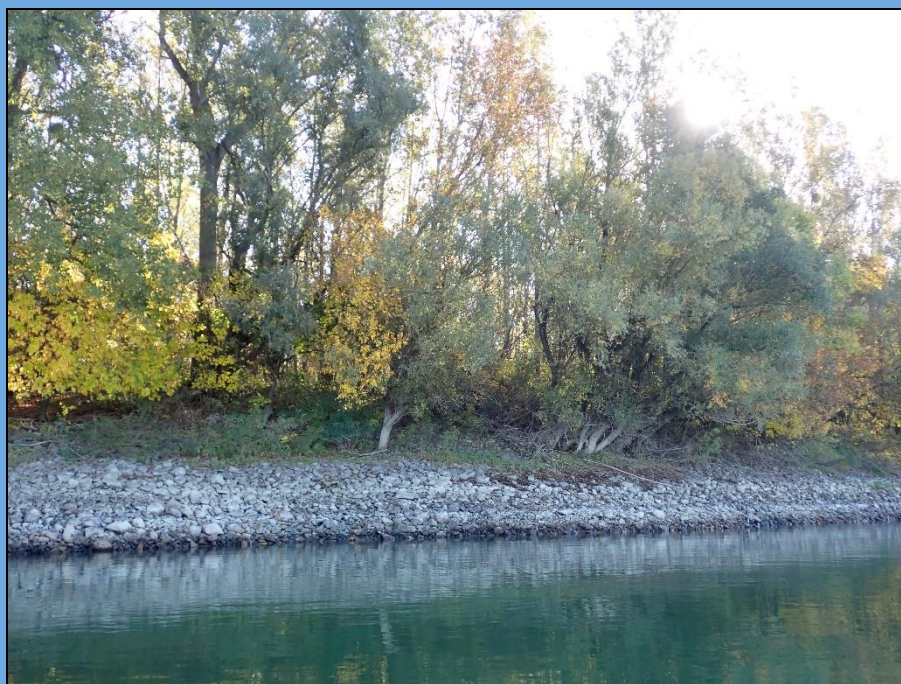
- Infrastructure is in good condition.
- Effect of material deposition ongoing (upstream, downstream).
- Material on the groyne head and effect of material deposition upstream and downstream visible, vegetation present on the beginning of the infrastructure.

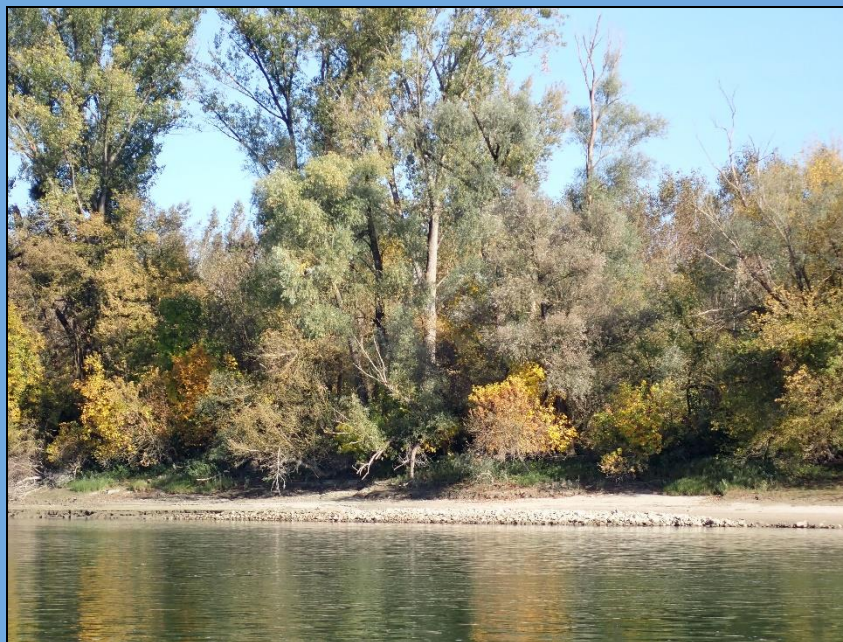
7. Left bank	Type:	Chainage (r.km)	Length (m)	Crown elevation (m.a.s.l.)
<b>1429-L1</b>	Revetment	1430+090 do 1429+516	539,78	82,03

- Infrastructure is in good condition.
- River bank erosion protection ongoing at low water levels.
- Stone revetment. Revetment material visible. Above crown revetment vegetation and trees present.

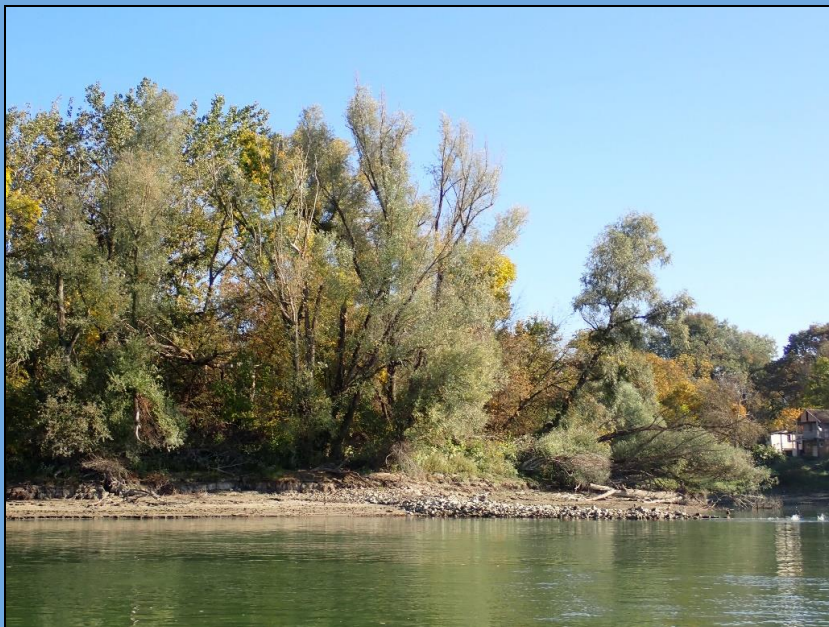
- Infrastructure is in bad condition.
- Effect of material deposition ongoing (upstream, downstream).
- Parts of parallel structure material and effect of material deposition upstream and downstream visible.

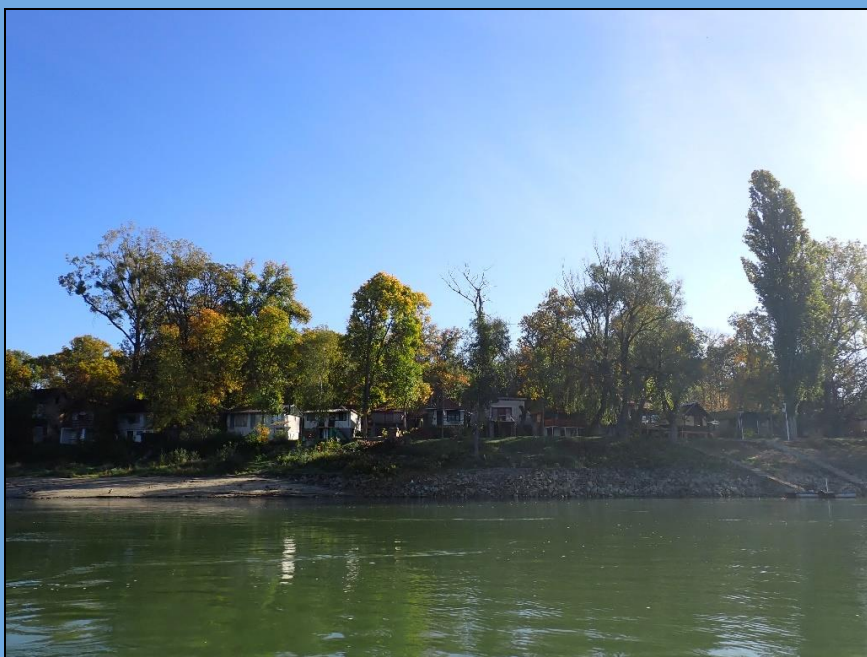
- Infrastructure is in bad condition.
- Effect of material deposition ongoing (upstream, downstream).
- Parts of groyne material and effect of material deposition upstream and downstream visible.

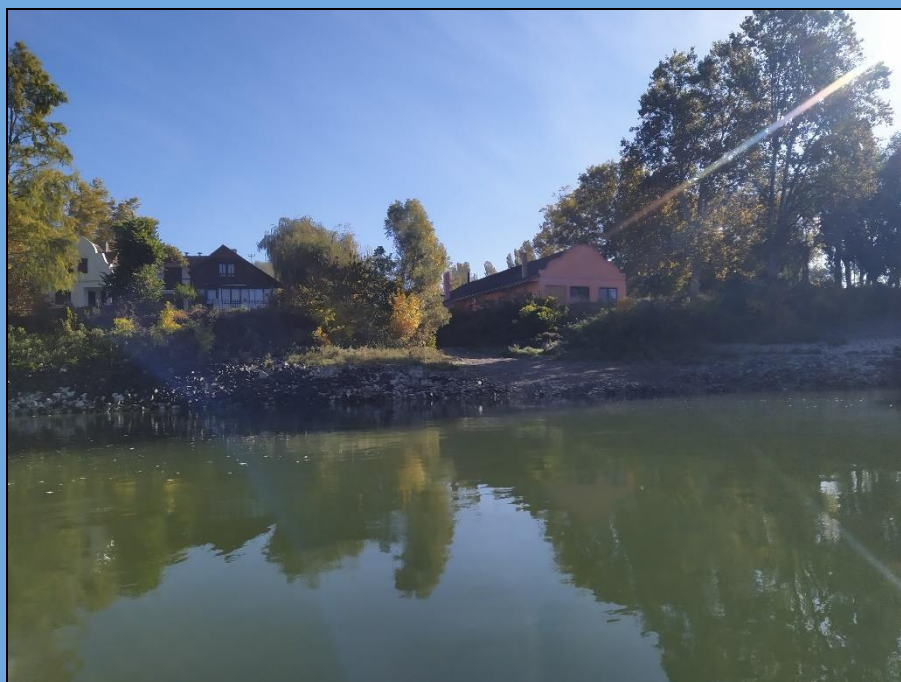
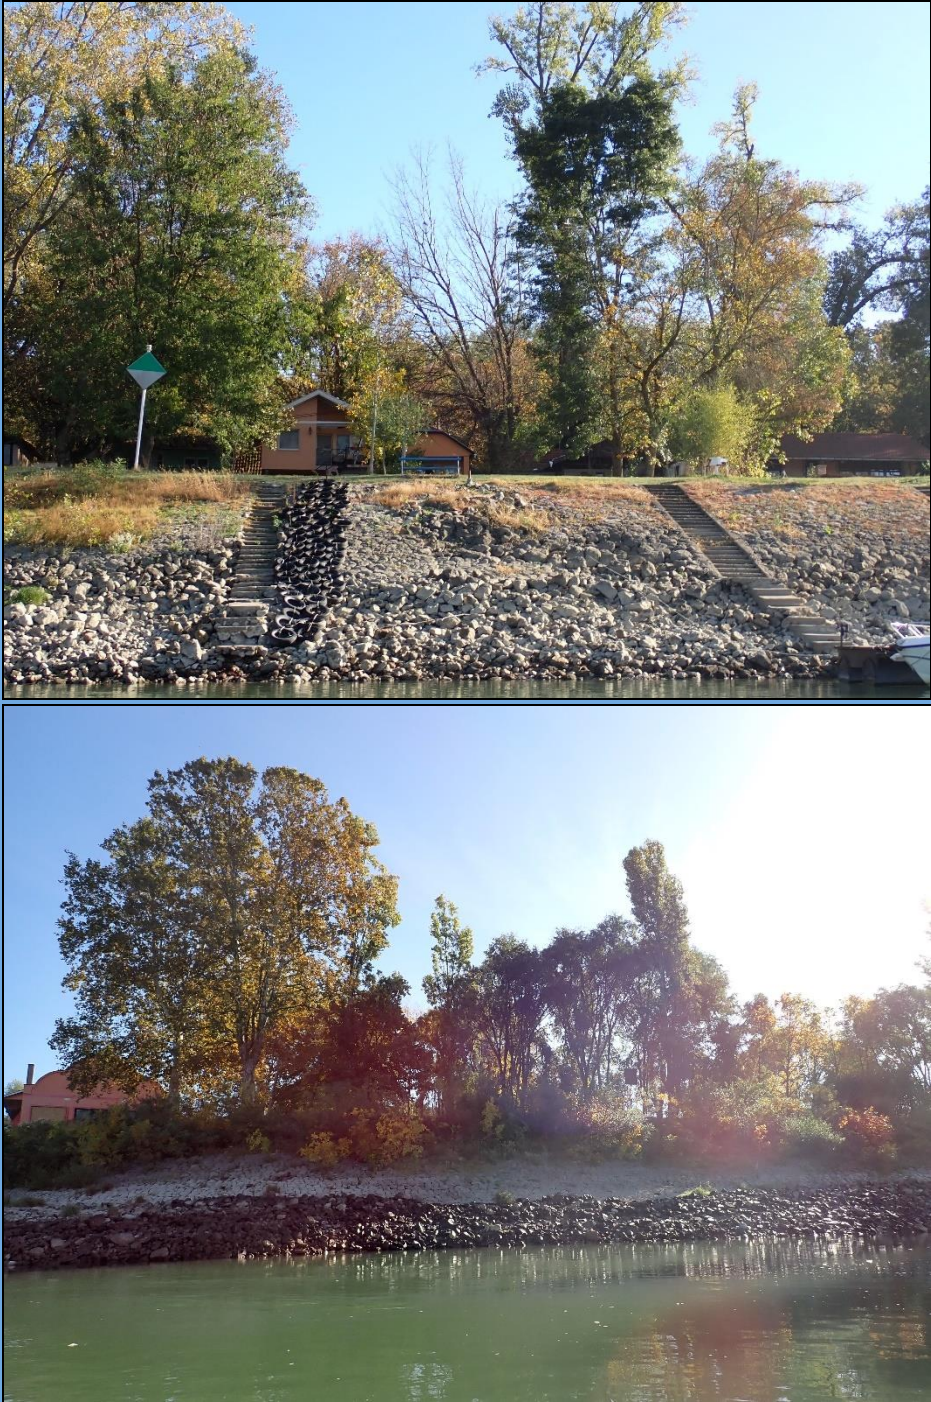
10. Left bank	Type:	Chainage (r.km)	Length (m)	Crown elevation (m.a.s.l.)
<b>1425-L6</b>	Revetment	1426+195 do 1425+712	524,55	85,53

- Infrastructure is in good condition.
- River bank erosion protection ongoing at medium water levels.
- Slope revetment from stone and concrete stone. Concrete stairs along the slope revetment.

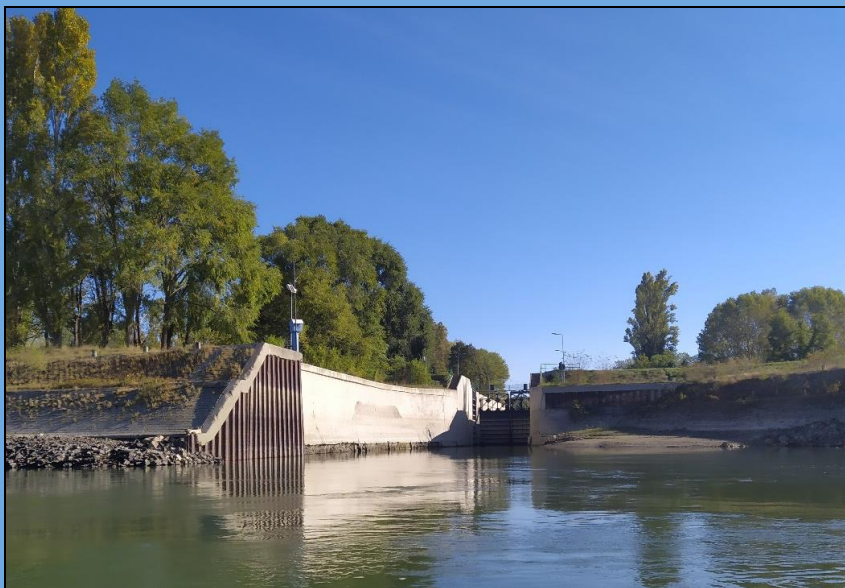
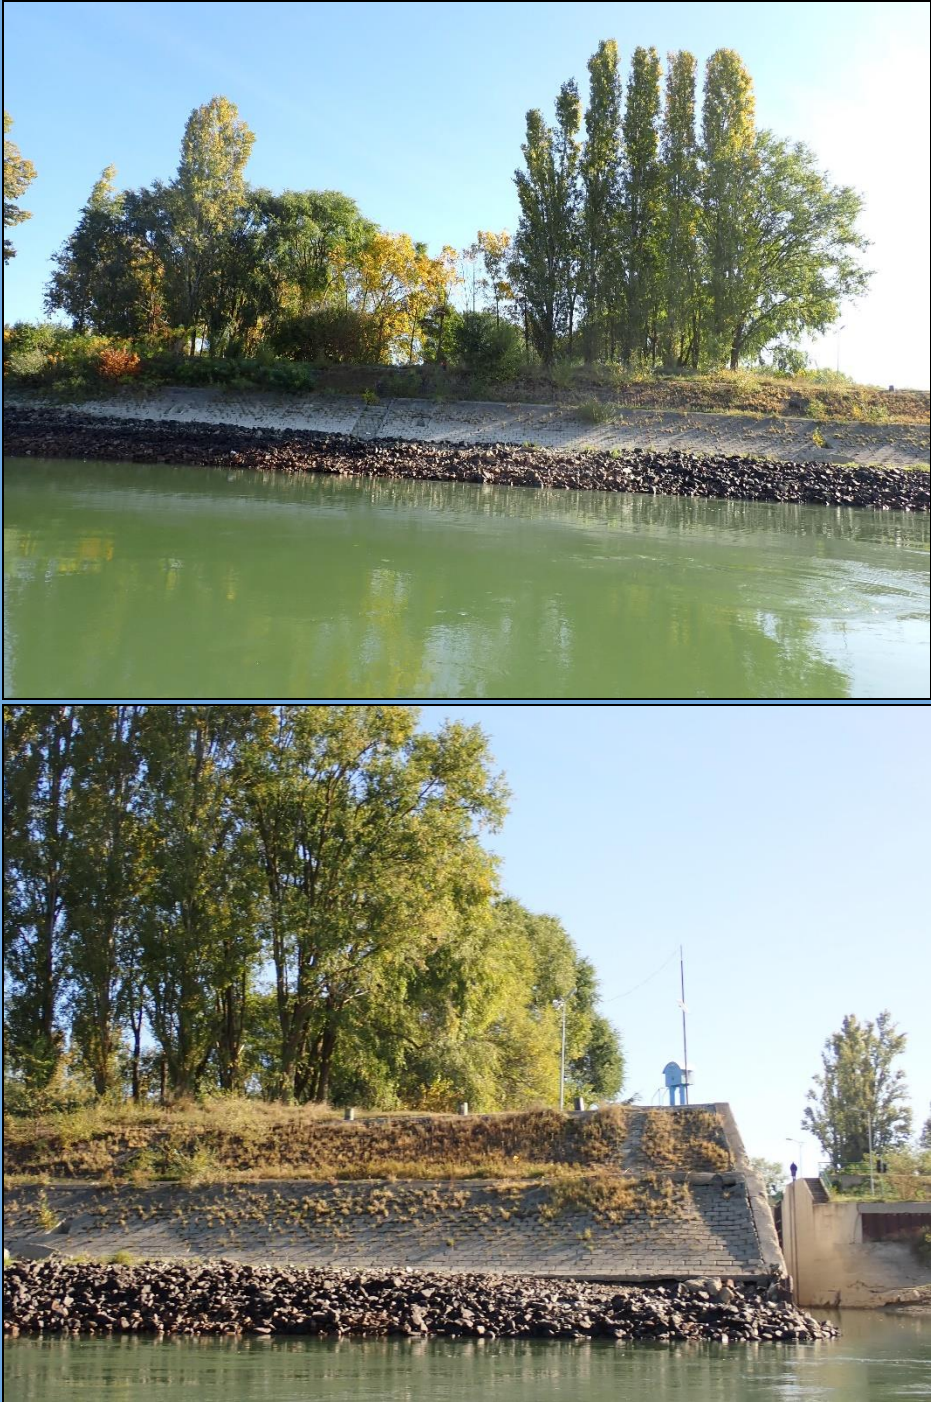
11. Left bank	Type:	Chainage (r.km)	Length (m)	Crown elevation (m.a.s.l.)
<b>1425-L5</b>	Revetment	1425+712 do 1425+577	145,97	83,15

- Infrastructure is in good condition.
- River bank erosion protection ongoing at high water levels.
- Part of slope revetment made from concrete stone, the rest of the slope is made of concrete blocks (city-type revetment). Concrete stairs along the slope revetment.

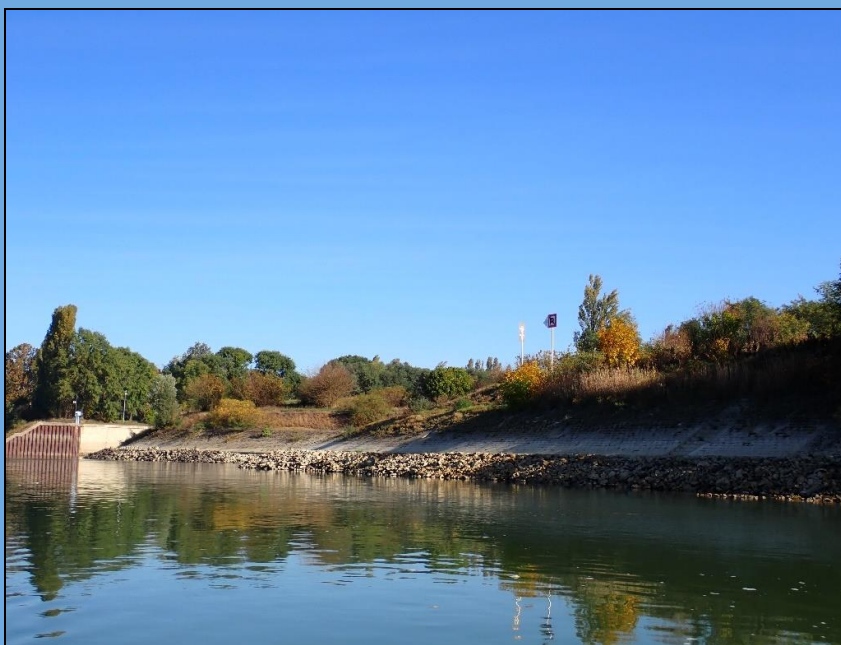
- Infrastructure is in good condition.
- River bank erosion protection ongoing at high water levels.
- Semicircular revetment. Revetment slope made of concrete blocks (city-type revetment).

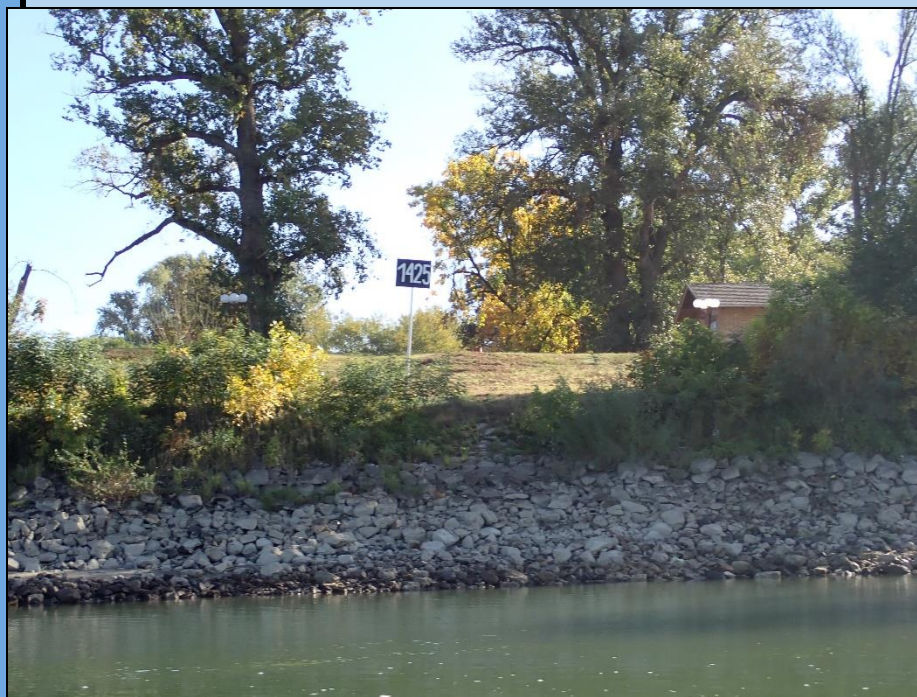
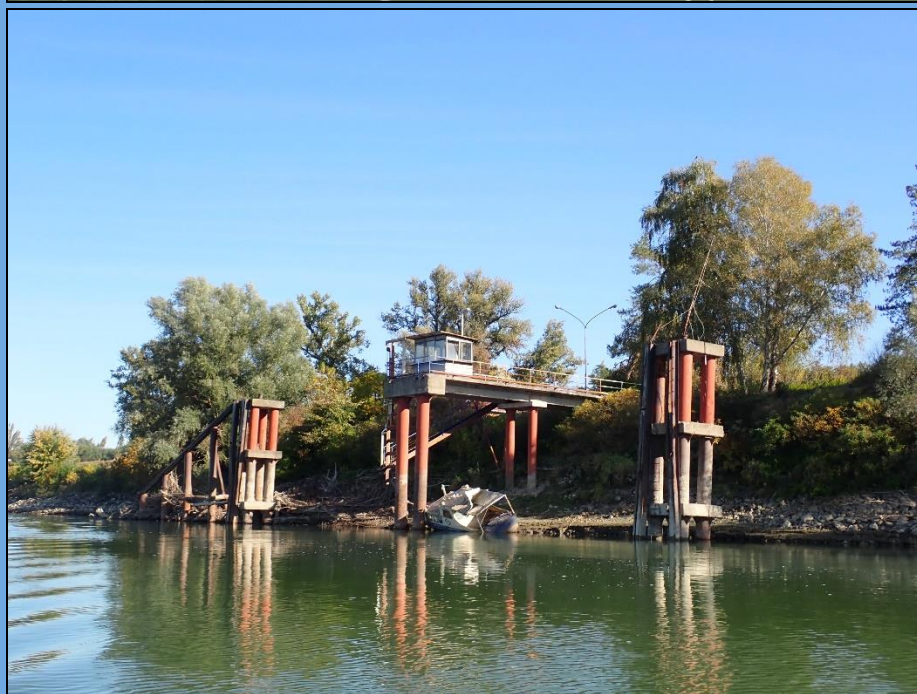
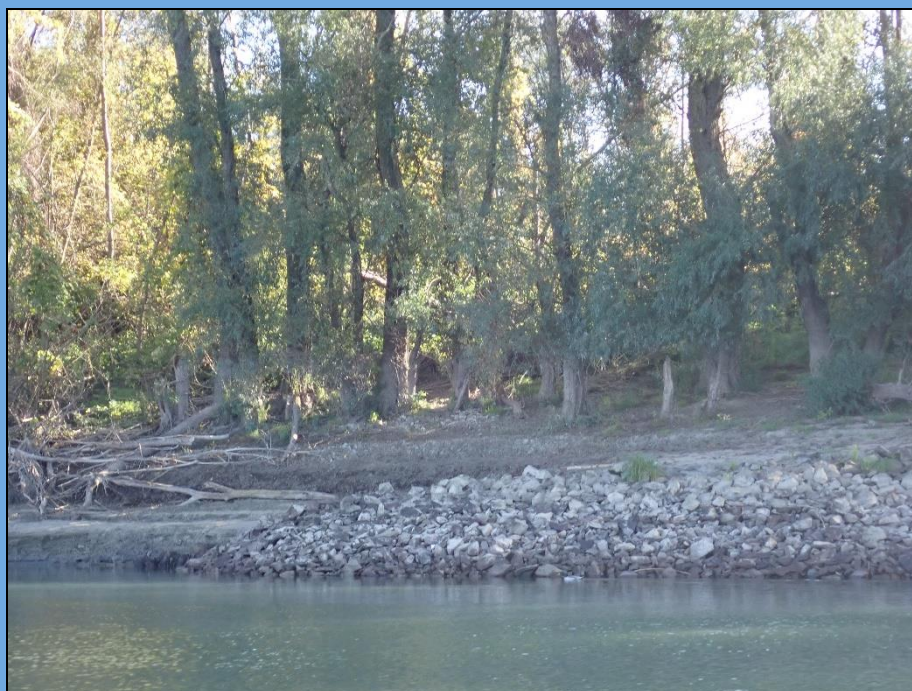
15. Left bank	Type:	Chainage (r.km)	Length (m)	Crown elevation (m.a.s.l.)
<b>1425-L1</b>	Revetment	1425+423 do 1424+959	451,65	81,79

- Infrastructure is in satisfying condition.
- River bank erosion protection ongoing at medium water levels.
- Stone revetment. Vegetation present above the infrastructure. Continues to the revetment 1425-L2. Visible columns of the old docking place in bad condition.

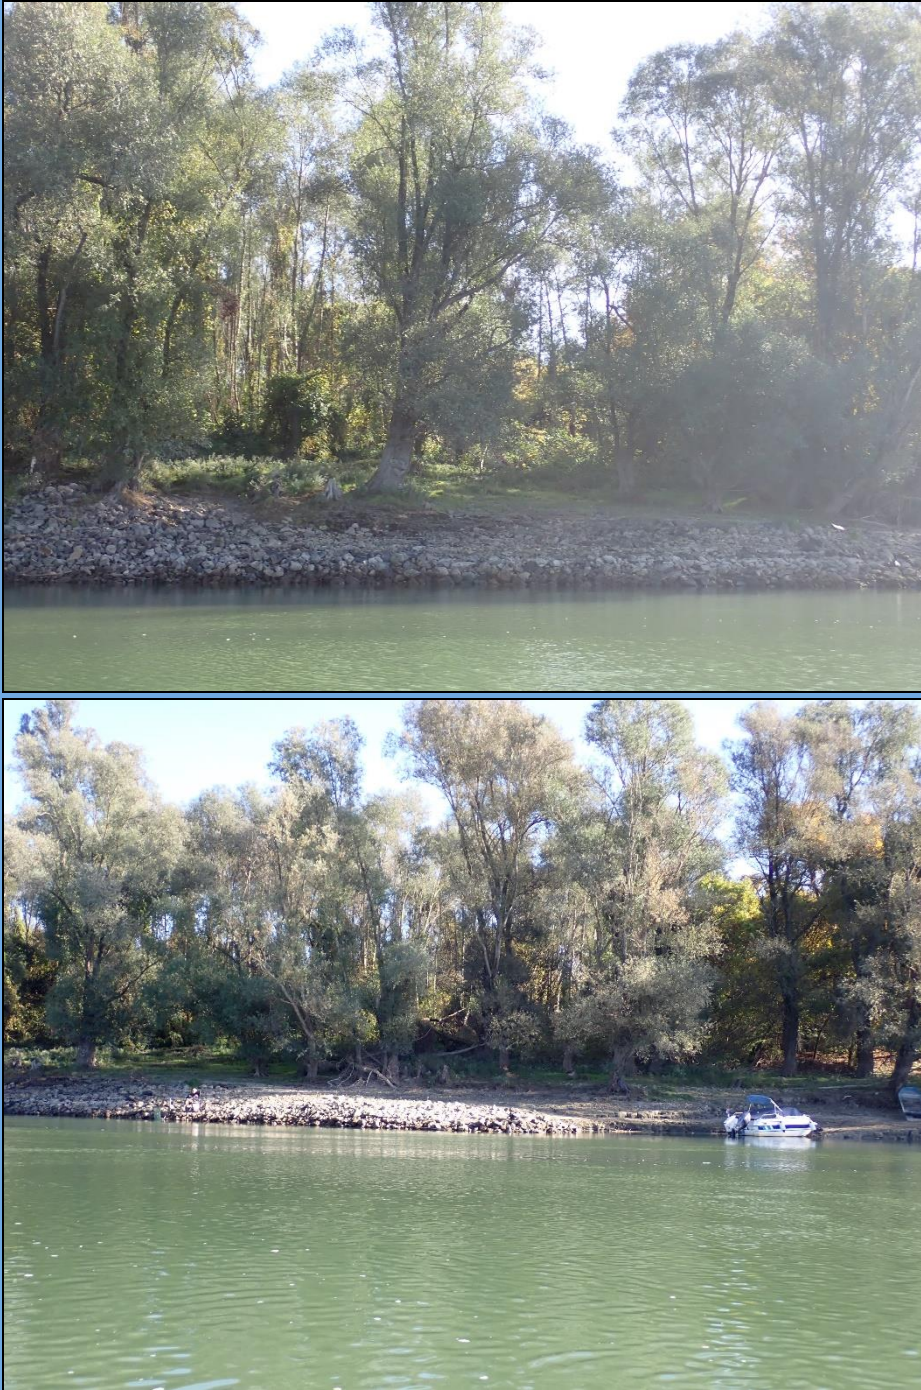
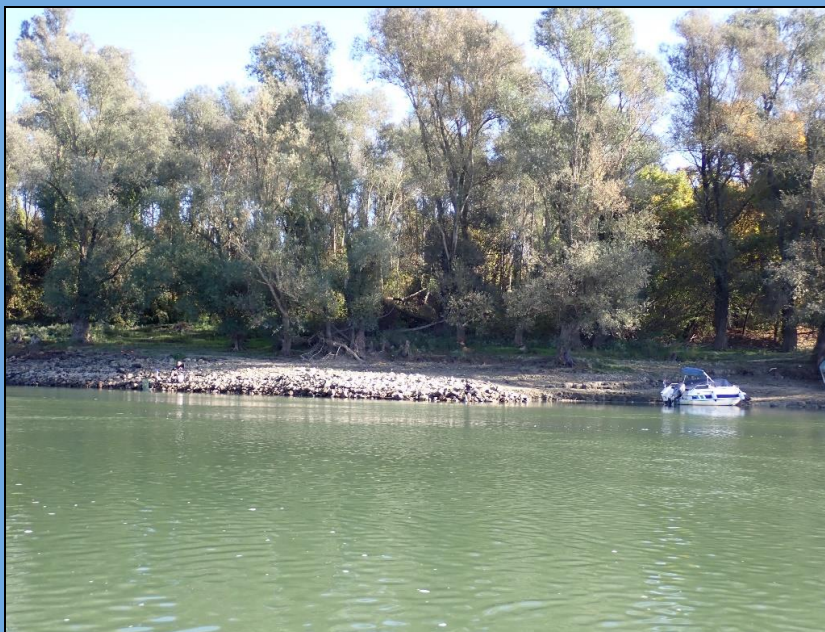
16. Left bank	Type:	Chainage (r.km)	Length (m)	Crown elevation (m.a.s.l.)
<b>1424-L2</b>	Revetment	1424+860 do 1424+662	155,90	79,34

- Infrastructure is in good condition.
- River bank erosion protection ongoing at low water levels.
- Stone revetment. Vegetation present above the infrastructure. Visible material revetment.

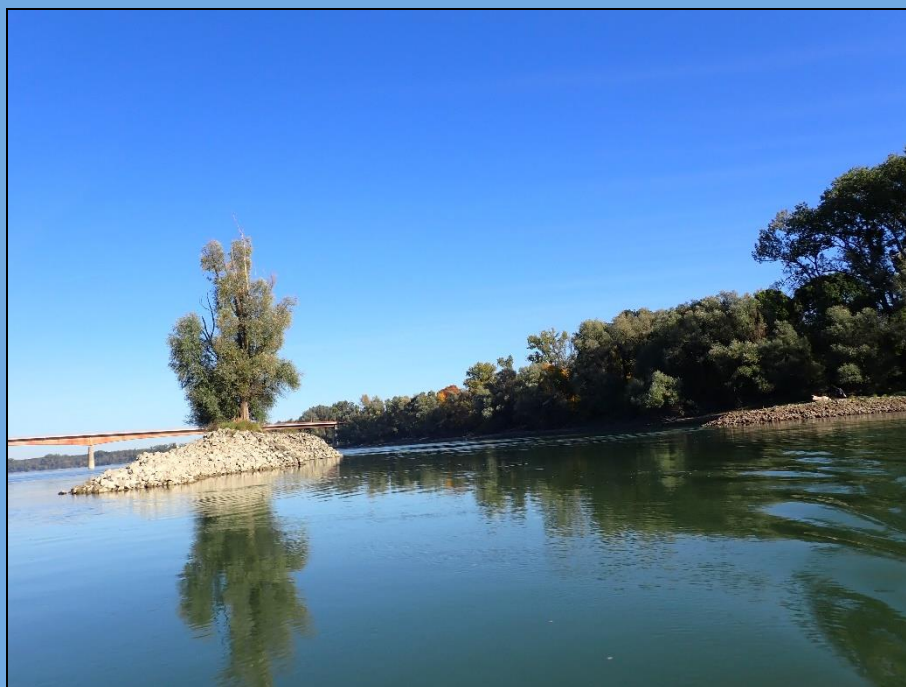
- Infrastructure is in good condition.
- Effect of material deposition ongoing (upstream, downstream).
- Material on the groyne head and effect of material deposition upstream and downstream visible, vegetation present on the beginning of the infrastructure. In continuity with revetment 1424-L2.

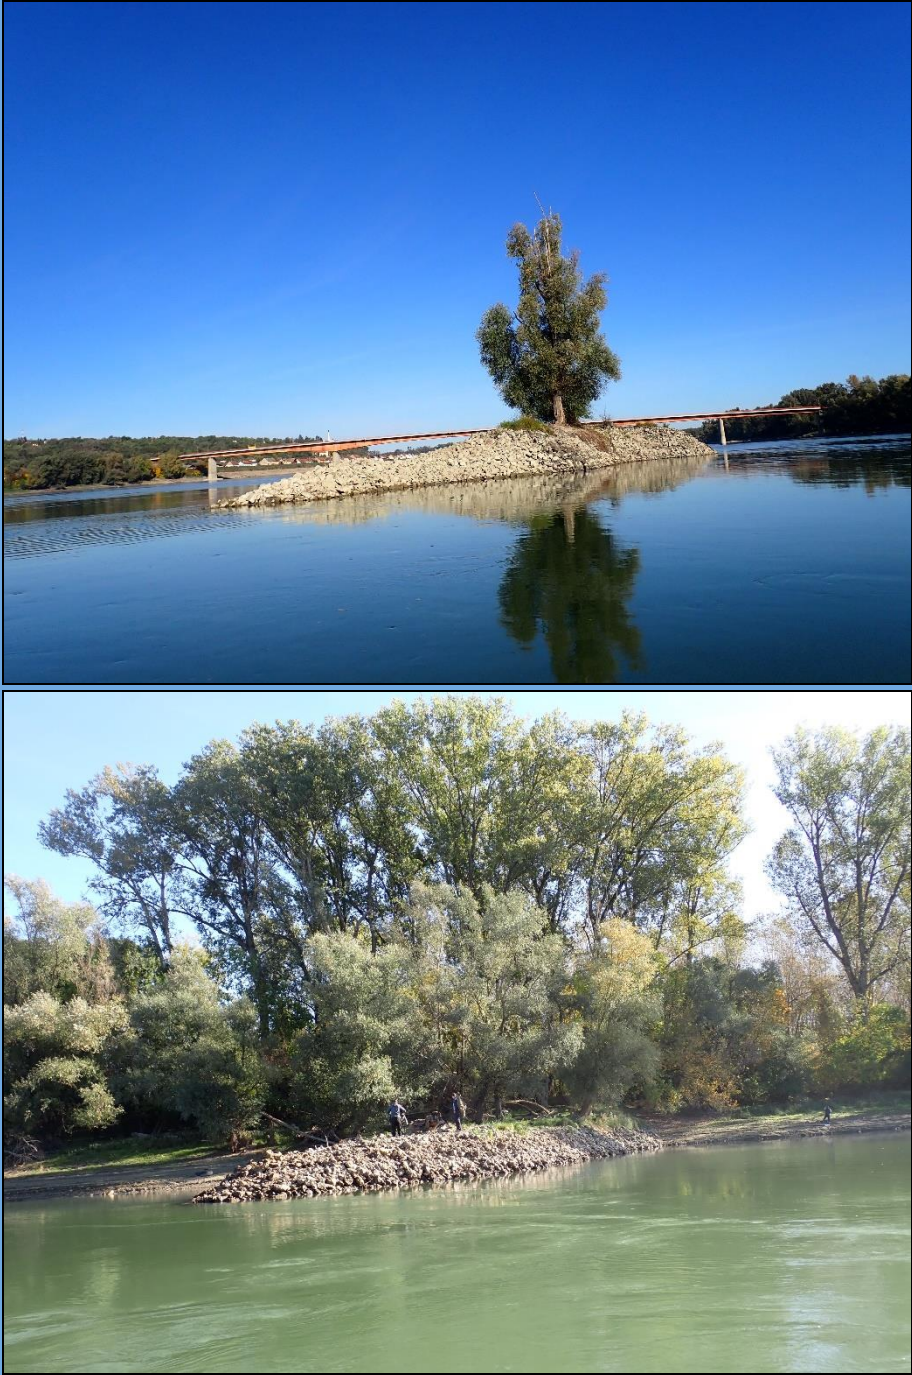
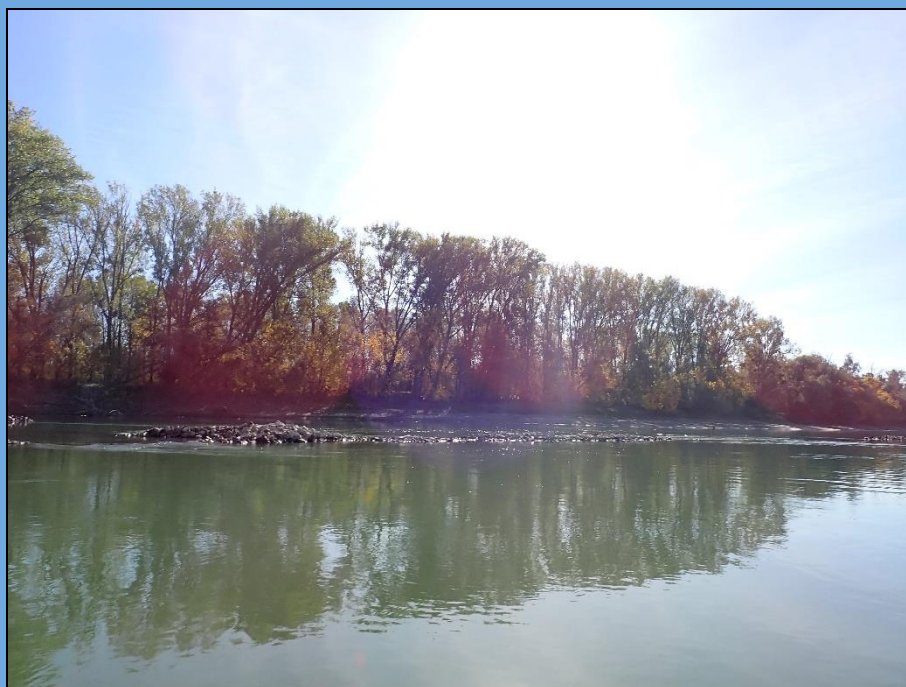
18. Left bank	Type:	Chainage (r.km)	Length (m)	Crown elevation (m.a.s.l.)
<b>1423-L1</b>	T-groyne	1423+963	98,82	82,71

- Infrastructure is in bad condition.
- Effect of material deposition failed.
- Material on the groyne head and groyne root visible. Separately groyne head from root.

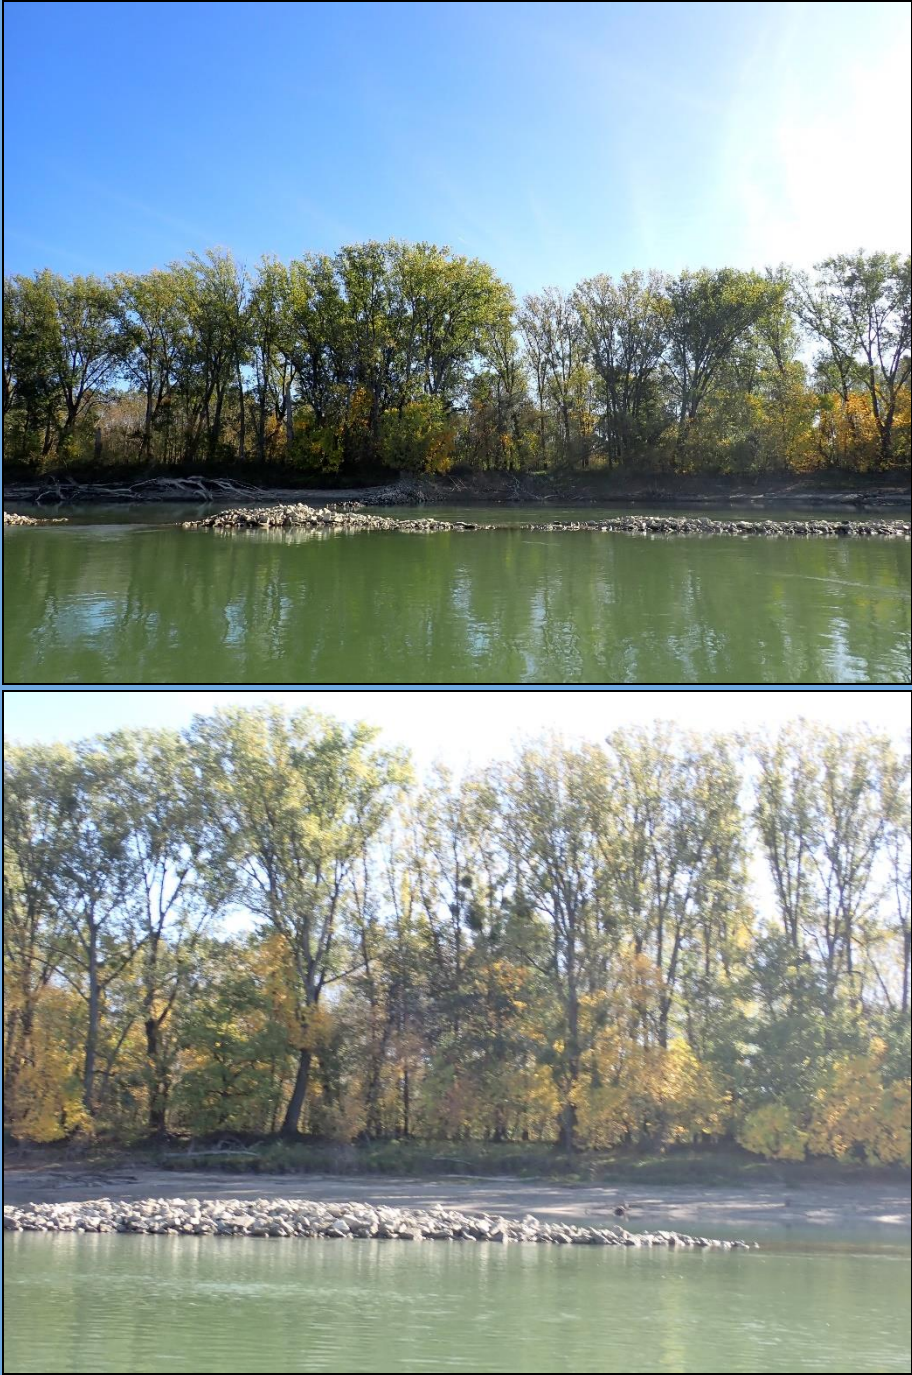
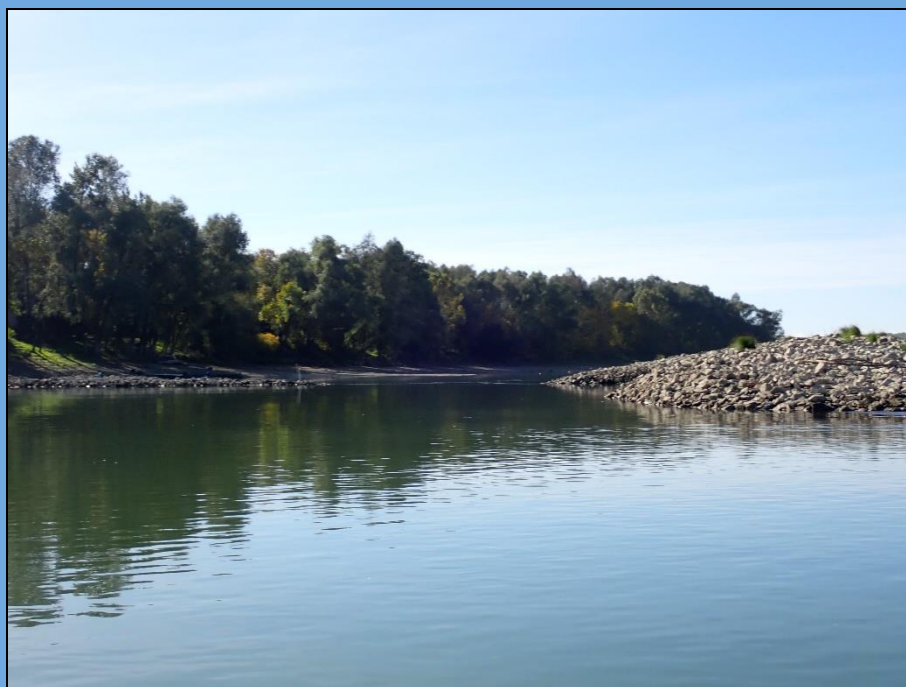
19. Left bank	Type:	Chainage (r.km)	Length (m)	Crown elevation (m.a.s.l.)
<b>1422-L2</b>	T-groyne	1422+894	177,17	79,22

- Infrastructure is in bad condition.
- Effect of material deposition ongoing (upstream, downstream).
- Groyne connection material not visible.

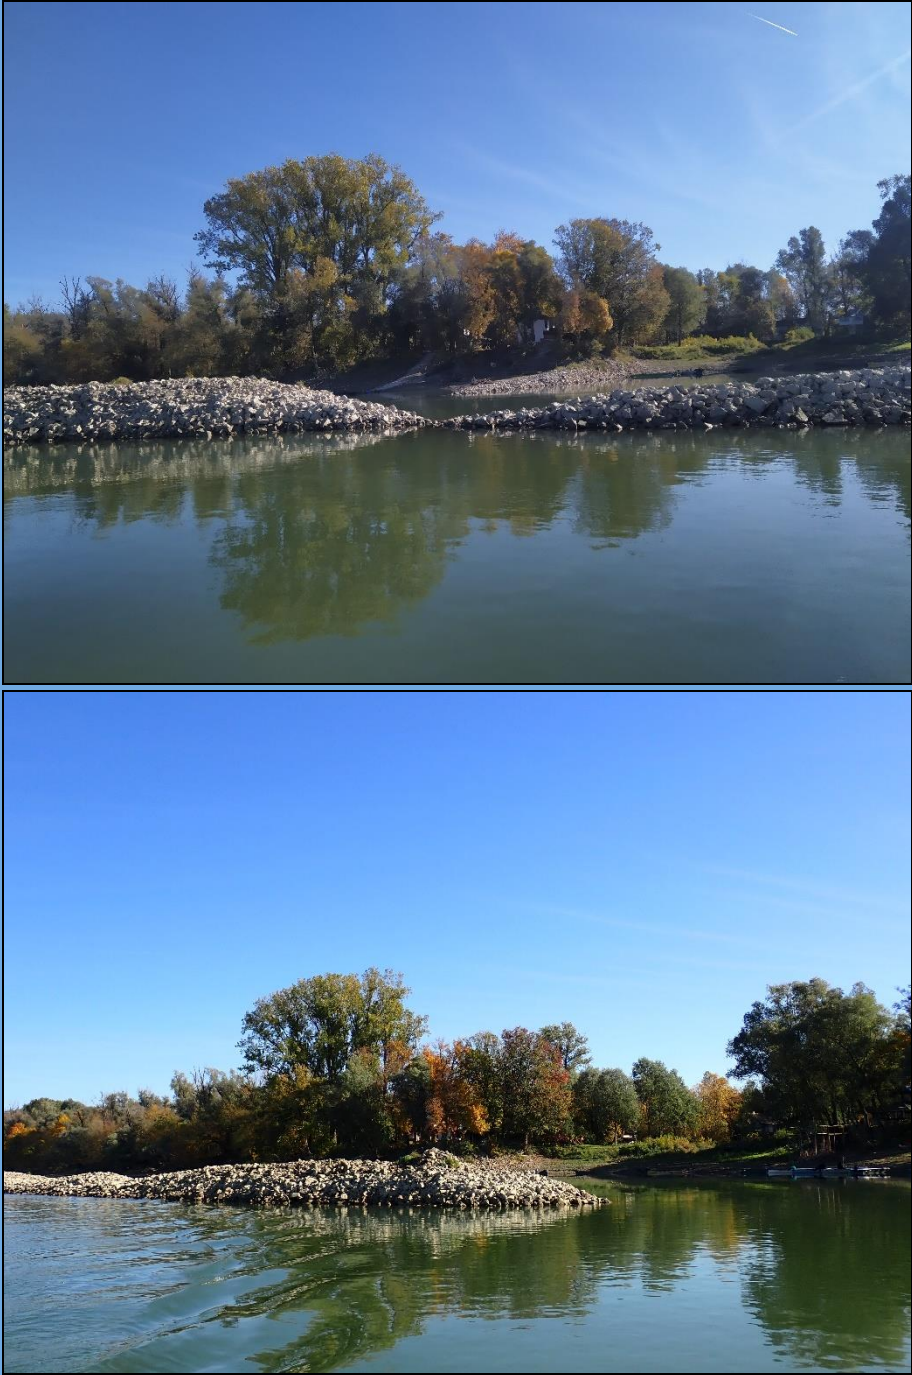
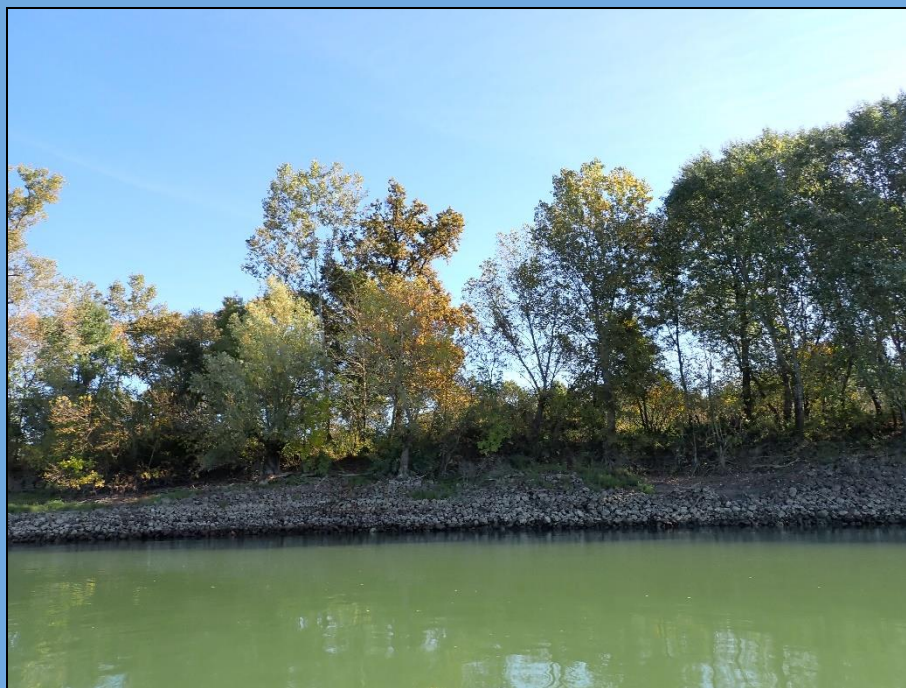
20. Left bank	Type:	Chainage (r.km)	Length (m)	Crown elevation (m.a.s.l.)
<b>1422-L1</b>	T-groyne	1422+281	158,98	81,55

- Infrastructure is in bad condition.
- Effect of material deposition failed.
- Groyne connection and head material visible. Irregular geometry of the groyne. Separately groyne head from connection.

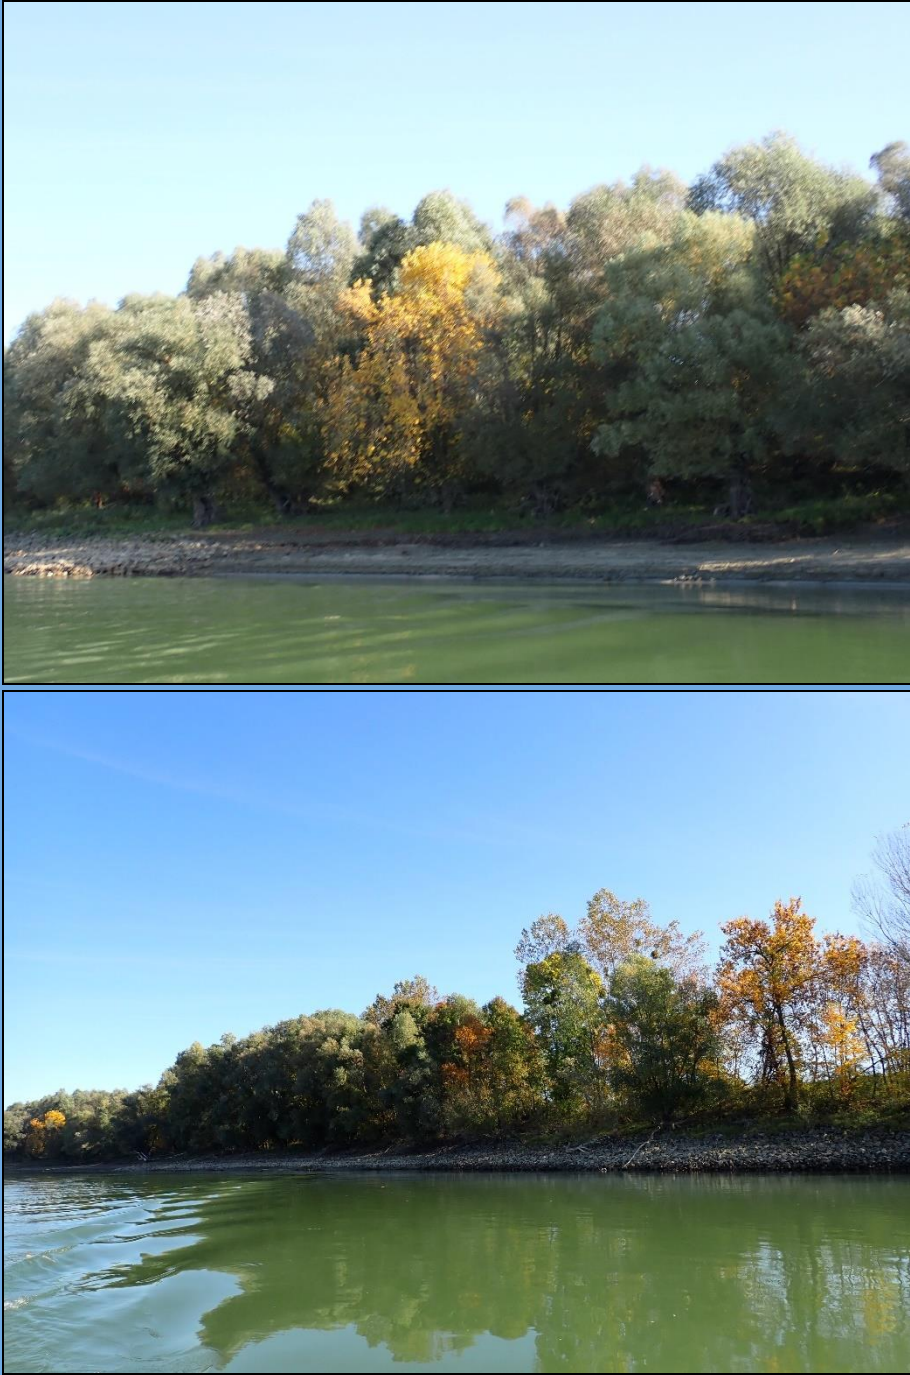
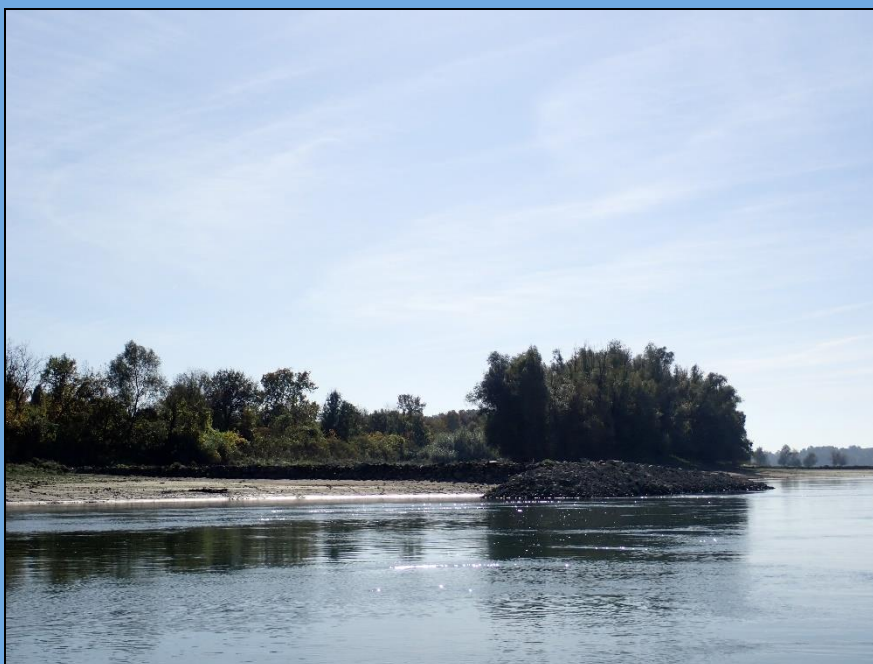
21. Left bank	Type:	Chainage (r.km)	Length (m)	Crown elevation (m.a.s.l.)
<b>1420-L2</b>	Revetment	1421+970 do 1420+529	1320,08	82,83

- Infrastructure is in good condition.
- River bank erosion protection ongoing at low water levels.
- Stone revetment. Vegetation present above the infrastructure. Visible material revetment. The beginning of the revetment in continuity, after 200m part of the revetment is washed away, visible material behind.
