**MONITORING OF HYDROLOGICAL, HYDRAULIC AND MORPHOLOGICAL CHARACTERISTICS OF THE DANUBE RIVER AND INVENTORY OF BIODIVERSITY COMPONENTS ON THE JOINT CROATIAN-SERBIAN SECTOR OF THE DANUBE RIVER**

**INVENTORY OF RIVER REGULATION INFRASTRUCTURE RELATED TO NAVIGATION**

**Project number:** I-2206/24

**LOCATION:** Danube river from rkm 1295,5 (Ilok) to rkm 1433,1  
(border with Hungary)

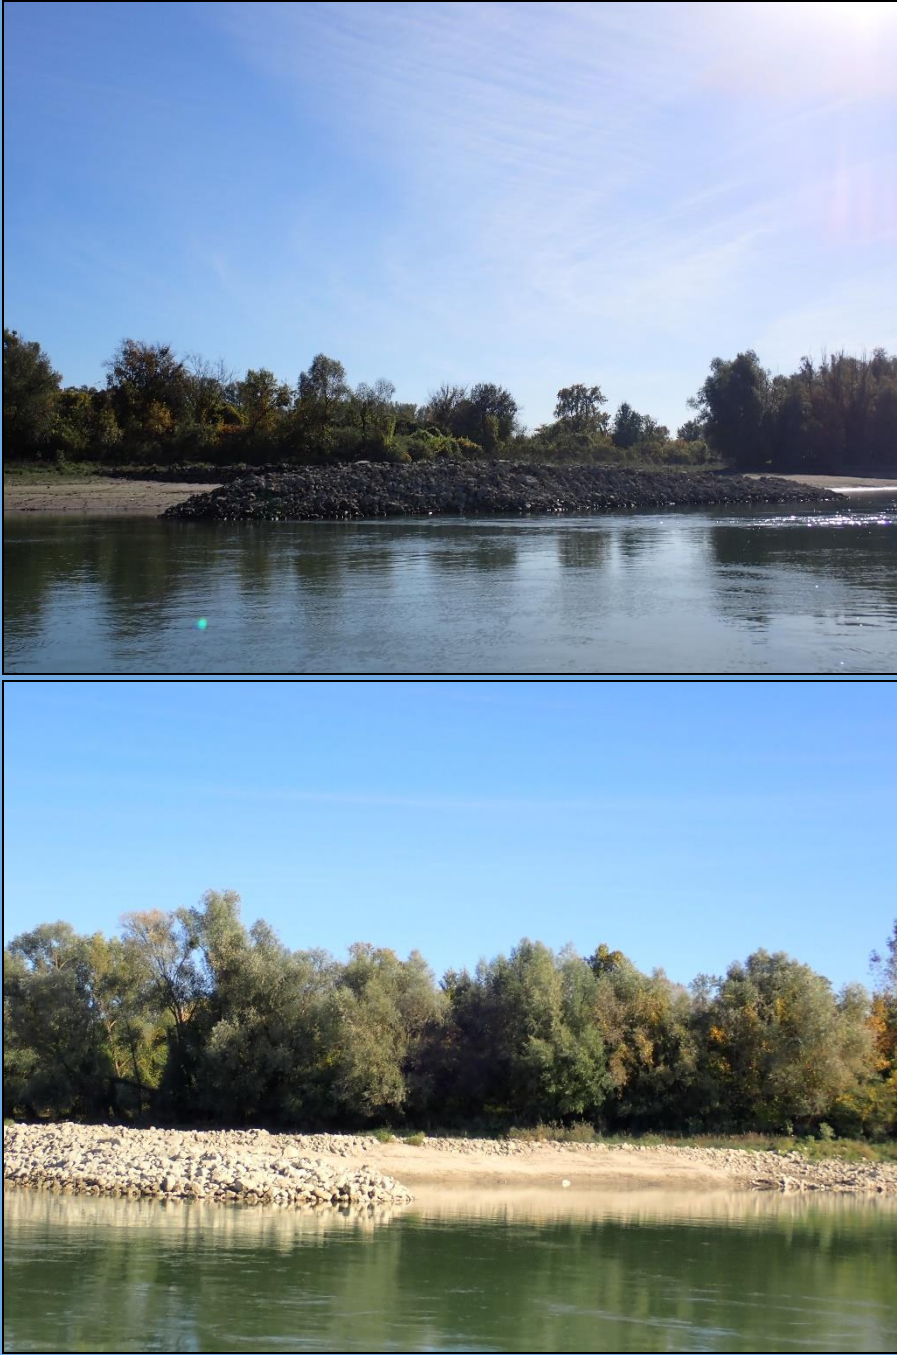
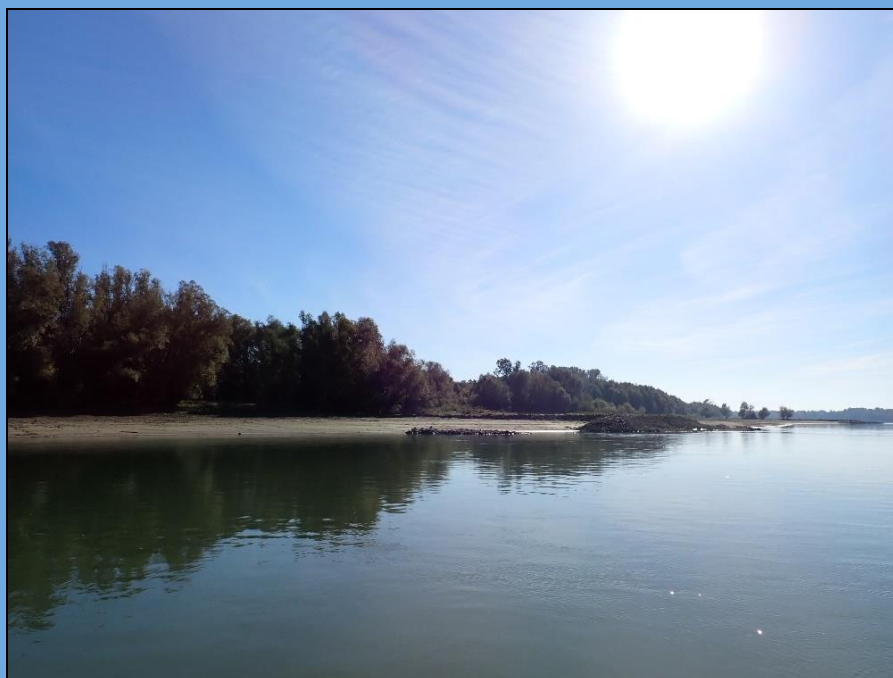
22. Left bank	Type:	Chainage (r.km)	Length (m)	Crown elevation (m.a.s.l.)
<b>1420-L1</b>	T-groyne	1420+281	51,95	81,48

- Infrastructure is in good condition.
- Effect of material deposition ongoing (upstream, downstream).
- Groyne connection, head material and effect of material deposition upstream and downstream visible. On the groyne connection downstream visible lack of stone below groyne crown.

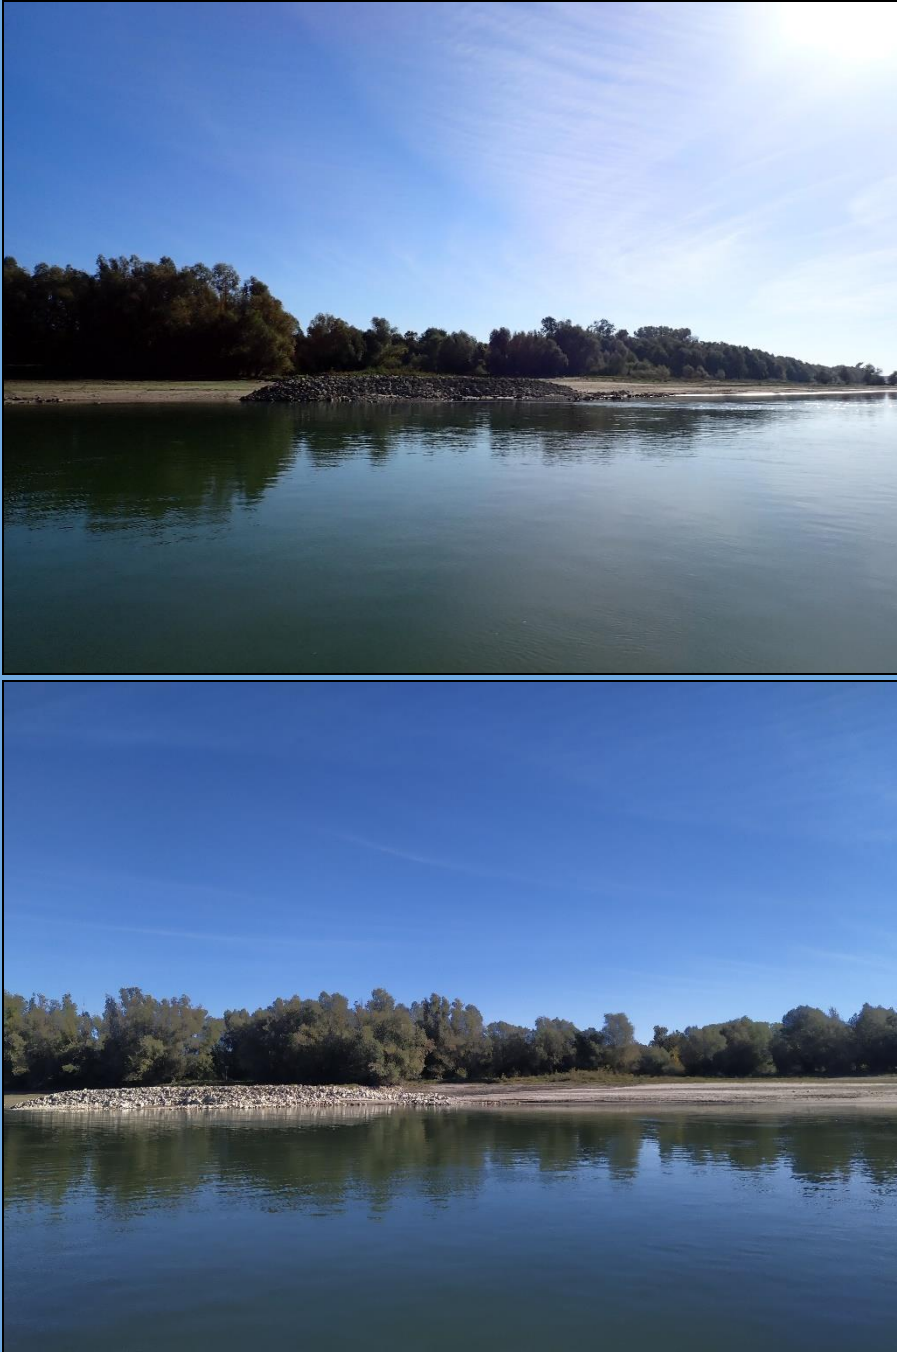
23. Left bank	Type:	Chainage (r.km)	Length (m)	Crown elevation (m.a.s.l.)
<b>1419-L2</b>	T-groyne	1419+990	53,21	81,64

- Infrastructure is in good condition.
- Effect of material deposition ongoing (upstream, downstream).
- Groyne connection, head material and effect of material deposition upstream and downstream visible.

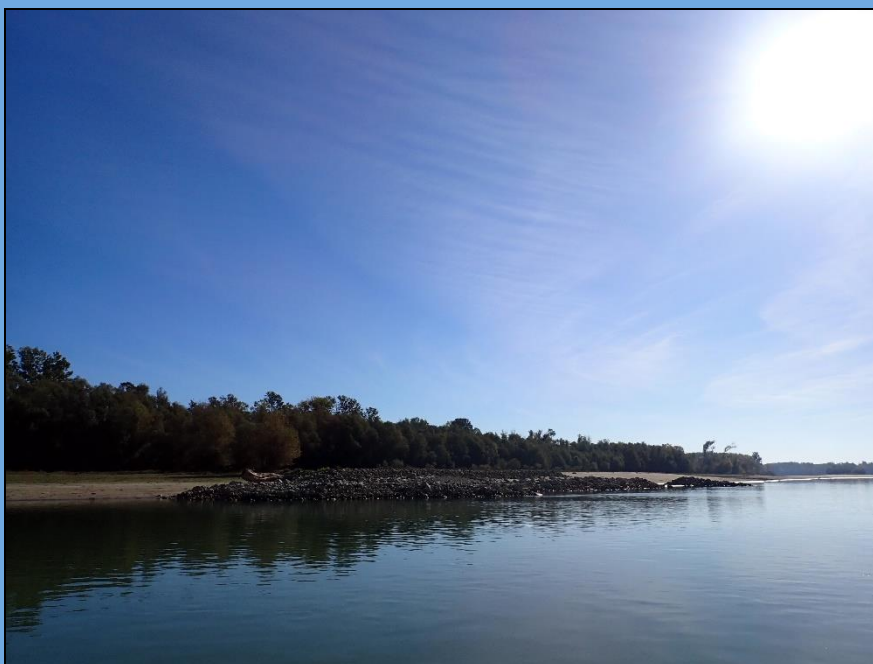
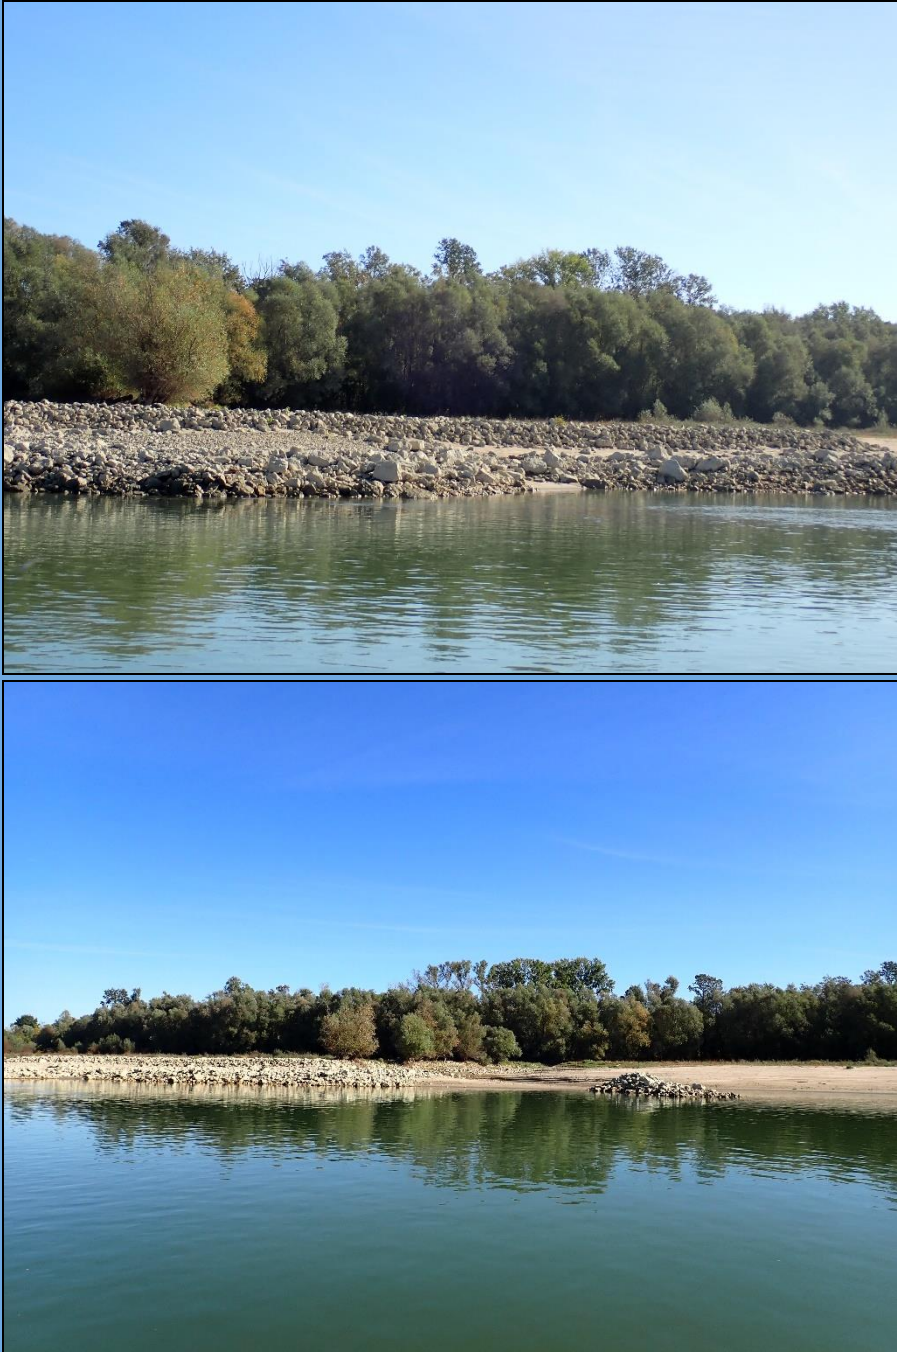
24. Left bank	Type:	Chainage (r.km)	Length (m)	Crown elevation (m.a.s.l.)
<b>1419-L1</b>	T-groyne	1419+612	91,96	81,60

- Infrastructure is in satisfying condition.
- Effect of material deposition ongoing (upstream, downstream).
- Groyne connection, head material and significantly effect of material deposition upstream and downstream visible. Groyne head irregular geometry. Trees present on the groyne crown connection.

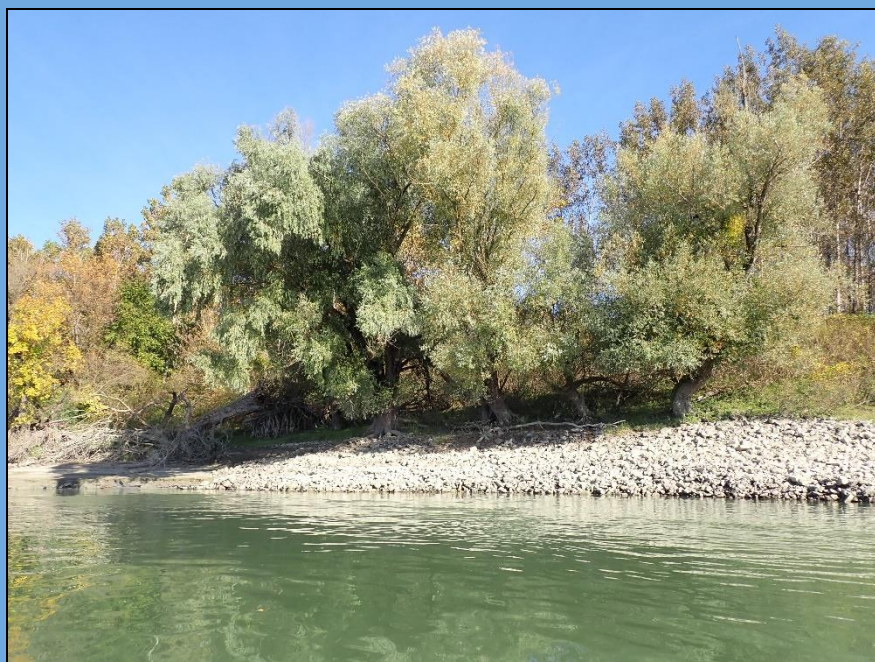
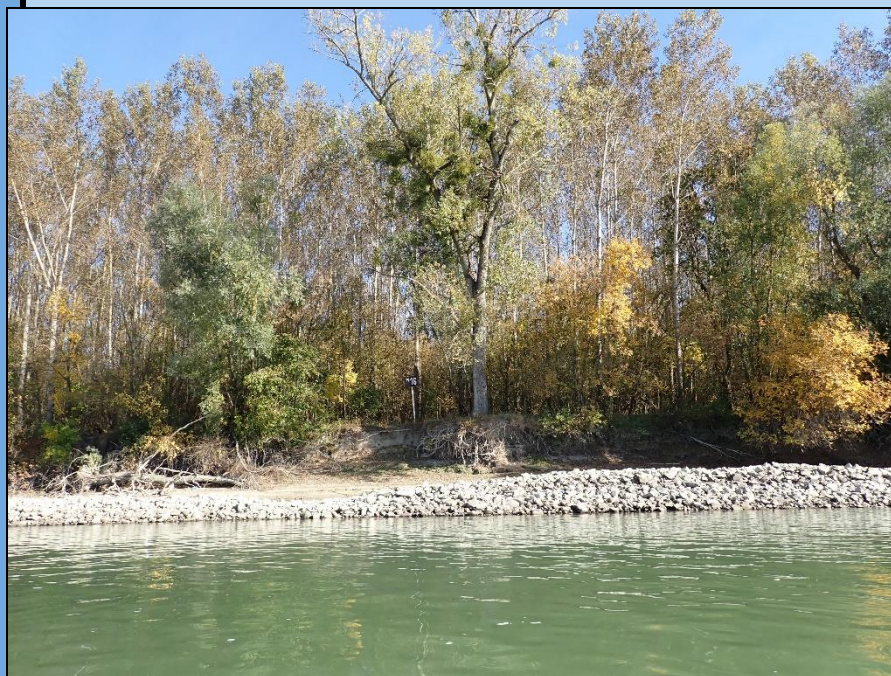
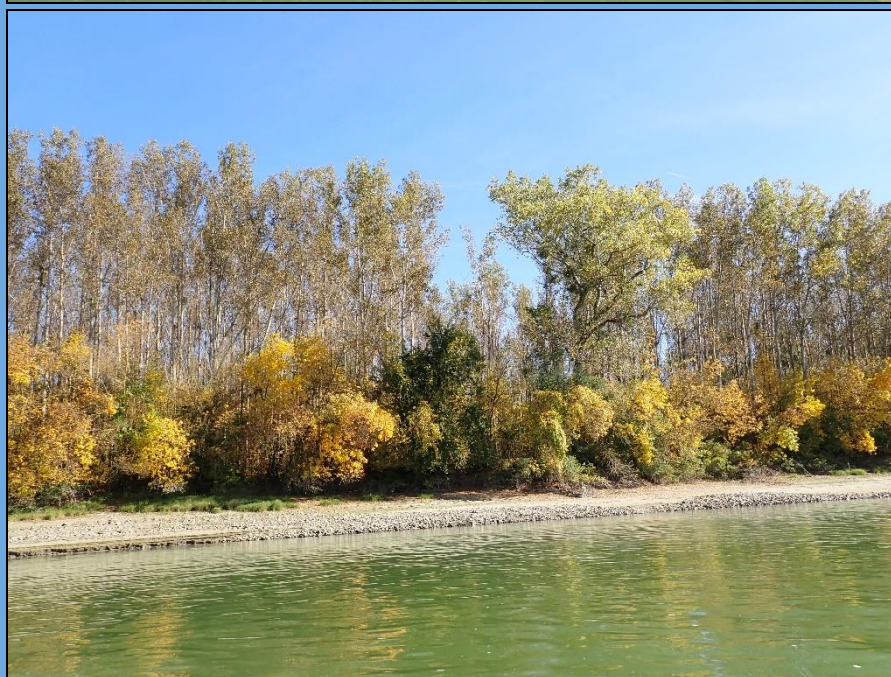
25. Left bank	Type:	Chainage (r.km)	Length (m)	Crown elevation (m.a.s.l.)
<b>1414-L1</b>	Revetment	1416+109 do 1414+355	1804,23	79,02

- Infrastructure is in bad condition.
- River bank erosion protection failed.
- Stone revetment. Visible material revetment at low water levels. Part of the revetment is washed away, visible material behind.

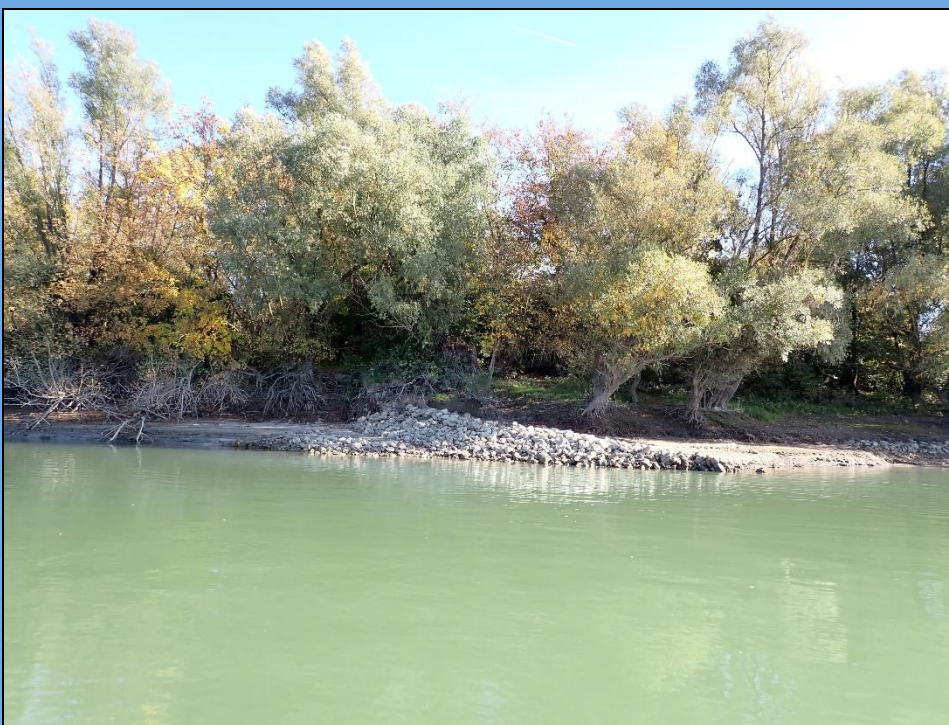
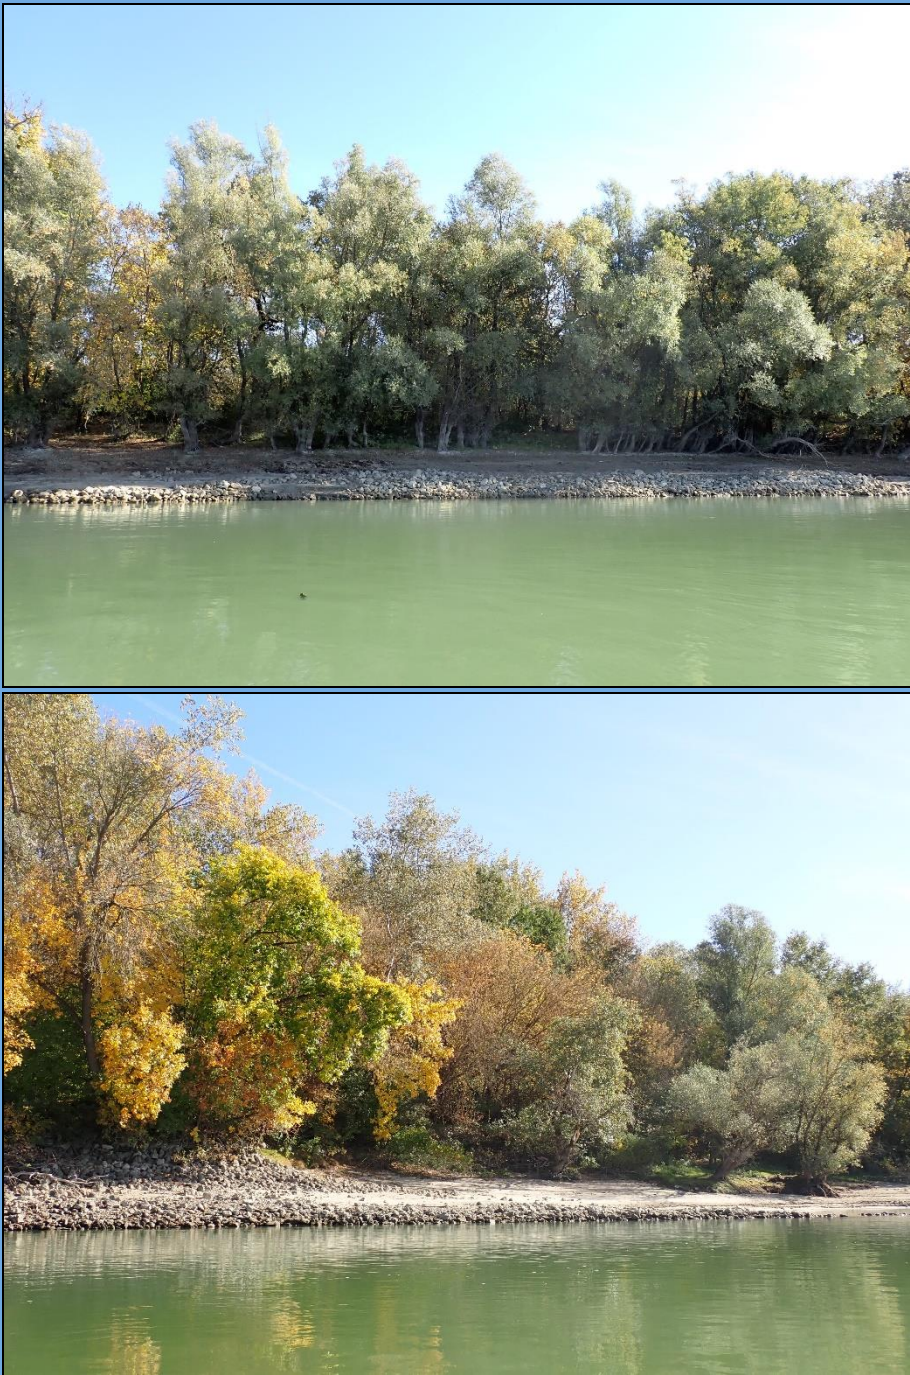
26. Left bank	Type:	Chainage (r.km)	Length (m)	Crown elevation (m.a.s.l.)
<b>1409-L1</b>	Revetment	1410+058 do 1409+398	647,38	78,64

- Infrastructure is in bad condition.
- River bank erosion protection failed.
- Stone revetment. Visible material revetment at low water levels. Part of the revetment is washed away, visible material behind.

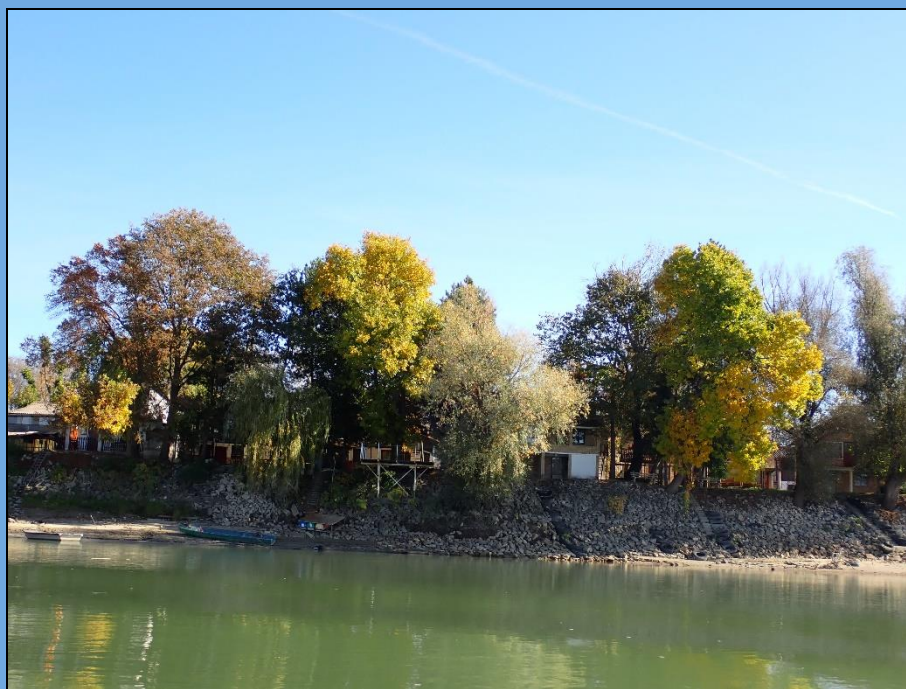
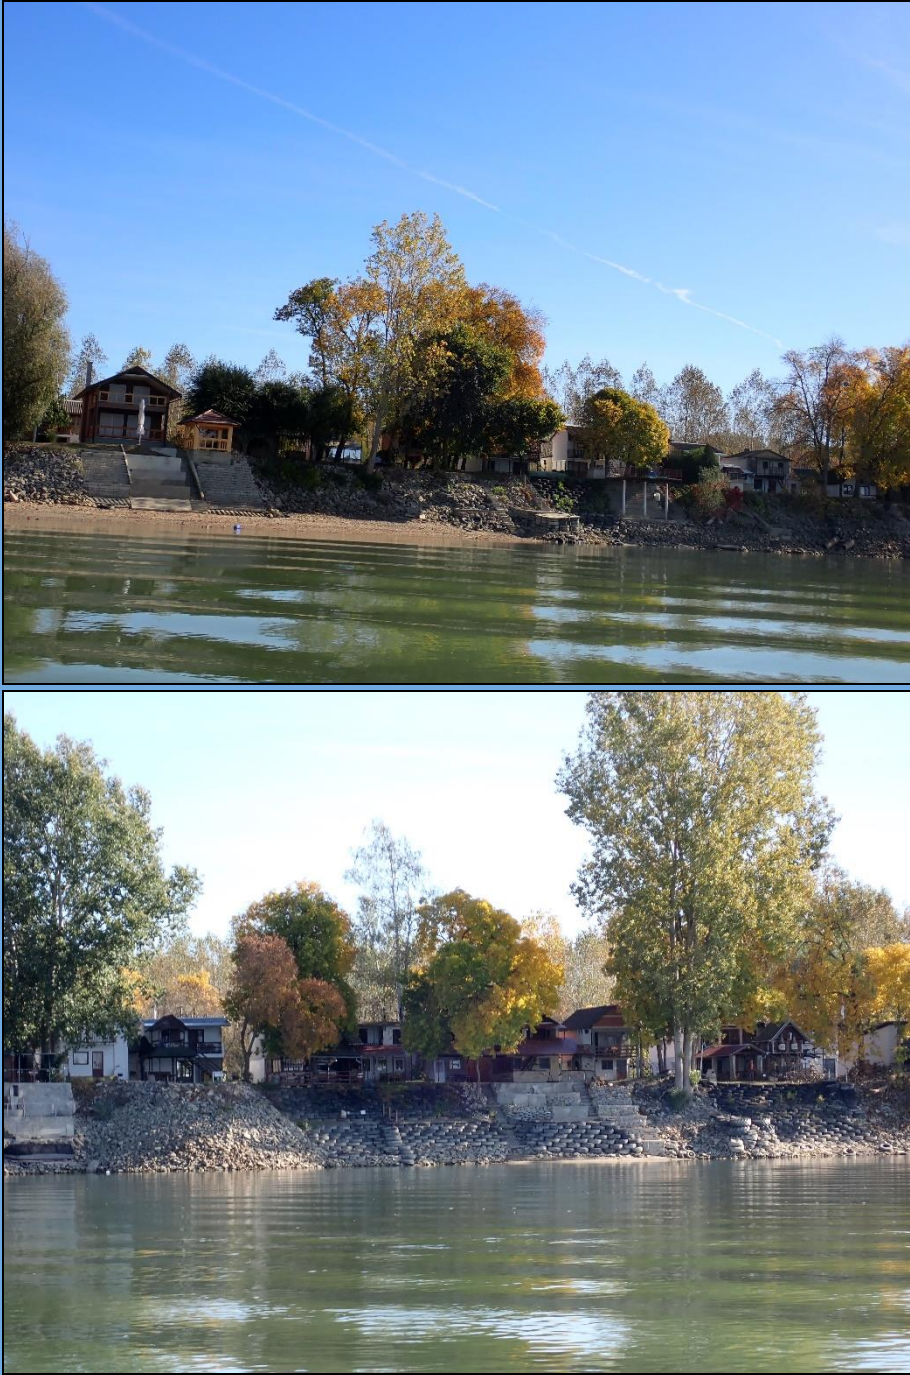
27. Left bank	Type:	Chainage (r.km)	Length (m)	Crown elevation (m.a.s.l.)
<b>1408-L1</b>	Revetment	1408+502 do 1408+198	291,88	78,50

- Infrastructure is in bad condition.
- River bank erosion protection failed.
- Revetment near the Vagoni settlement. On slopes visible stone, car tires and reinforced concrete stairs, irregular geometry structure.

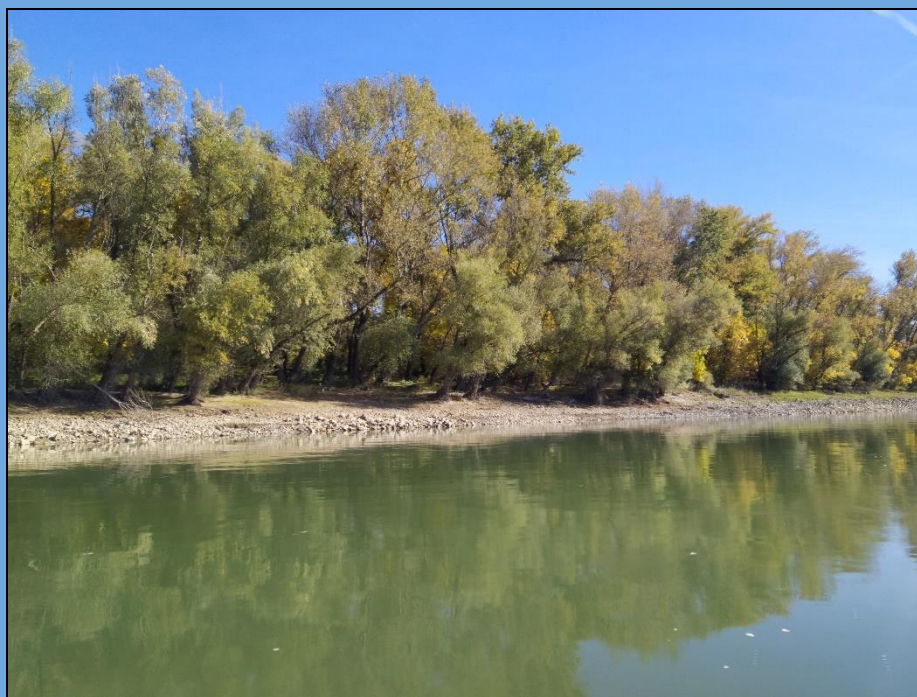
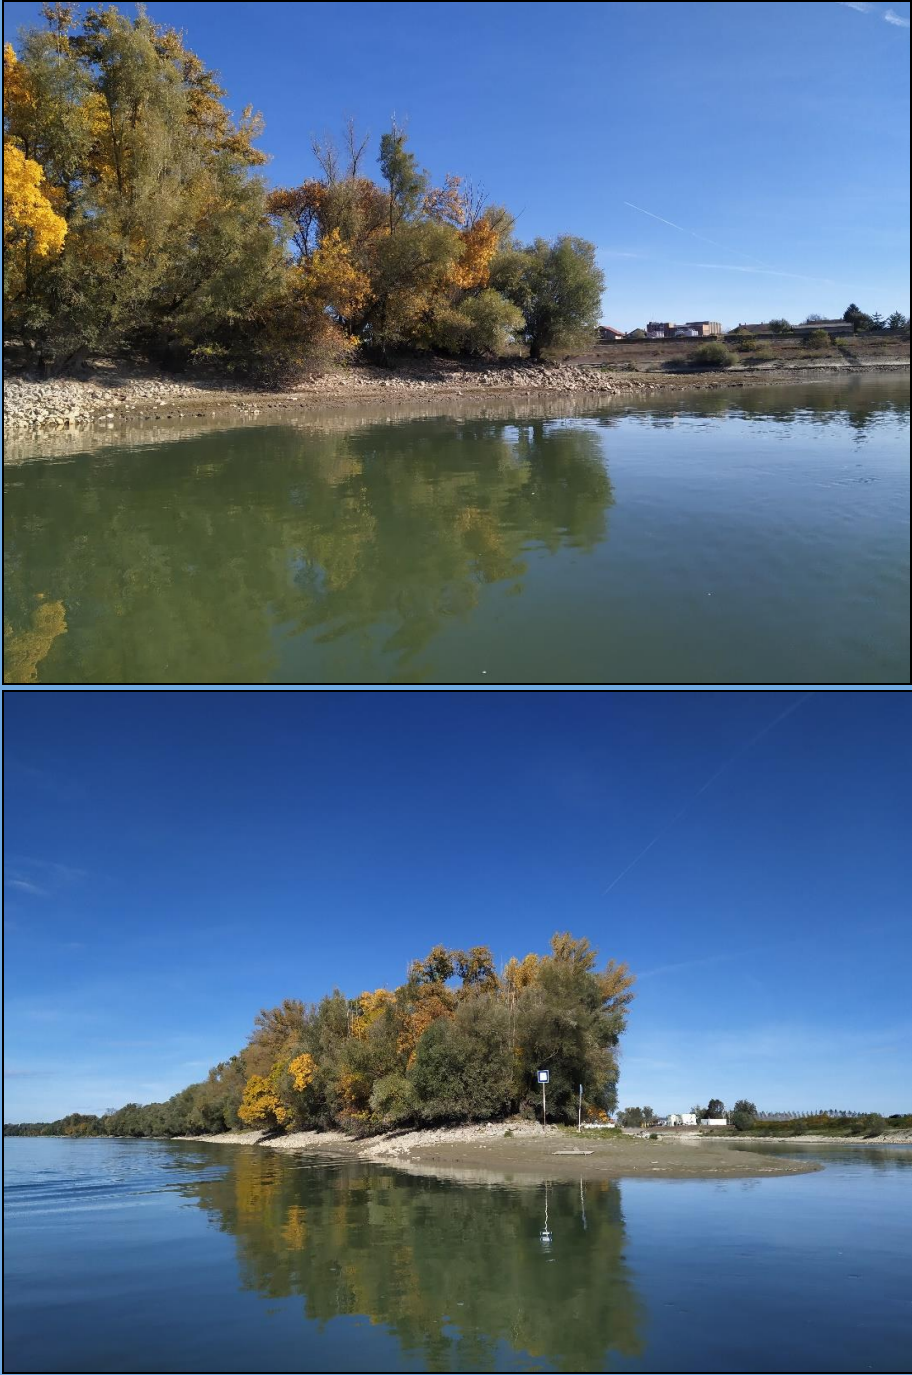
28. Left bank	Type:	Chainage (r.km)	Length (m)	Crown elevation (m.a.s.l.)
<b>1401-L2</b>	Revetment	1401+863 do 1401+619	351,28	78,40

- Infrastructure is in bad condition.
- River bank erosion protection failed.
- Stone revetment. Visible material revetment at low water levels. Part of the revetment is washed away, visible material behind from the river side. There is no visible material on the side of the backwater near the port of Apatin.

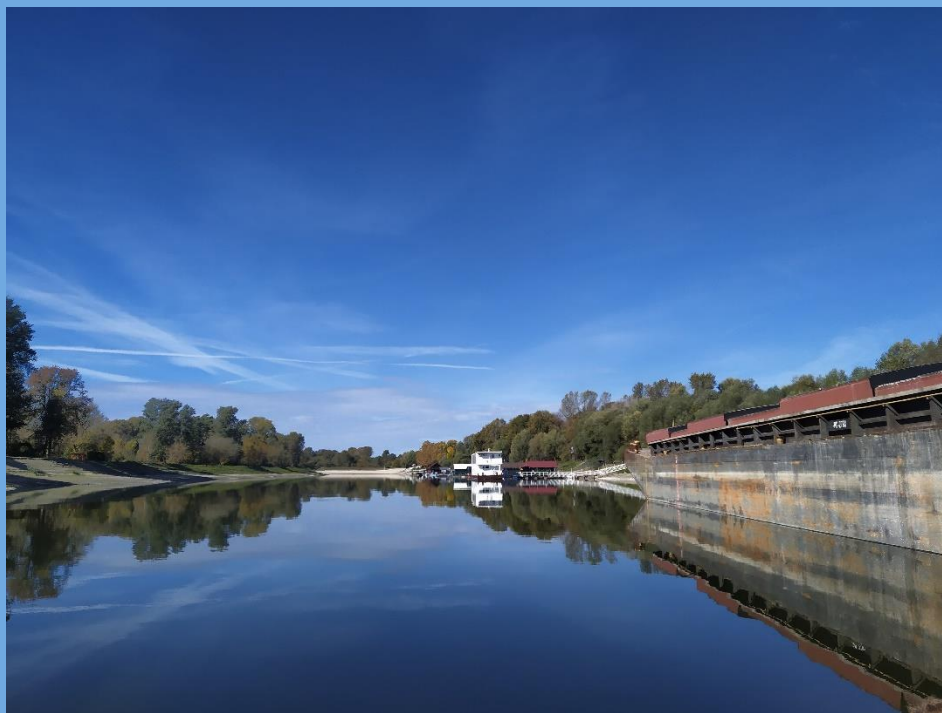
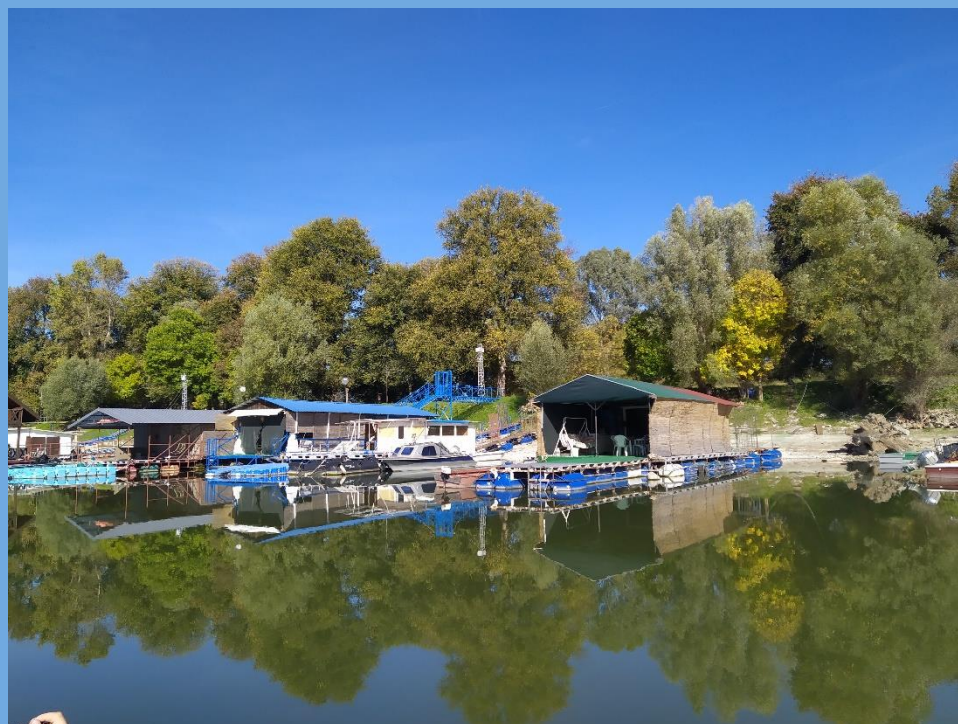
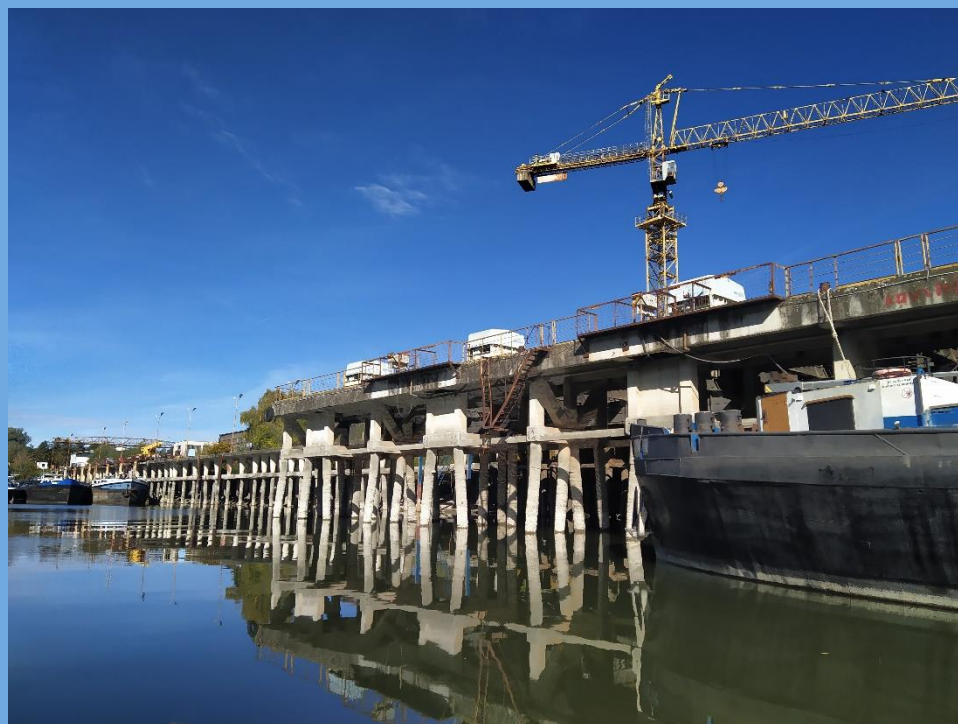
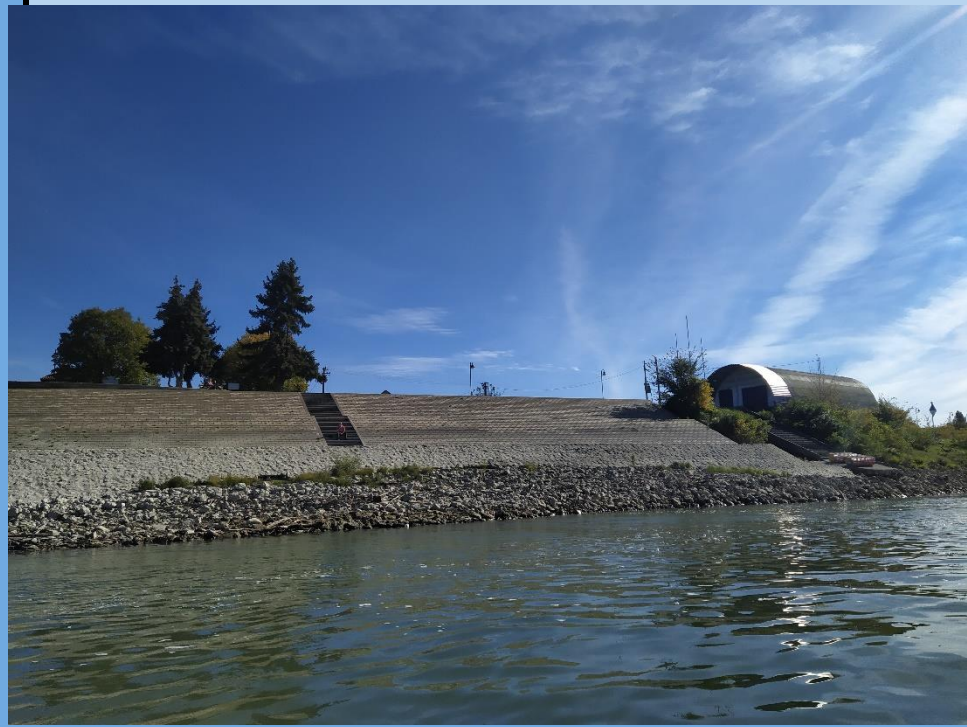
29. Left bank	Type:	Chainage (r.km)	Length (m)	Elevation toe (m.a.s.l.)
<b>1401-L1</b>	Revetment	1403+7247 do 1401+340	2516,32	78,42

- Infrastructure is in good condition (bad, good, excellent)
- Upstream river bank erosion protection failed. River bank erosion protection at shipyard Apatin ongoing. Downstream river bank erosion protection ongoing at high water levels.
- Upstream of the Apatin barrier, the revetment is not visible from the water side. From the barrier to the vertical revetment of the Apatin shipyard, there is no revetment material present. On the vertical revetment of the shipyard, visible deformation of the columns. At the Apatin passenger docking place, a city-type revetment in excellent condition. Along the downstream part of the revetment stone in concrete. A new city-type revetment near the Apatin marina. Downstream from the Apatin marina, a city-type revetment with irregular geometry and visible deformation.

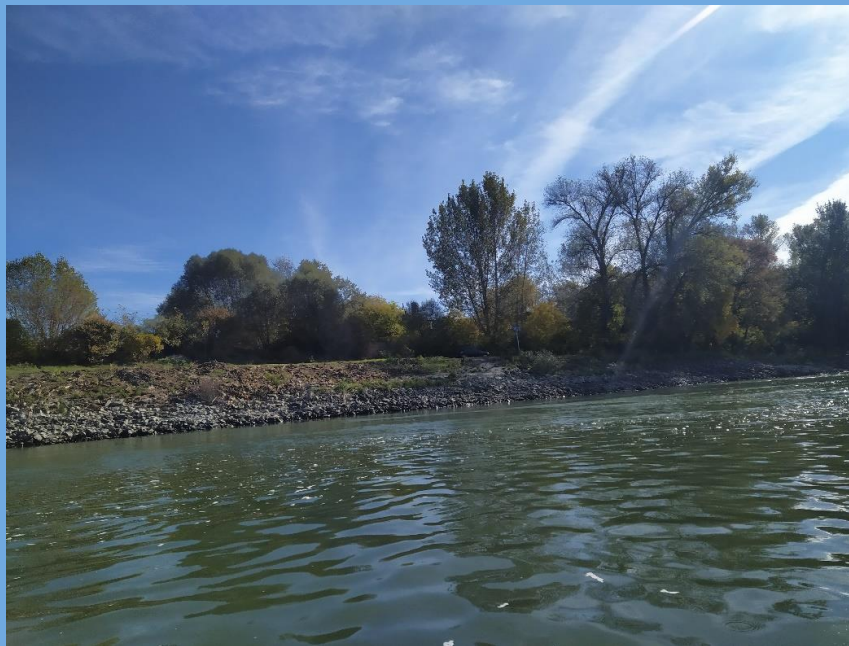
- Infrastructure is in good condition.
- River bank erosion protection ongoing at low water levels.
- Stone revetment. Vegetation present above the infrastructure. Visible material revetment.

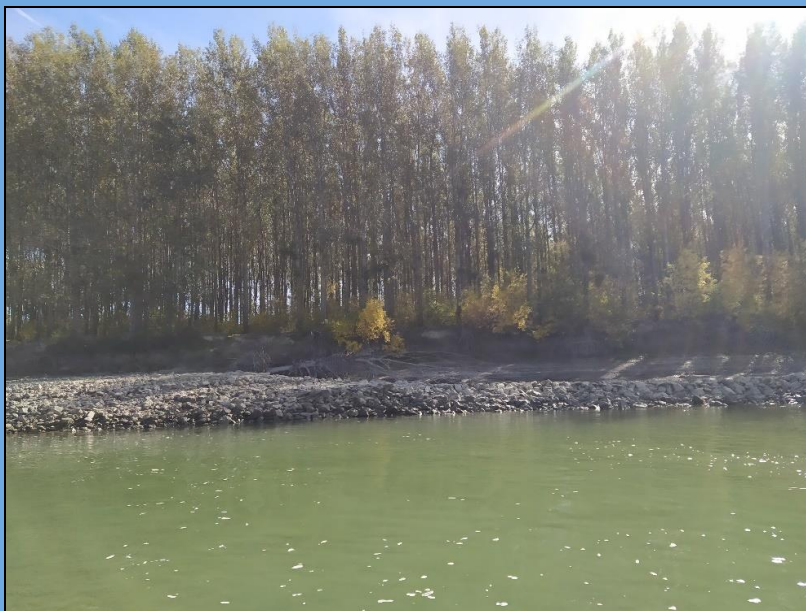
- Infrastructure is in bad condition.
- River bank erosion protection failed.
- Stone revetment. Visible material revetment at low water levels. Part of the revetment is washed away, visible material behind.

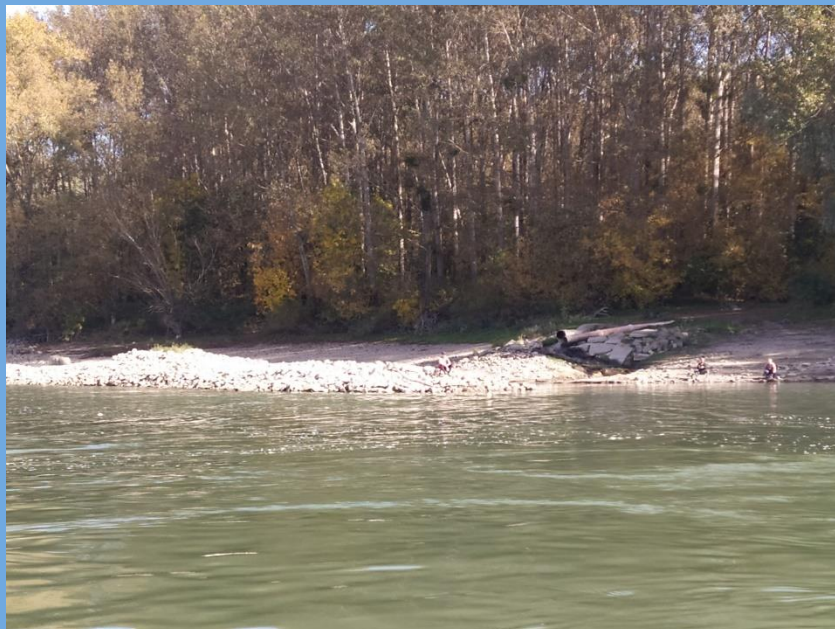
- Infrastructure is in bad condition.
- Effect of material deposition failed (upstream, downstream).
- Irregular geometry of the structure. Partially effect of material deposition upstream and downstream visible. It is located upstream from revetment 1400-L2.

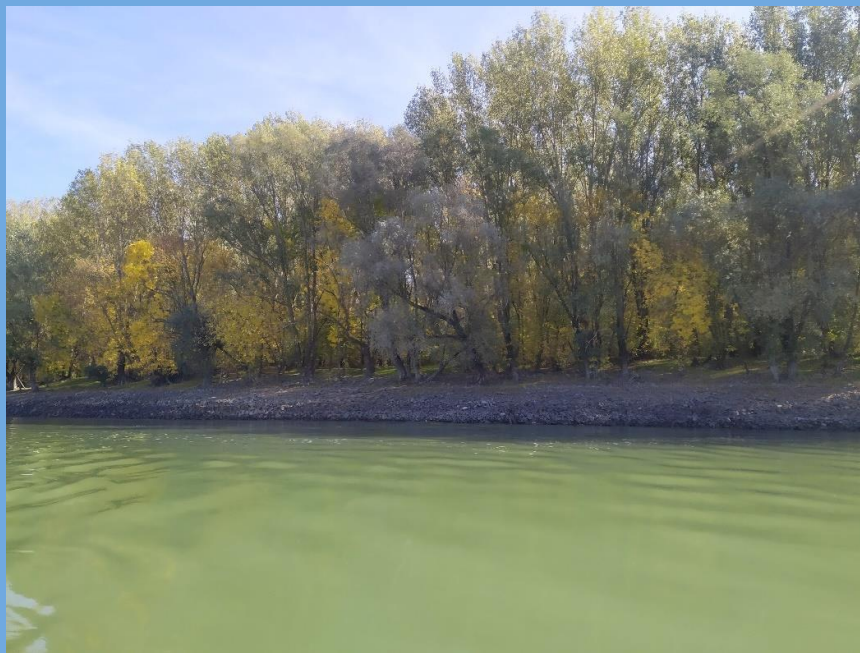
- Infrastructure is in good condition.
- River bank erosion protection ongoing at low water levels.
- Stone revetment. Vegetation present above the infrastructure. Visible material revetment.

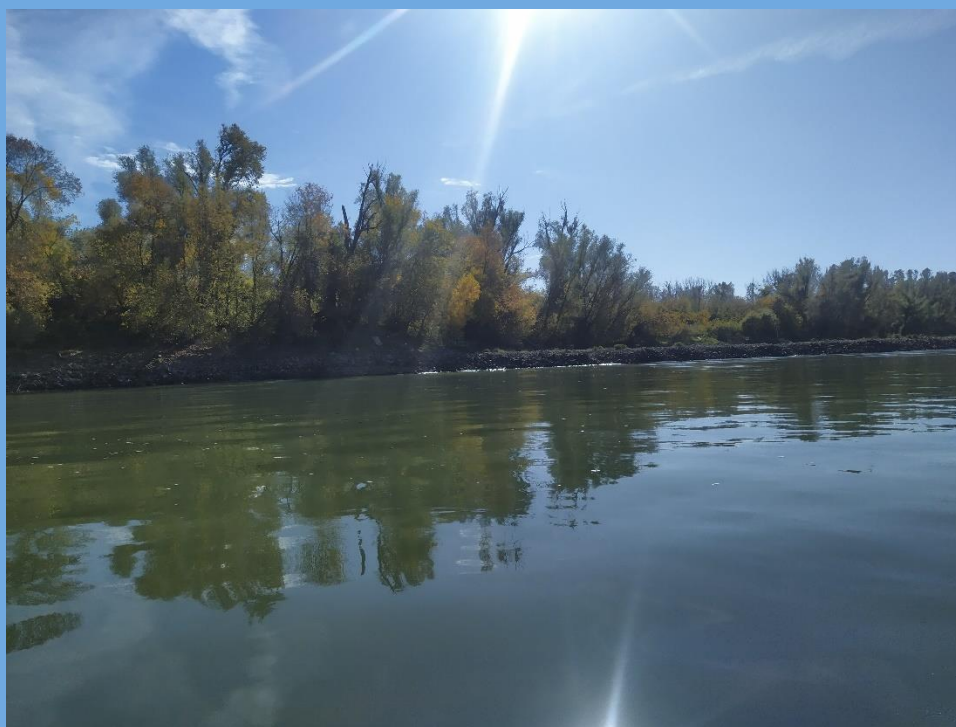
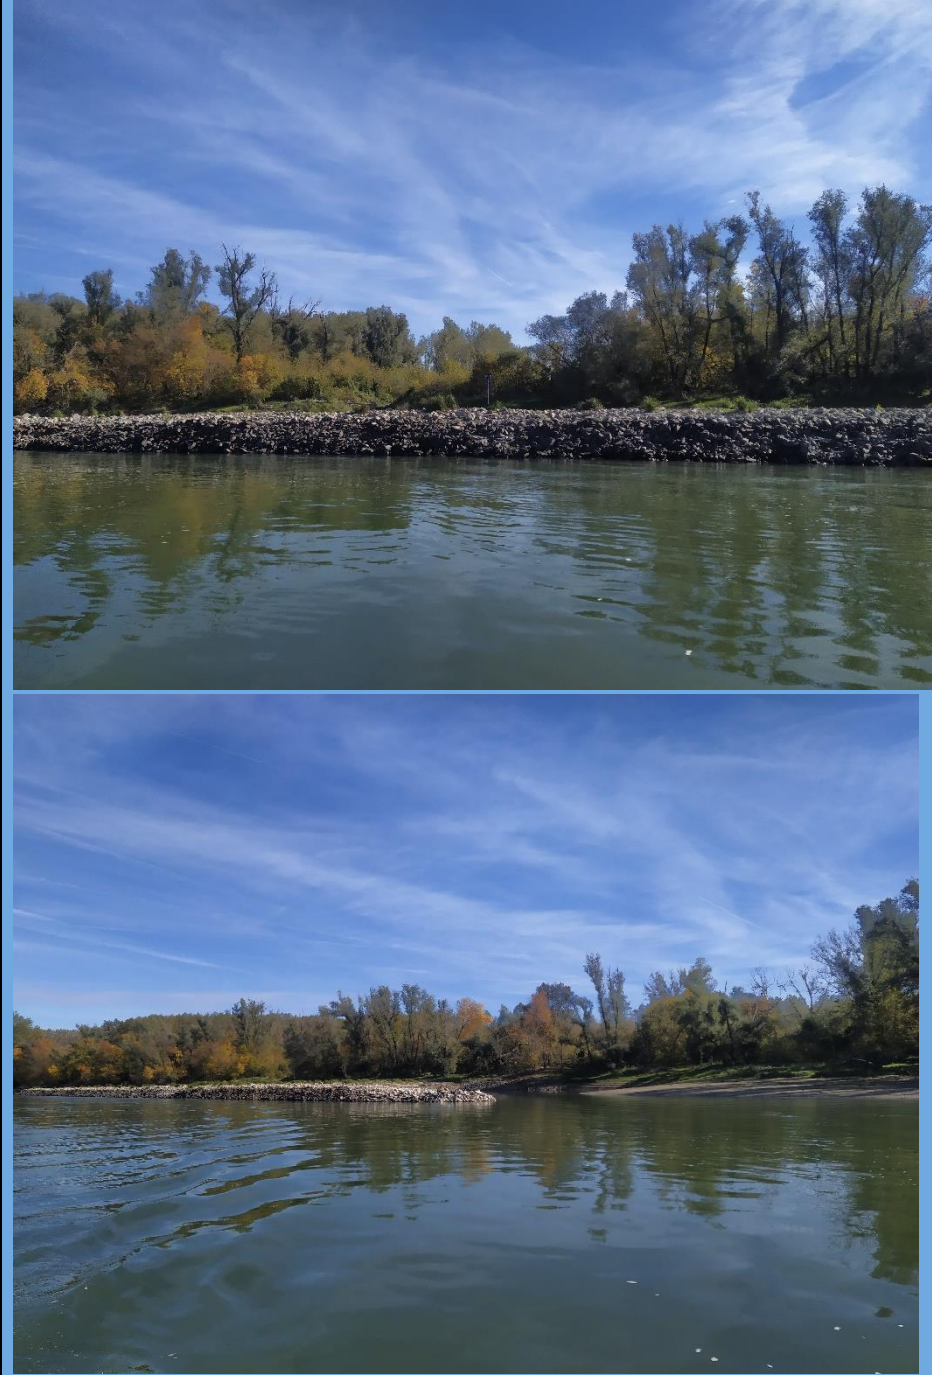
34. Left bank	Type:	Chainage (r.km)	Length (m)	Crown elevation (m.a.s.l.)
<b>1398-L2</b>	Parallel structure	1399+155 do 1398+889	251,53	80,06

- Infrastructure is in excellent condition.
- Effect of material deposition ongoing (downstream).
- Continuing on the revetment 1399-L1. Parallel structure material visible. Vegetation present on the groyne crown.

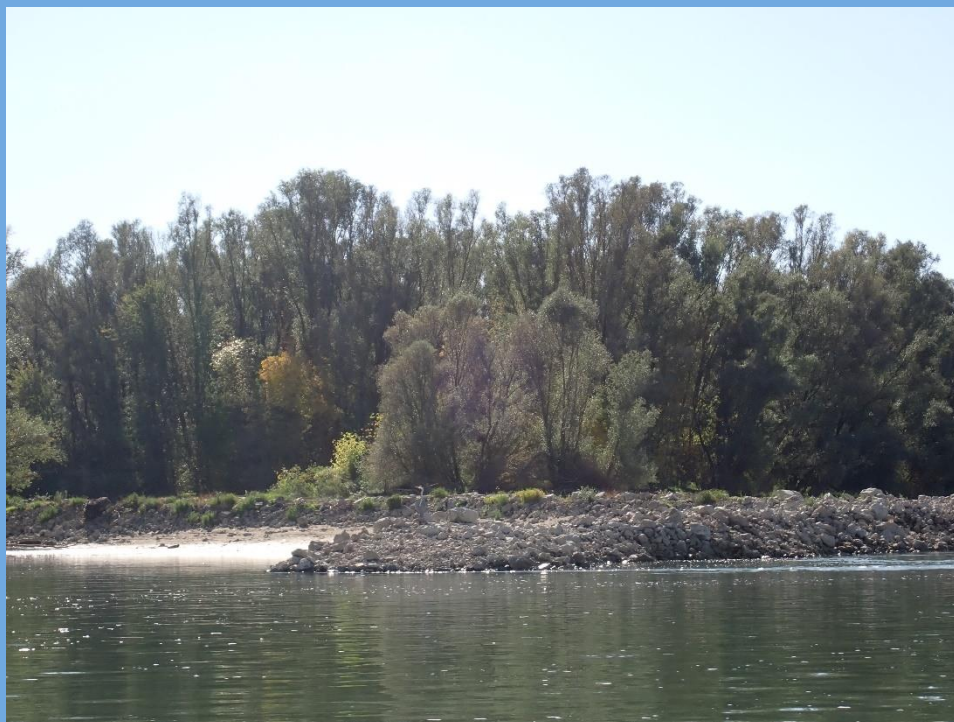
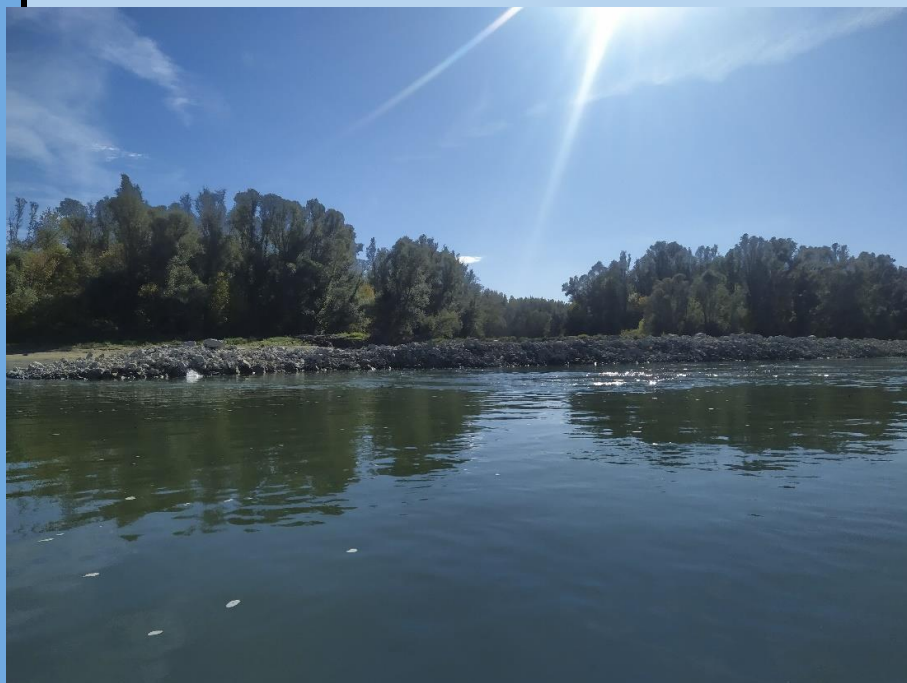
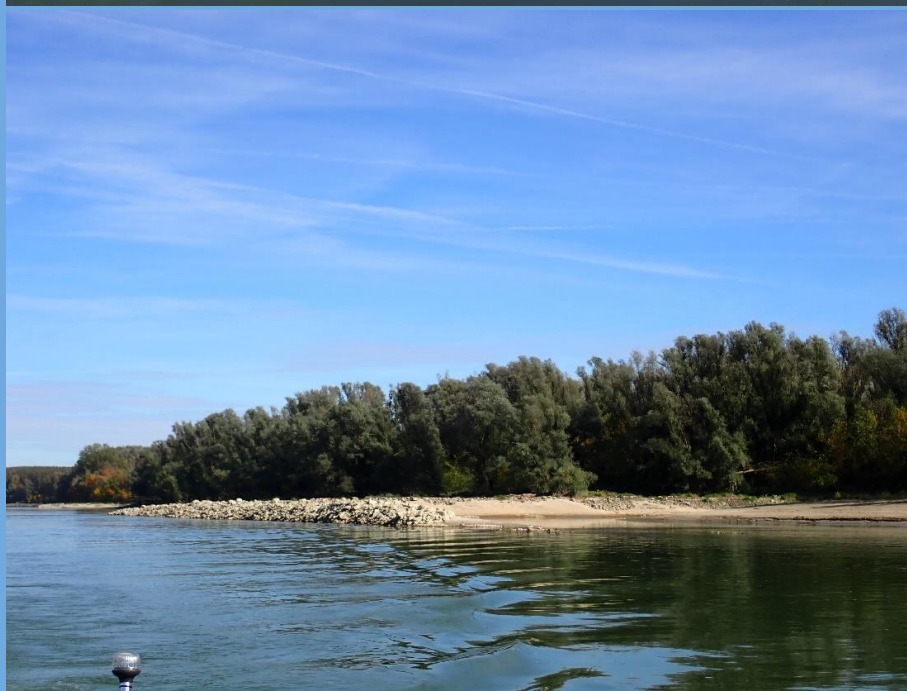
35. Left bank	Type:	Chainage (r.km)	Length (m)	Crown elevation (m.a.s.l.)
<b>1398-L1</b>	T-groyne	1398+518	138,45	80,12

- Infrastructure is in good condition.
- Effect of material deposition ongoing (upstream, downstream).
- Groyne connection, head material and starting effect of material deposition upstream and downstream visible. On the groyne connection downstream visible lack of stone below groyne crown.
