**MONITORING OF HYDROLOGICAL, HYDRAULIC AND MORPHOLOGICAL CHARACTERISTICS OF THE DANUBE RIVER AND INVENTORY OF BIODIVERSITY COMPONENTS ON THE JOINT CROATIAN-SERBIAN SECTOR OF THE DANUBE RIVER**

**INVENTORY OF RIVER REGULATION INFRASTRUCTURE RELATED TO NAVIGATION**

**Project number:** I-2206/24

**LOCATION:** Danube river from rkm 1295,5 (Ilok) to rkm 1433,1  
(border with Hungary)

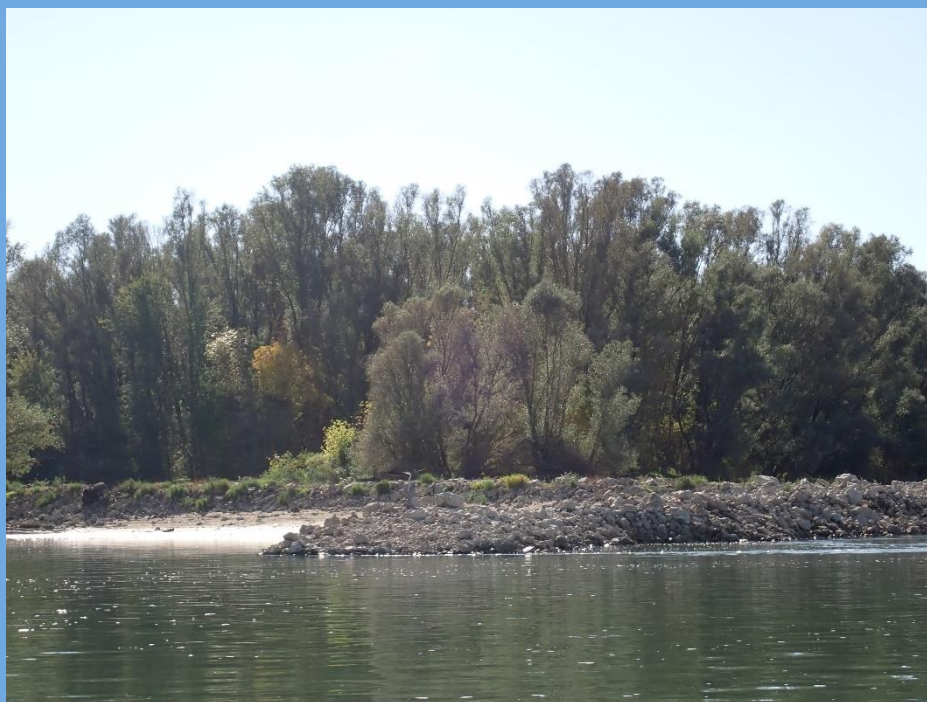
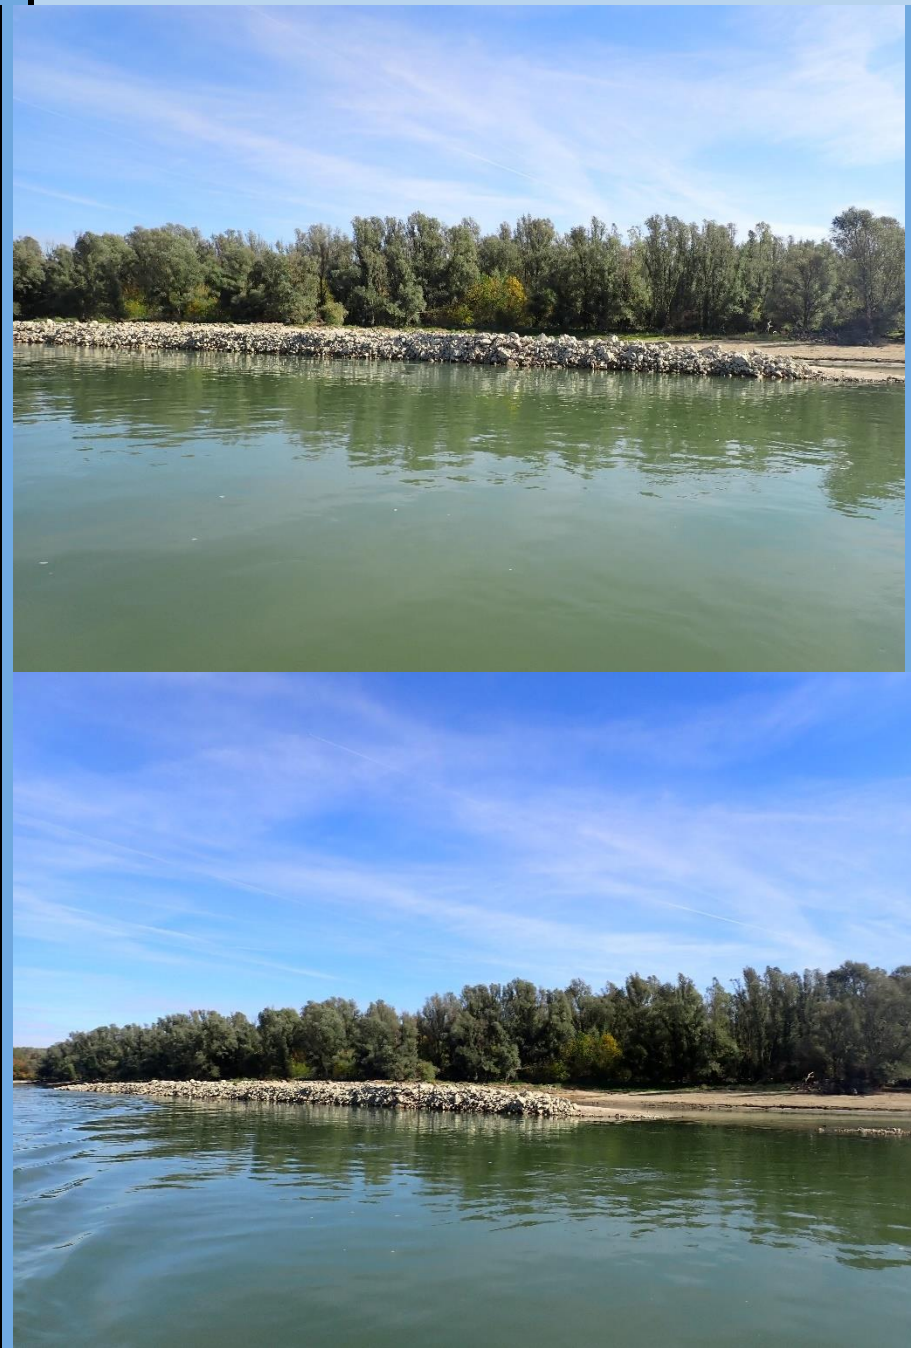
36. Left bank	Type:	Chainage (r.km)	Length (m)	Crown elevation (m.a.s.l.)
<b>1397-L2</b>	T-groyne	1397+970	85,97	80,59

- Infrastructure is in good condition.
- Effect of material deposition ongoing (upstream, downstream).
- Groyne connection, head material and starting effect of material deposition upstream and downstream visible. Fallen trees present on the groyne crown connection.

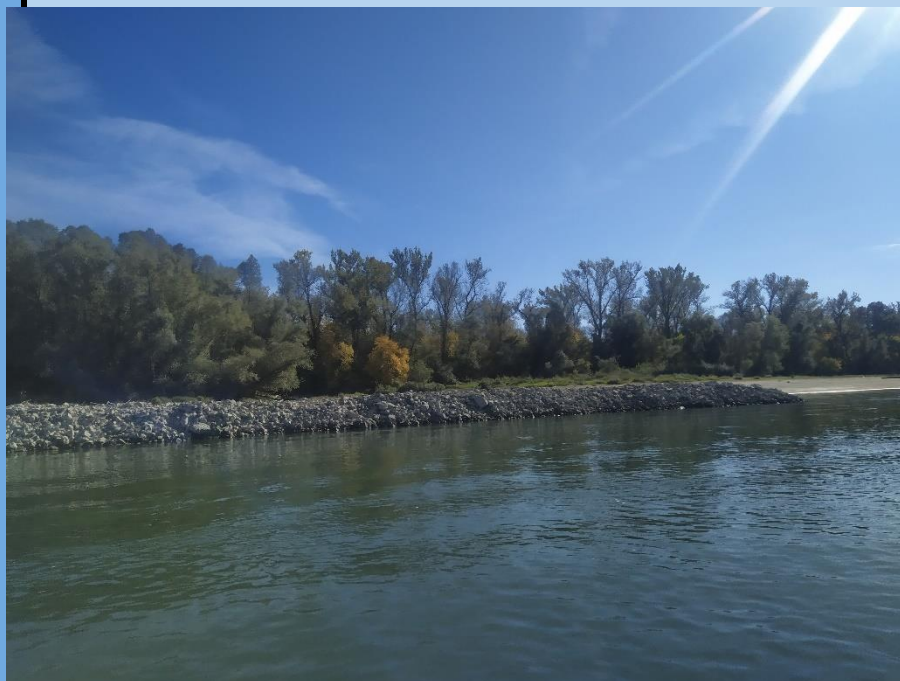
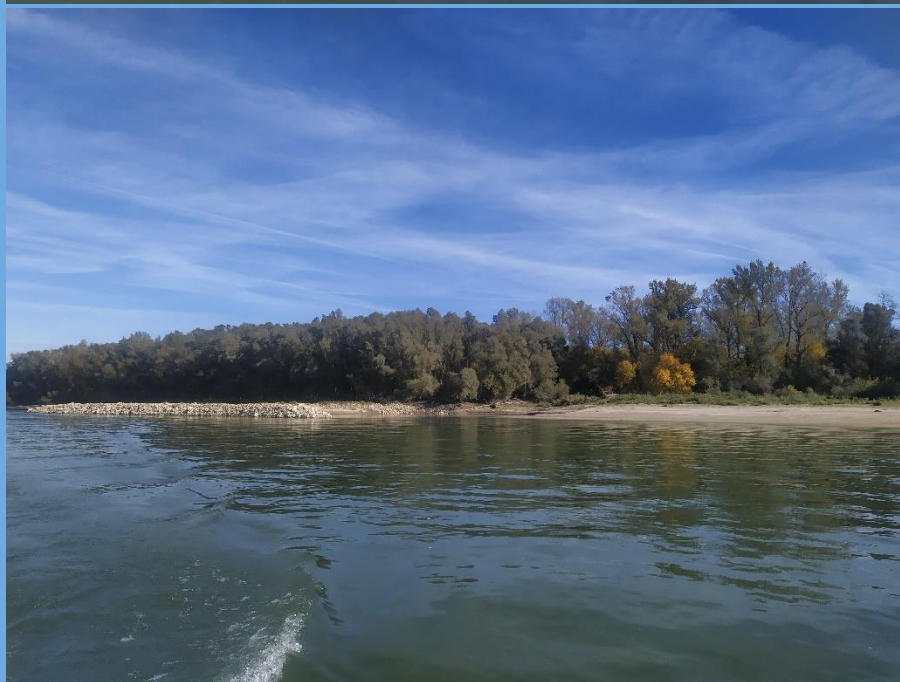
37. Left bank	Type:	Chainage (r.km)	Length (m)	Crown elevation (m.a.s.l.)
<b>1397-L1</b>	T-groyne	1397+362	91,82	80,34

- Infrastructure is in good condition.
- Effect of material deposition ongoing (upstream, downstream).
- Groyne connection, head material and starting effect of material deposition upstream and downstream visible. On the groyne connection downstream visible lack of stone below groyne crown.

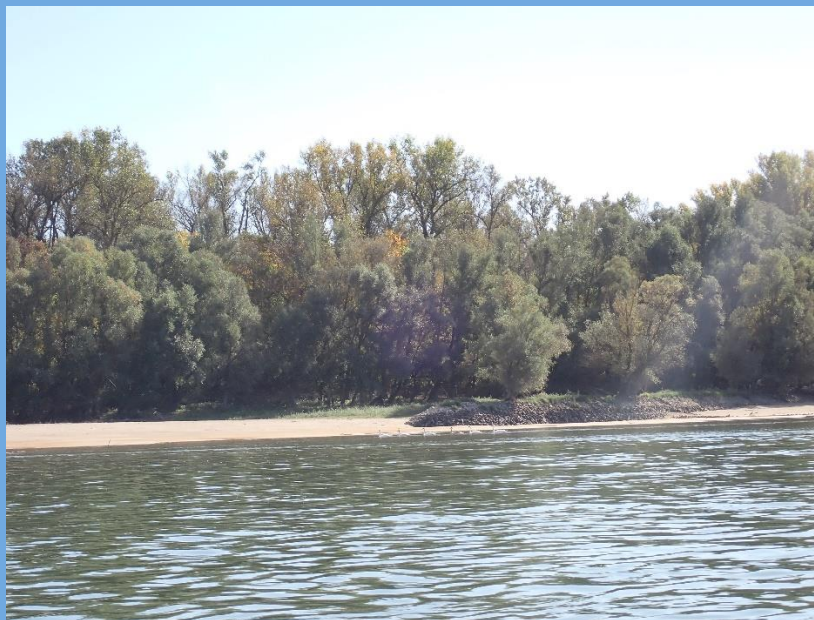
- Infrastructure is in good condition.
- Effect of material deposition finished (upstream, downstream).
- Groyne connection, head material and significantly effect of material deposition upstream and downstream visible. Trees present on the groyne crown connection.

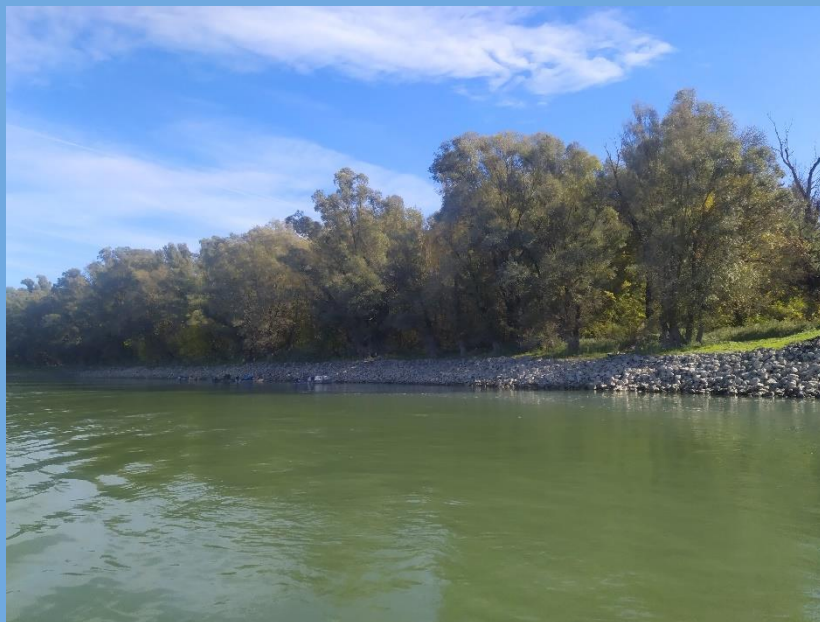
- Infrastructure is in good condition.
- River bank erosion protection ongoing at low water levels.
- Visible material revetment. Vegetation and trees present above the infrastructure.

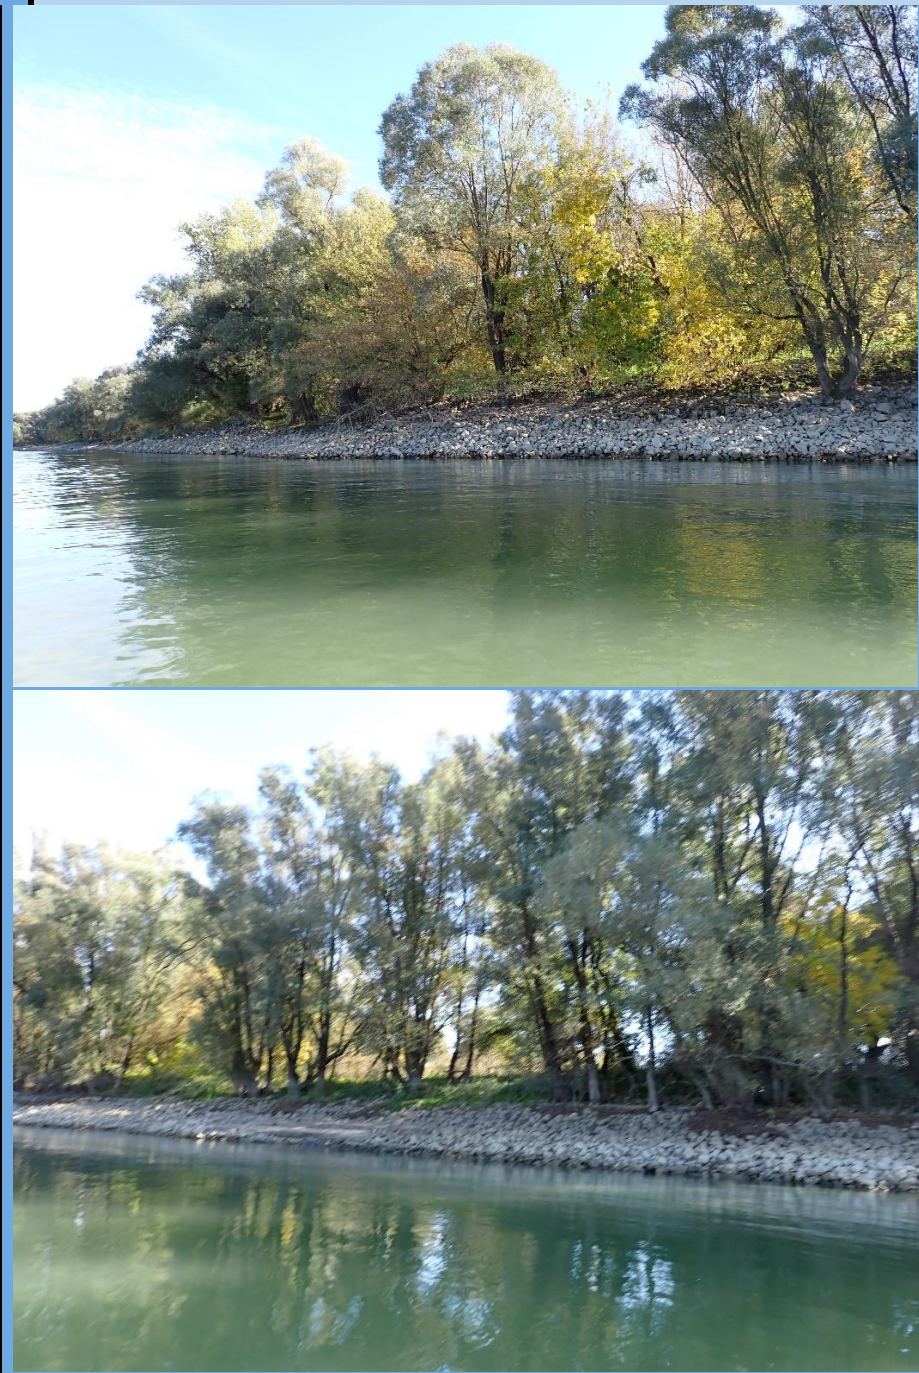
40. Left bank	Type:	Chainage (r.km)	Length (m)	Crown elevation (m.a.s.l.)
<b>1394-L1</b>	Revetment	1395+288 do 1394+480	806,21	78,22

- Infrastructure is in good condition.
- River bank erosion protection ongoing at low water levels.
- Visible material revetment. Vegetation and trees present above the infrastructure.

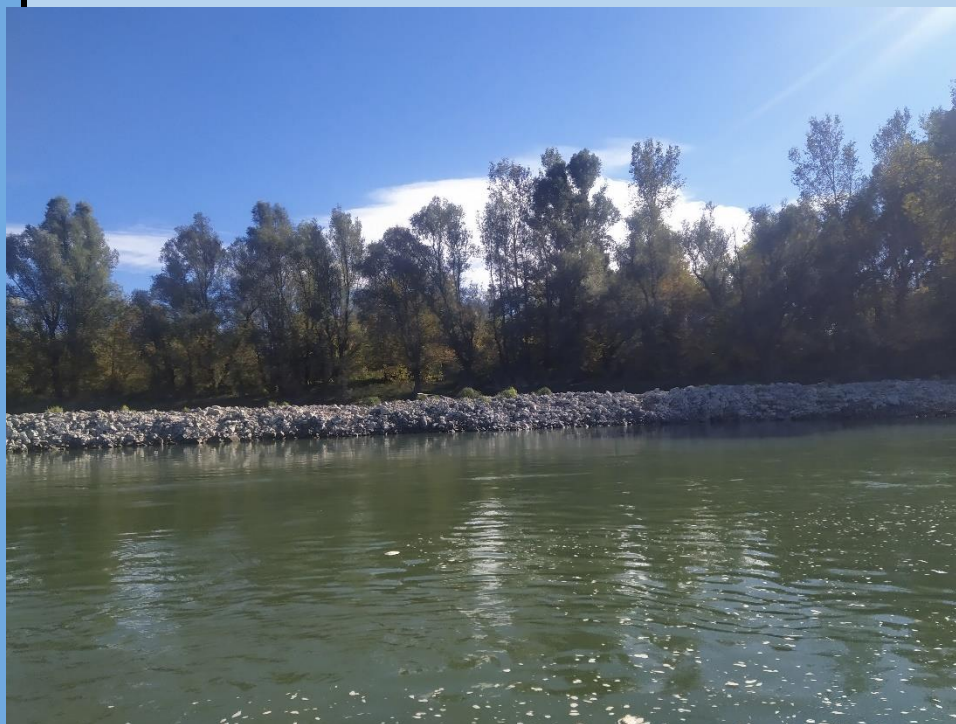
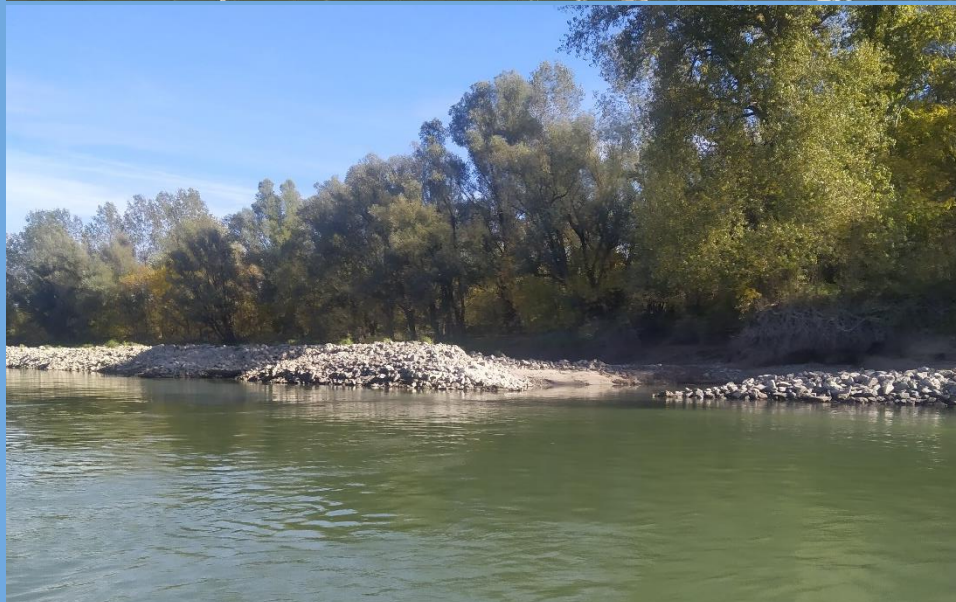
41. Left bank	Type:	Chainage (r.km)	Length (m)	Crown elevation (m.a.s.l.)
<b>1389-L1</b>	Parallel structure	1390+052 do 1389+761	427,78	78,73

- Infrastructure is in good condition.
- River bank protection from erosion ongoing at low water levels.
- Parallel structure material visible. Vegetation and trees present above the infrastructure. Starting downstream of the revetment 1388-L3.

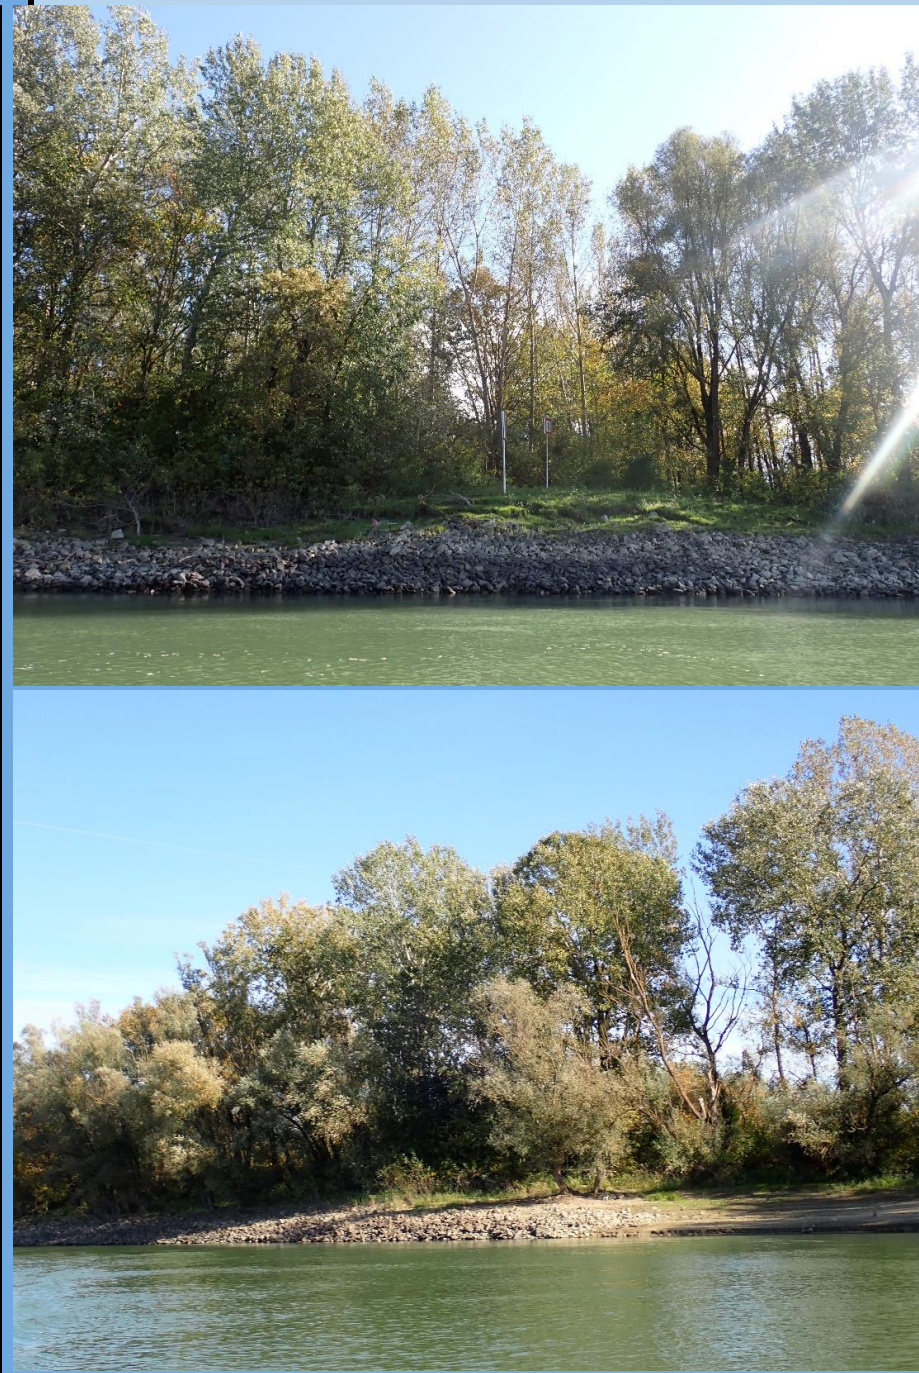
42. Left bank	Type:	Chainage (r.km)	Length (m)	Crown elevation (m.a.s.l.)
<b>1388-L3</b>	Revetment	1389+761 do 1388+890	1086,96	79,62

- Infrastructure is in good condition.
- River bank erosion protection ongoing at low water levels.
- Begins at rkm 1390. Material of the structure and two groynes are visible g. Observed backfilling from the body of the building towards the shore. Effect of material deposition ongoing.

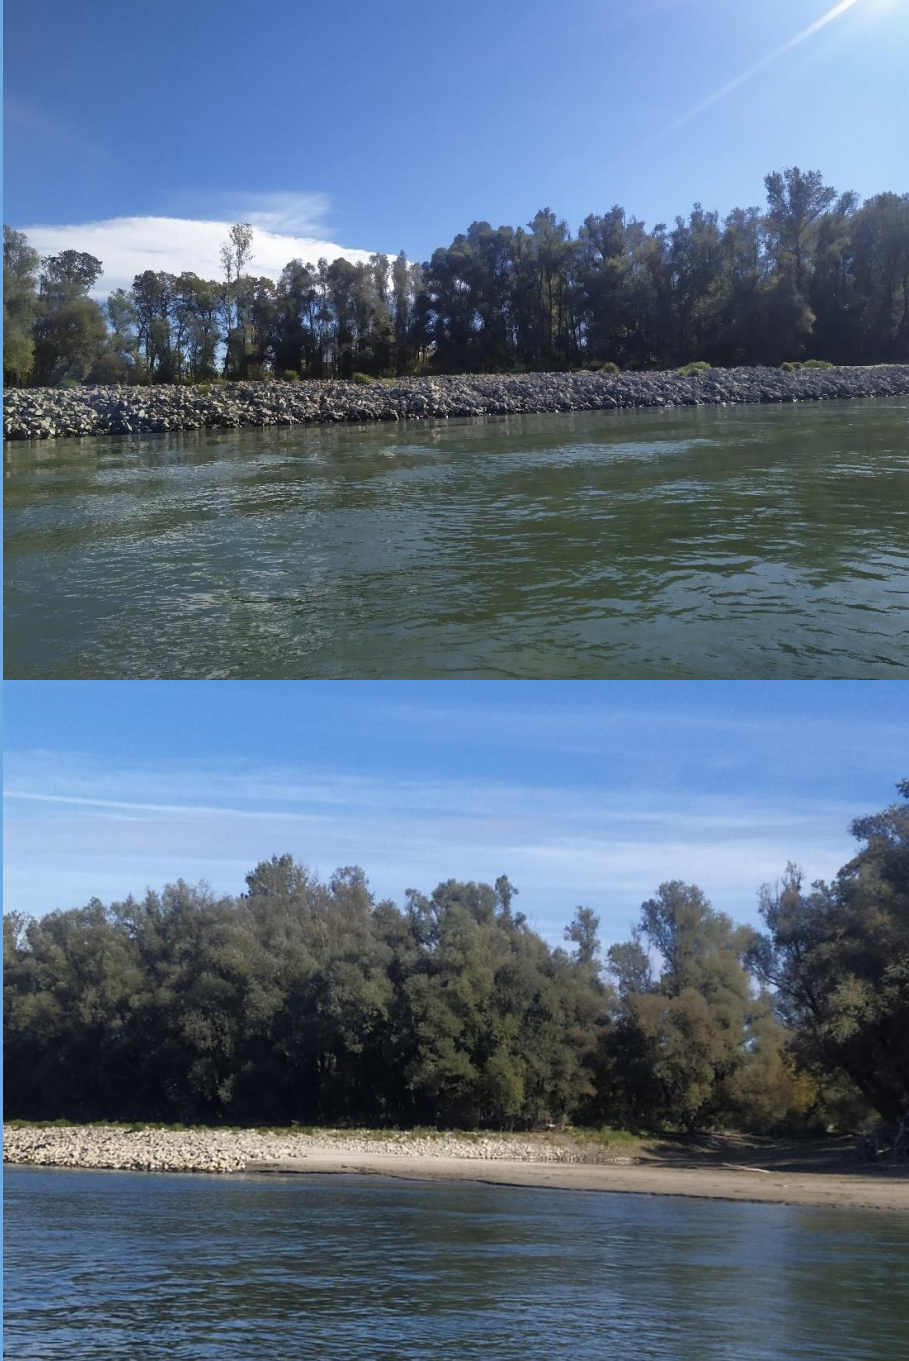
43. Left bank	Type:	Chainage (r.km)	Length (m)	Crown elevation (m.a.s.l.)
<b>1388-L2</b>	T-groyne	1388+731	136,16	80,20

- Infrastructure is in excellent condition.
- Effect of material deposition ongoing (upstream, downstream).
- T-groyne, groyne connection, head material and effect of material deposition upstream and downstream visible.

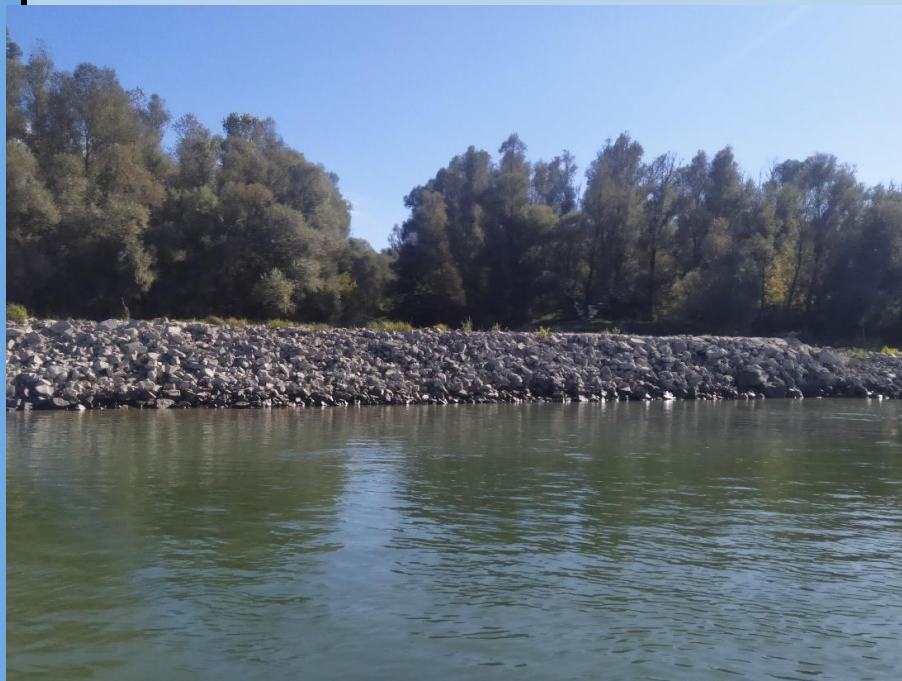
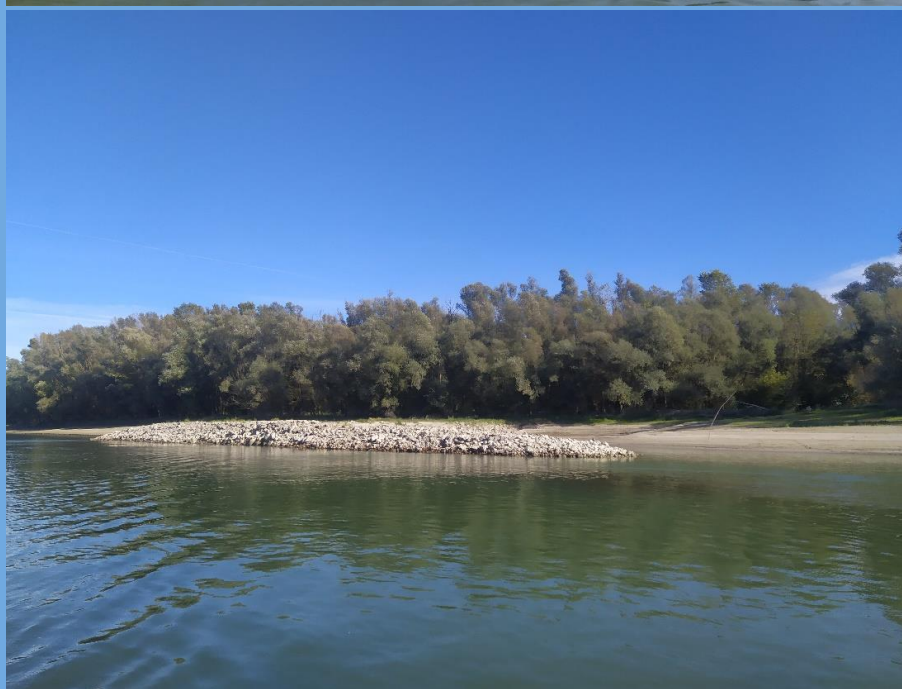
44. Left bank	Type:	Chainage (r.km)	Length (m)	Crown elevation (m.a.s.l.)
<b>1388-L1</b>	T-groyne	1388+376	82,18	80,20

- Infrastructure is in excellent condition.
- Effect of material deposition ongoing (upstream, downstream).
- T-groyne, groyne connection, head material and effect of material deposition upstream and downstream visible.

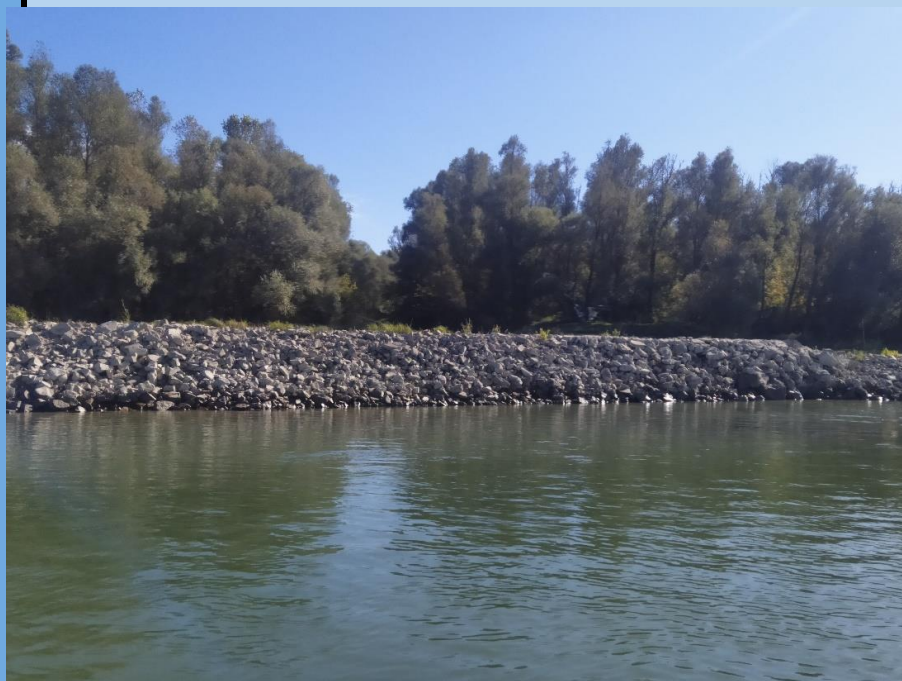
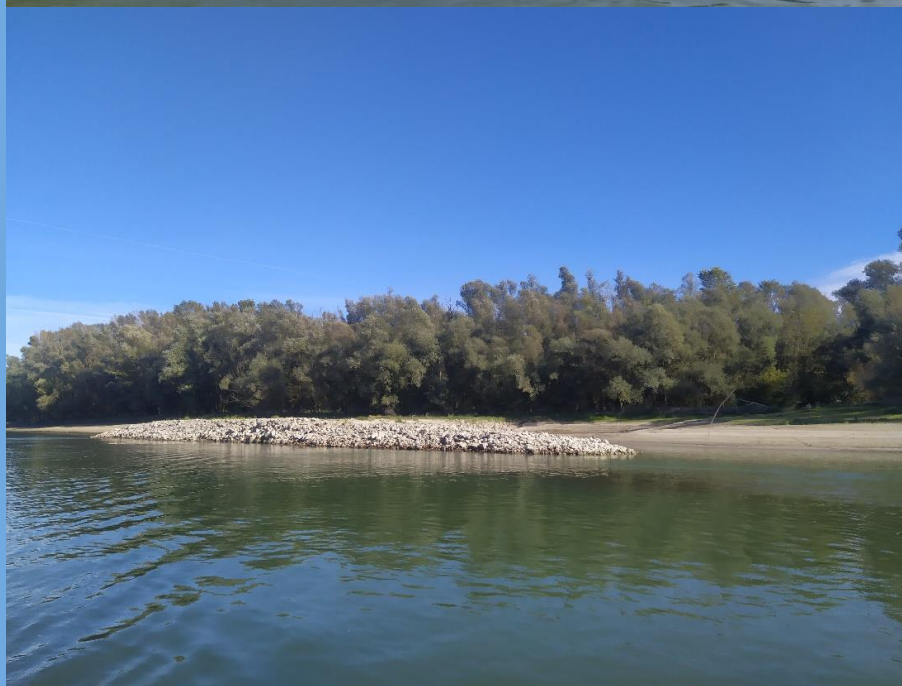
45. Left bank	Type:	Chainage (r.km)	Length (m)	Crown elevation (m.a.s.l.)
<b>1387-L2</b>	T-groyne	1387+888	104,24	80,14

- Infrastructure is in good condition.
- Effect of material deposition ongoing (upstream, downstream).
- T-groyne, groyne connection, head material and effect of material deposition upstream and downstream visible. Vegetation present on the crown of the infrastructure.

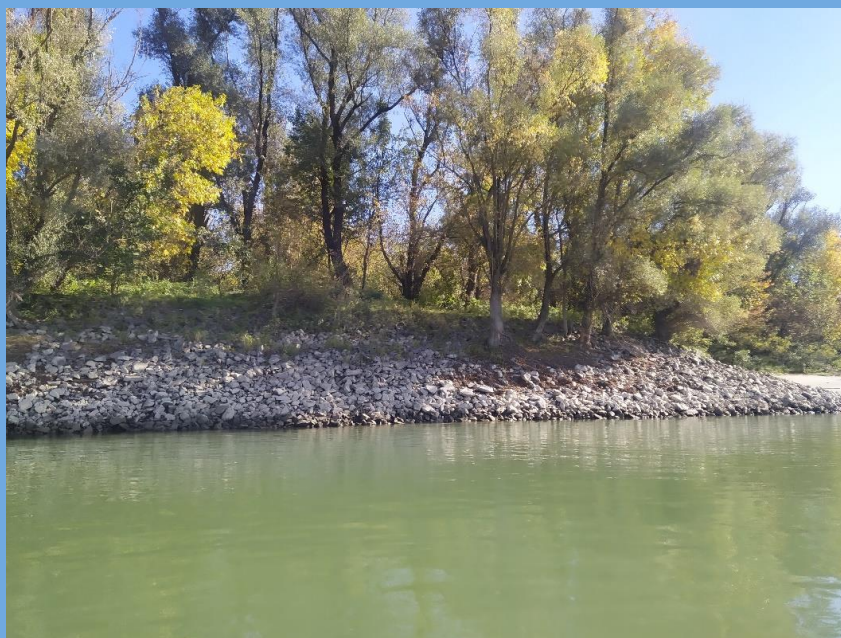
- Infrastructure is in good condition.
- River bank erosion protection ongoing at medium water levels.
- Stone revetment. Visible material revetment. Vegetation and trees present above the infrastructure.

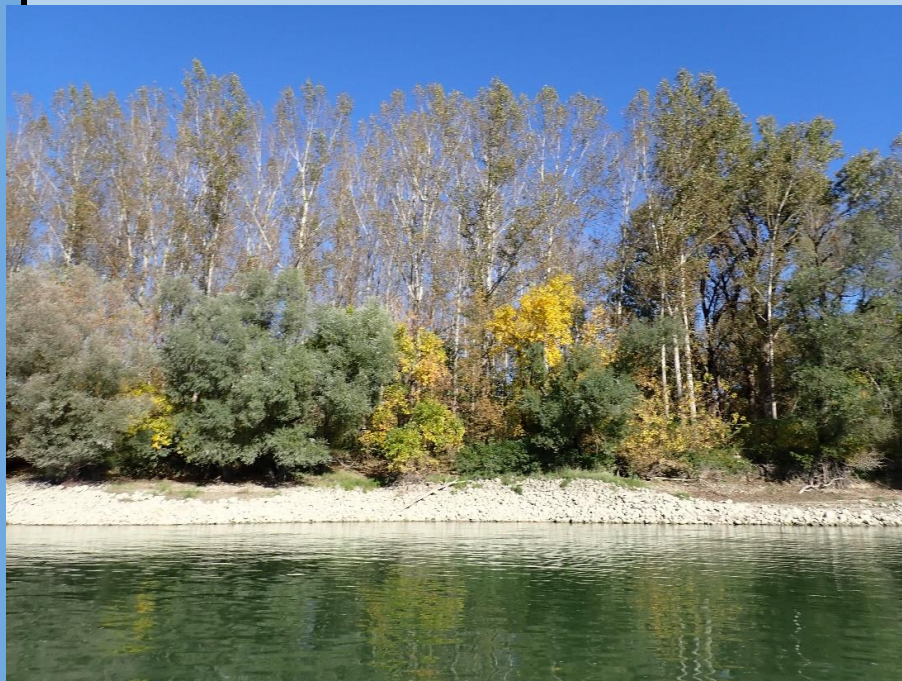
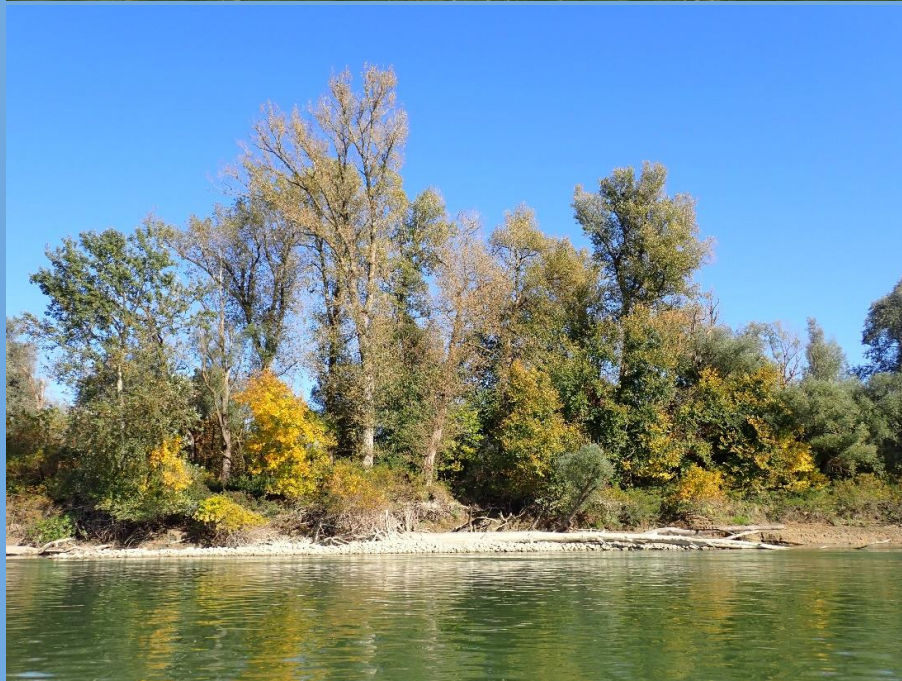
47. Left bank	Type:	Chainage (r.km)	Length (m)	Crown elevation (m.a.s.l.)
<b>1382-L2</b>	Revetment	1383+971 do 1382+473	1309,07	78,10

- Infrastructure is in bad condition.
- River bank erosion protection failed.
- Stone revetment. River bank erosion behind revetment present. Visible material revetment at low water levels. Revetment in continuity.

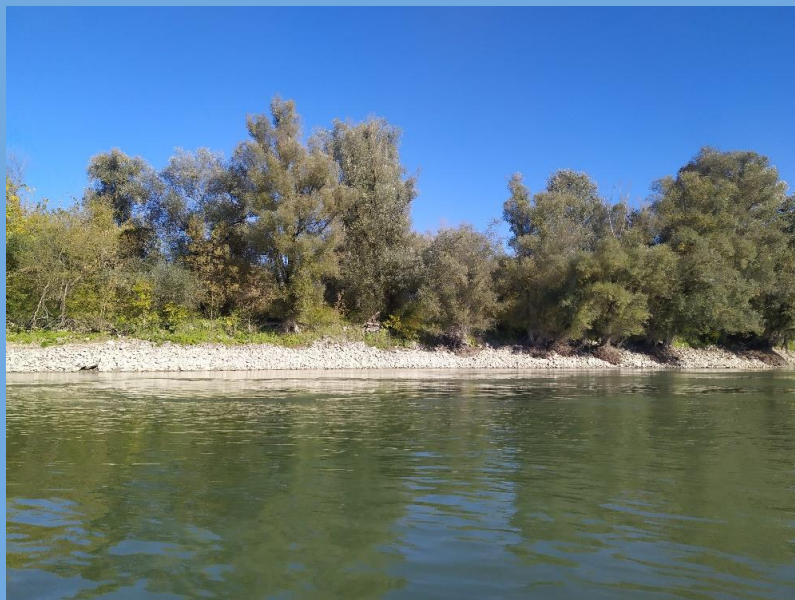
- Infrastructure is in satisfying condition.
- Barrier on backwater flow failed at low water level.
- Visible material revetment along the slope downstream. Vegetation above the revetment. On the upstream part of the infrastructure, revetment material is not visible.

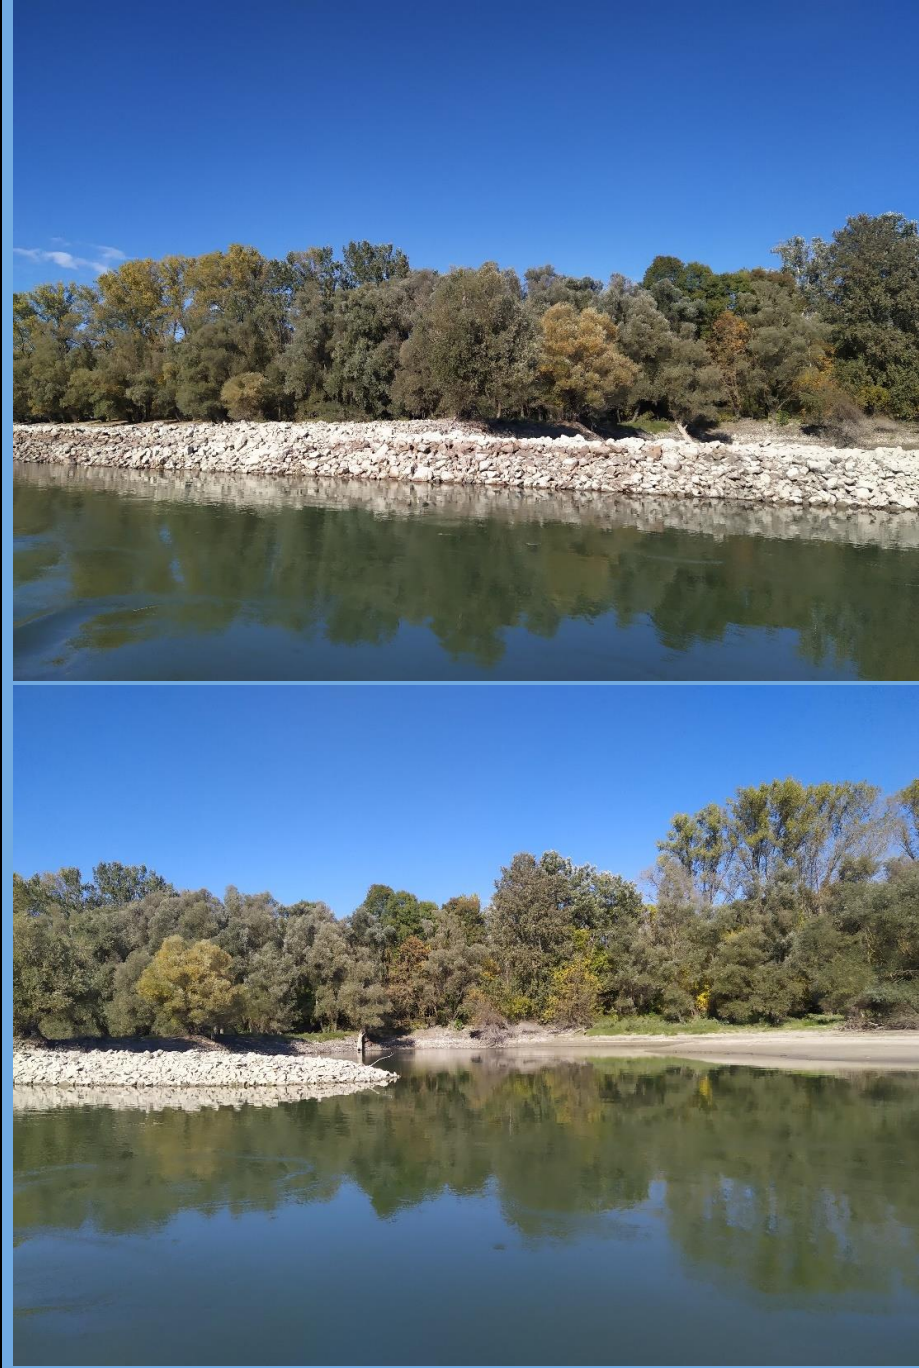
49. Left bank	Type:	Chainage (r.km)	Length (m)	Crown elevation (m.a.s.l.)
<b>1381-L1</b>	T-groyne	1381+241	82,61	79,67

- Infrastructure is in excellent condition.
- Effect of material deposition ongoing (upstream, downstream).
- Groyne connection, head material and effect of material deposition upstream and downstream visible. Trees present on the groyne crown connection.

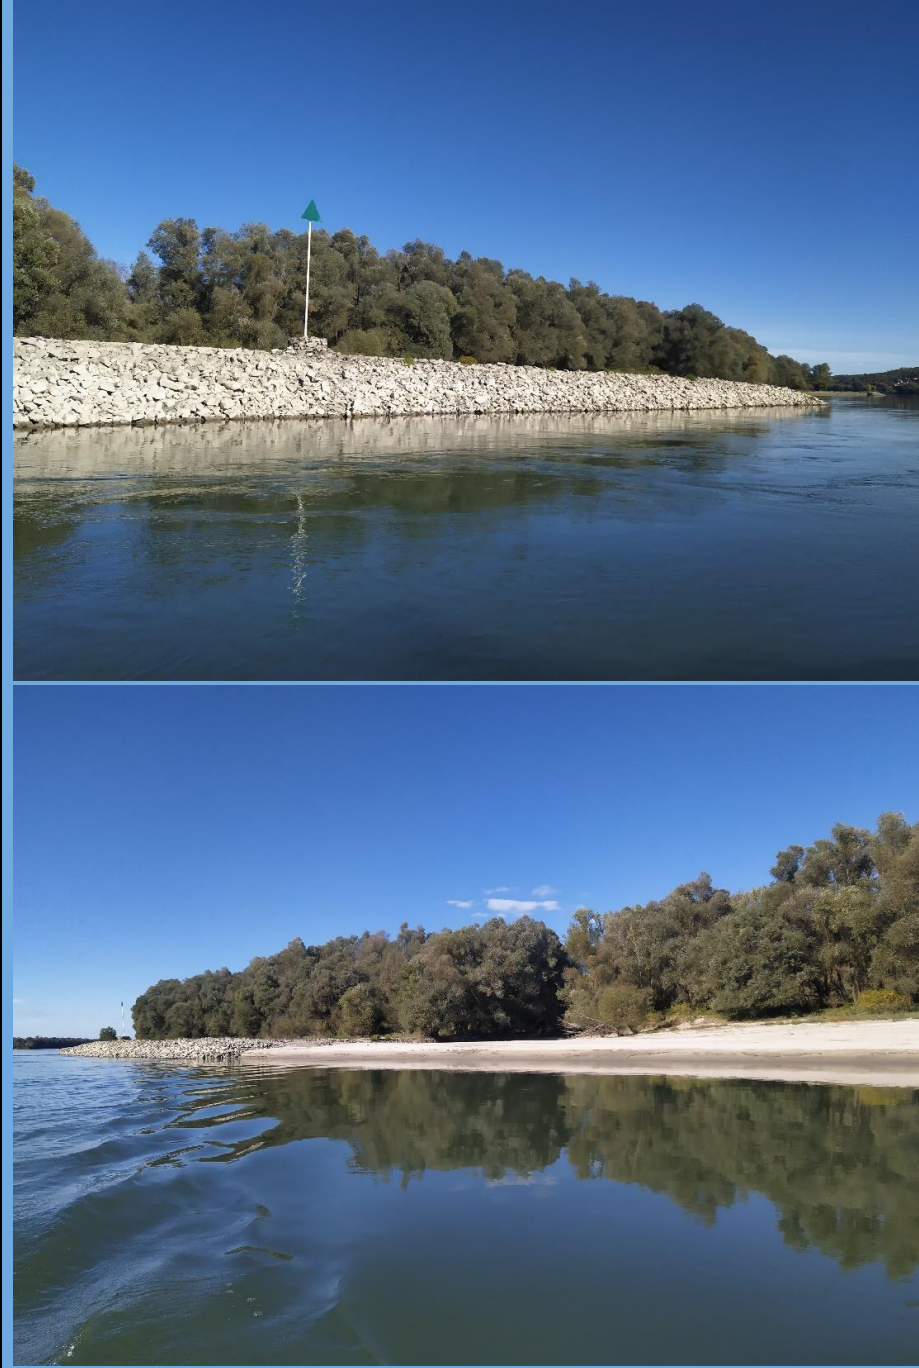
50. Left bank	Type:	Chainage (r.km)	Length (m)	Crown elevation (m.a.s.l.)
<b>1380-L2</b>	T-groyne	1380+837	84,03	79,89

- Infrastructure is in excellent condition.
- Effect of material deposition ongoing (upstream, downstream).
- Groyne connection and head material visible. Starting effect of material deposition upstream. Downstream effect of material deposition finished.

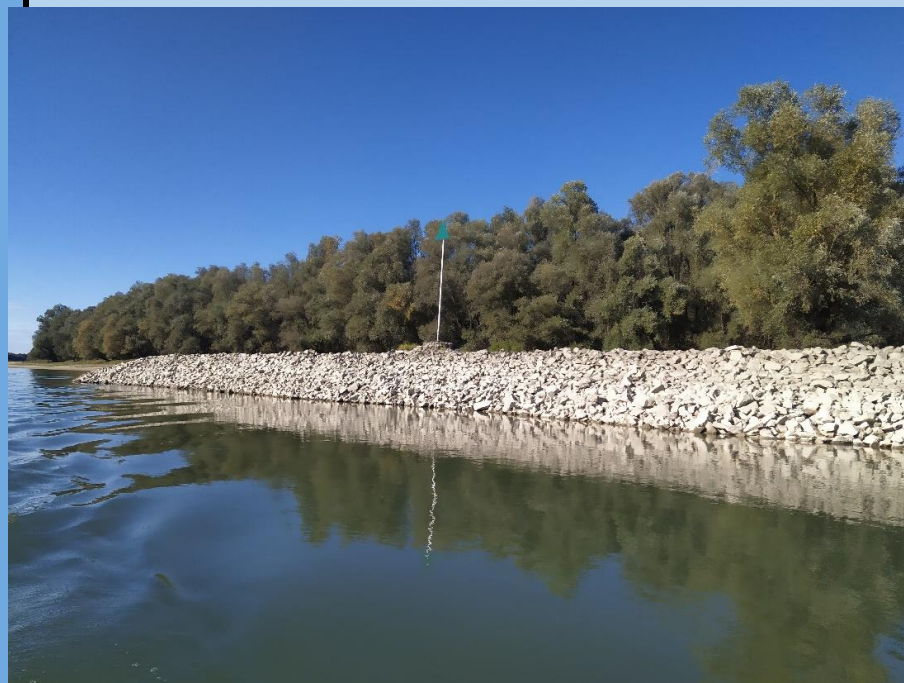
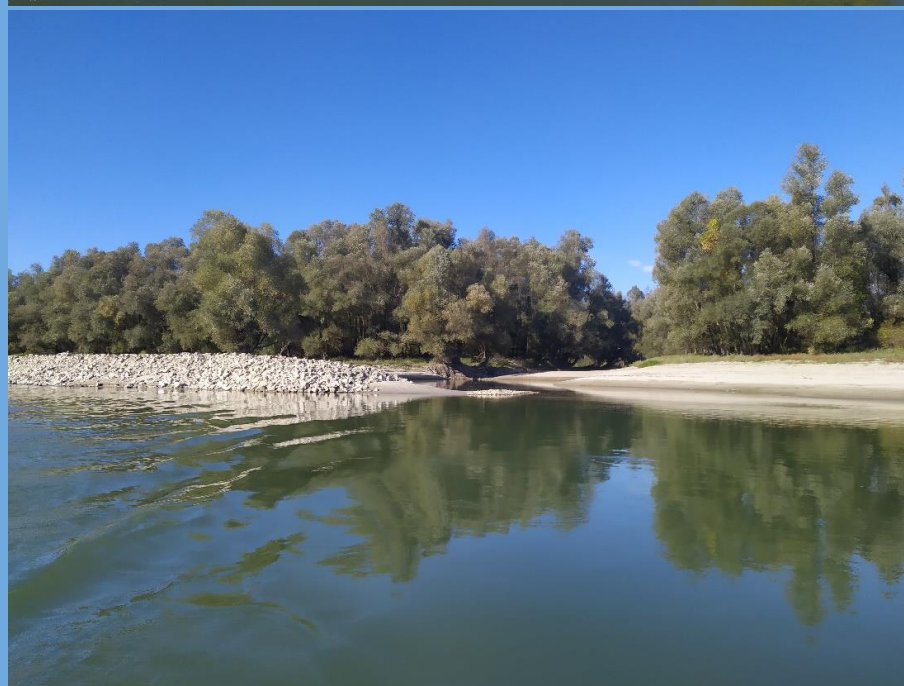
51. Left bank	Type:	Chainage (r.km)	Length (m)	Crown elevation (m.a.s.l.)
<b>1380-L1</b>	T-groyne	1380+199	95,57	79,87

- Infrastructure is in excellent condition.
- Effect of material deposition ongoing (upstream, downstream).
- Groyne connection, head material and starting effect of material deposition upstream and downstream visible. Trees present on the groyne crown connection.

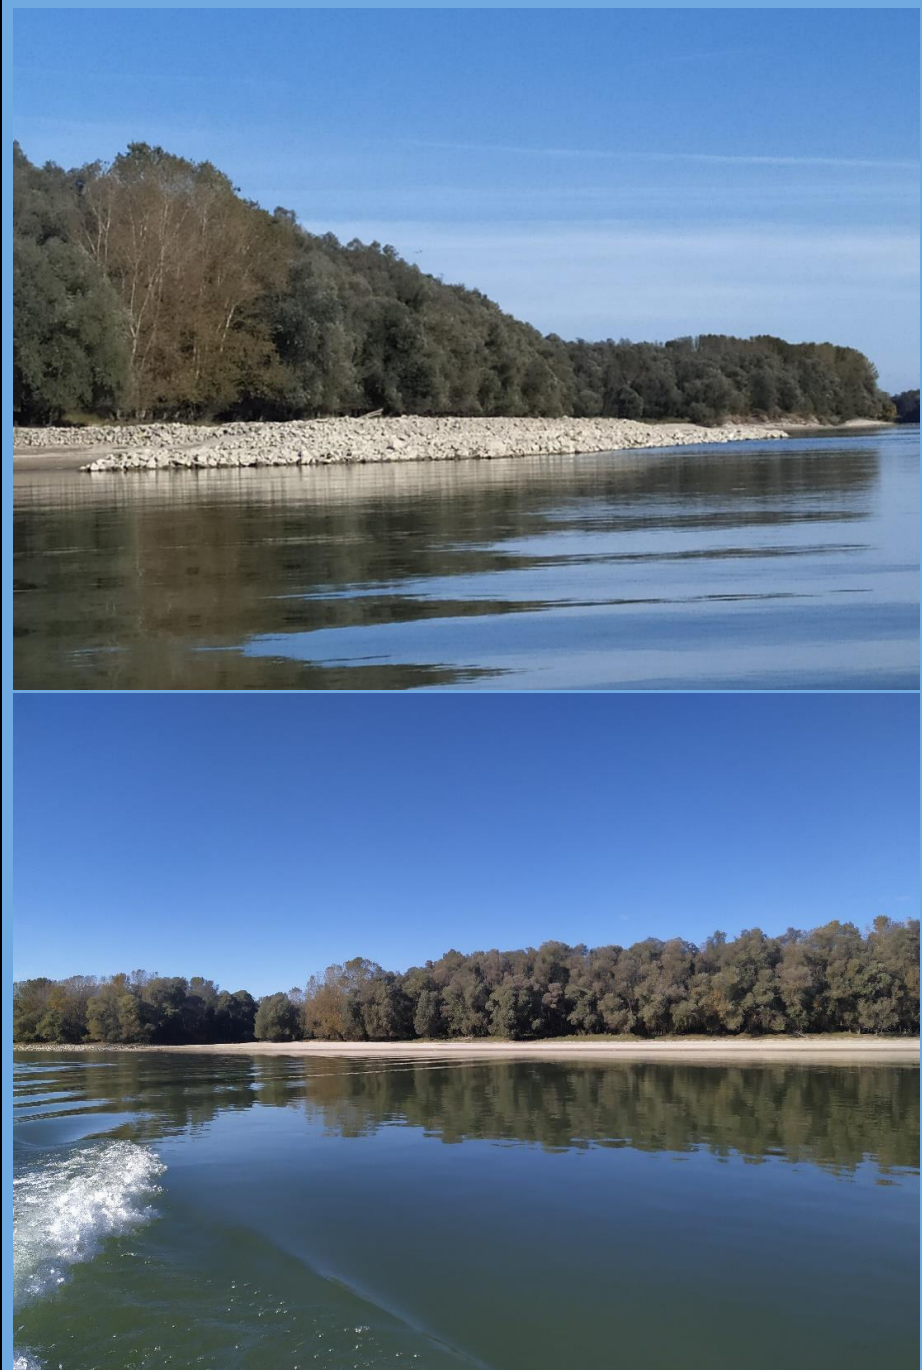
52. Left bank	Type:	Chainage (r.km)	Length (m)	Crown elevation (m.a.s.l.)
<b>1379-L2</b>	T-groyne	1379+588	119,68	79,74

- Infrastructure is in good condition.
- Effect of material deposition ongoing (upstream, downstream).
- Groyne connection and head material visible. Visible deformation of the part of groyne head upstream. Starting effect of material deposition upstream. Downstream effect of material deposition finished.

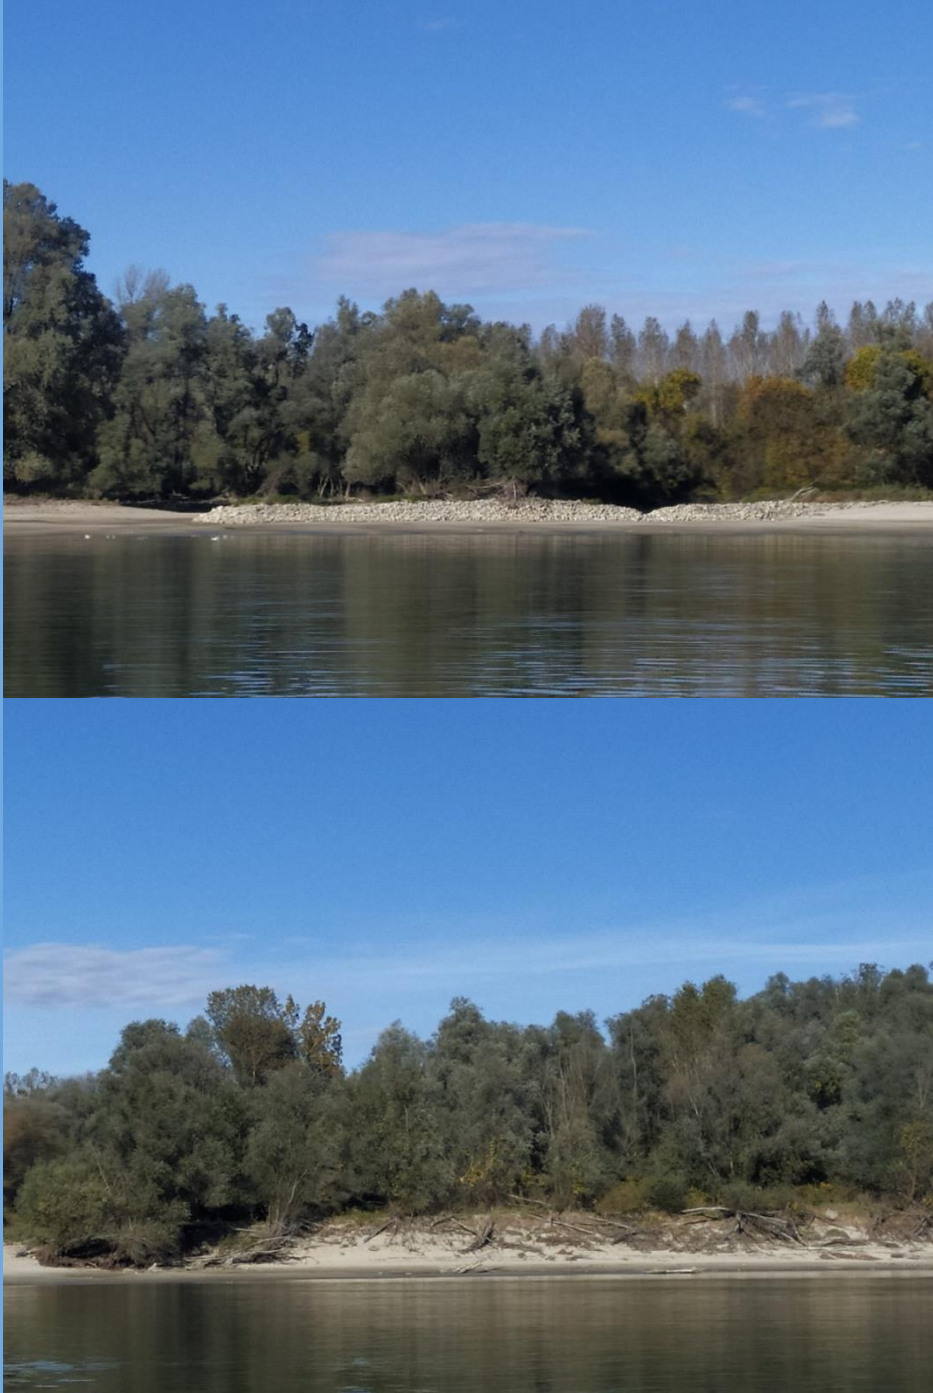
53. Left bank	Type:	Chainage (r.km)	Length (m)	Crown elevation (m.a.s.l.)
<b>1379-L1</b>	T-groyne	1379+058	53,27	79,67

- Infrastructure is in satisfying condition.
- Effect of material deposition finished (upstream, downstream).
- Groyne head material and effect of material deposition upstream and downstream visible. Trees present on the groyne crown connection.
