**MONITORING OF HYDROLOGICAL, HYDRAULIC AND MORPHOLOGICAL CHARACTERISTICS OF THE DANUBE RIVER AND INVENTORY OF BIODIVERSITY COMPONENTS ON THE JOINT CROATIAN-SERBIAN SECTOR OF THE DANUBE RIVER**

**INVENTORY OF RIVER REGULATION INFRASTRUCTURE RELATED TO NAVIGATION**

**Project number:** I-2206/24

**LOCATION:** Danube river from rkm 1295,5 (Ilok) to rkm 1433,1  
(border with Hungary)

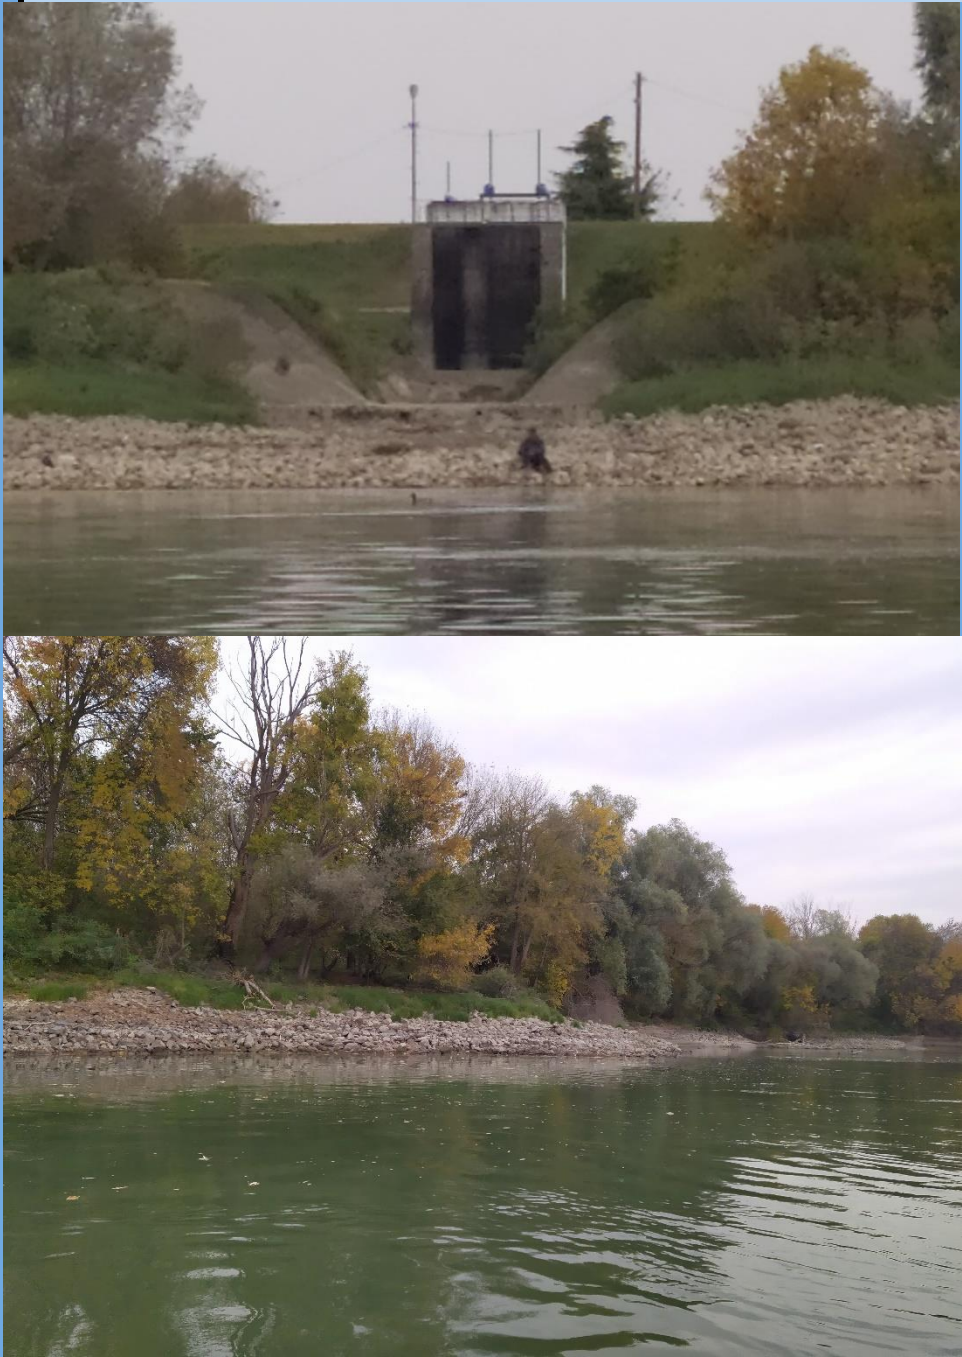
54. Left bank	Type:	Chainage (r.km)	Length (m)	Crown elevation (m.a.s.l.)
<b>1374-L1</b>	Revetment	1374+911 do 1374+031	976,28	79,71

- Infrastructure is in bad condition.
- River bank erosion protection failed.
- Stone revetment. River bank erosion behind revetment present. Visible material revetment at low water levels from the river side.

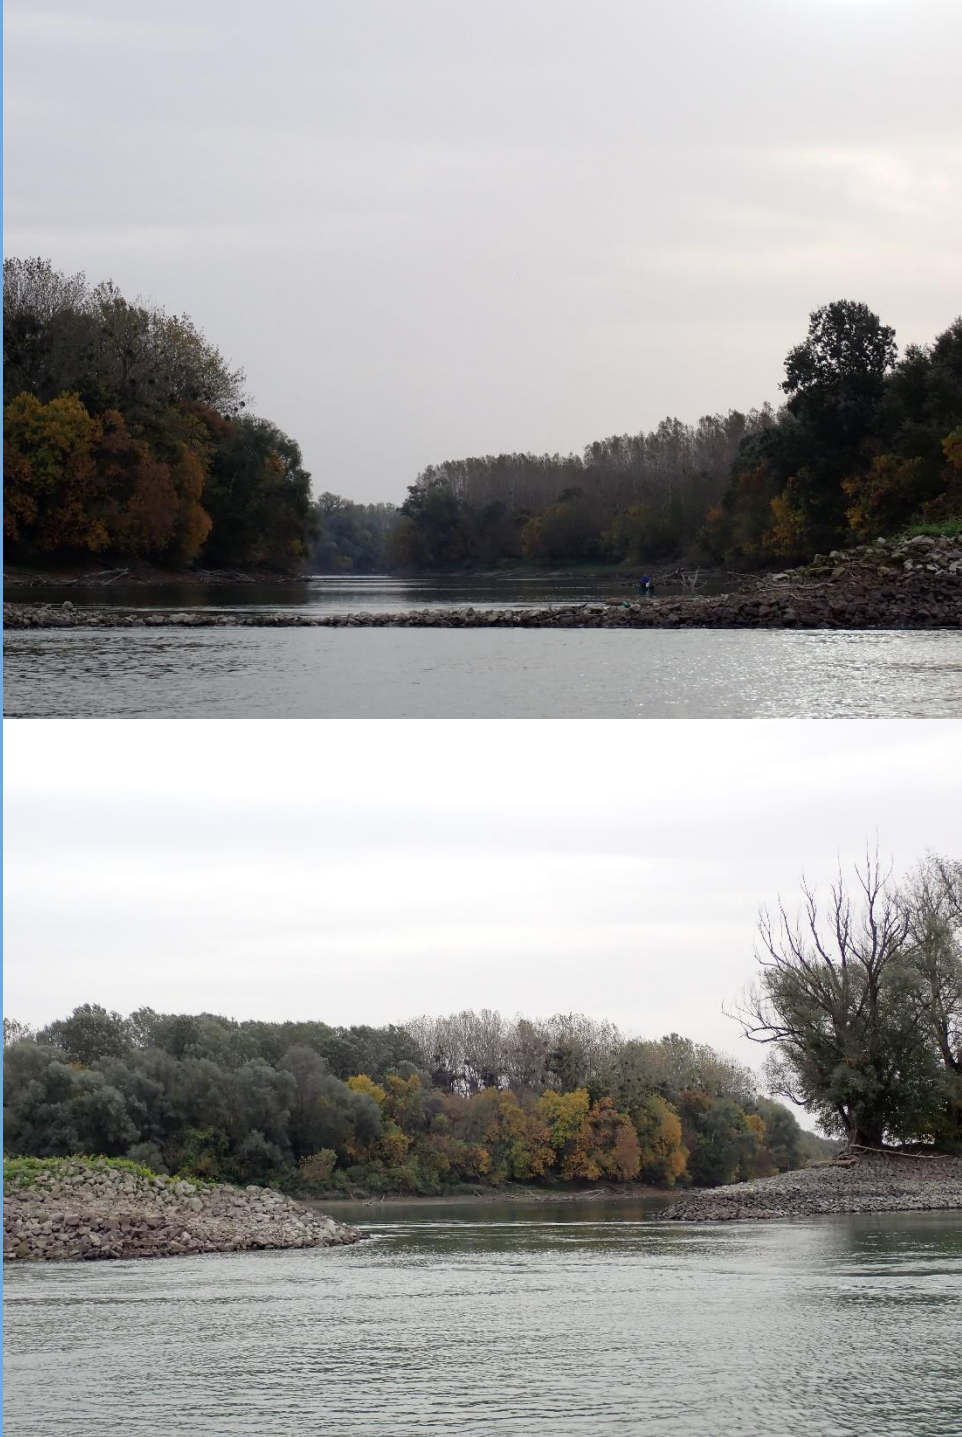
55. Left bank	Type:	Chainage (r.km)	Length (m)	Crown elevation (m.a.s.l.)
<b>1373-L2</b>	Barrier	1373+269 do 1373+839	144,36	80,11

- Infrastructure is in bad condition.
- Barrier on backwater flow failed at low water level.
- Barrier material visible. Irregular geometry of the structure. Downstream open barrier.

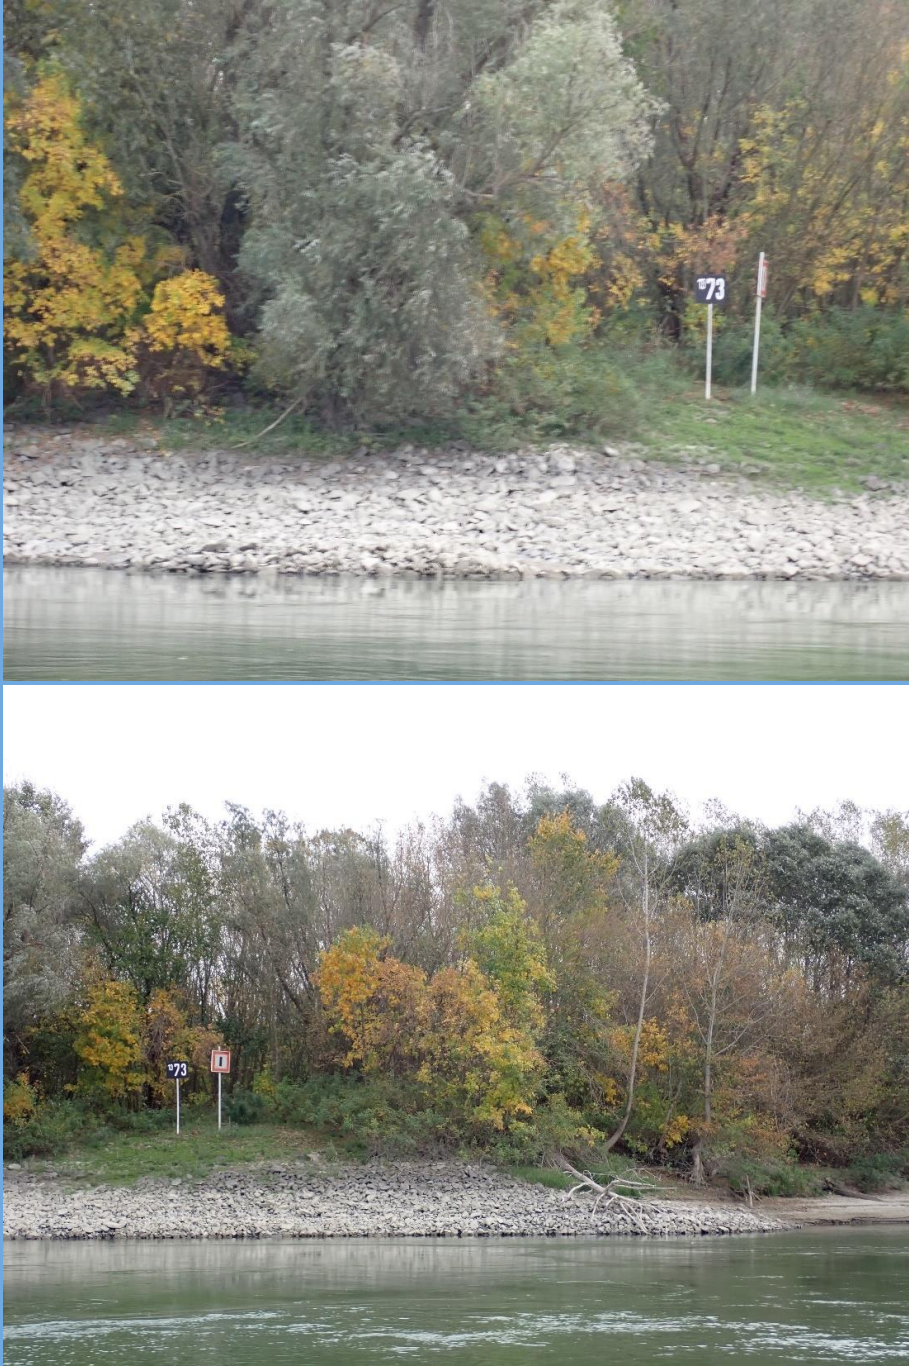
56. Left bank	Type:	Chainage (r.km)	Length (m)	Crown elevation (m.a.s.l.)
<b>1373-L1</b>	Revetment	1373+137 do 1373+000	132,41	77,37

- Infrastructure is in satisfying condition.
- River bank erosion protection ongoing at medium water levels.
- Stone revetment. Visible parts of material revetment upstream.

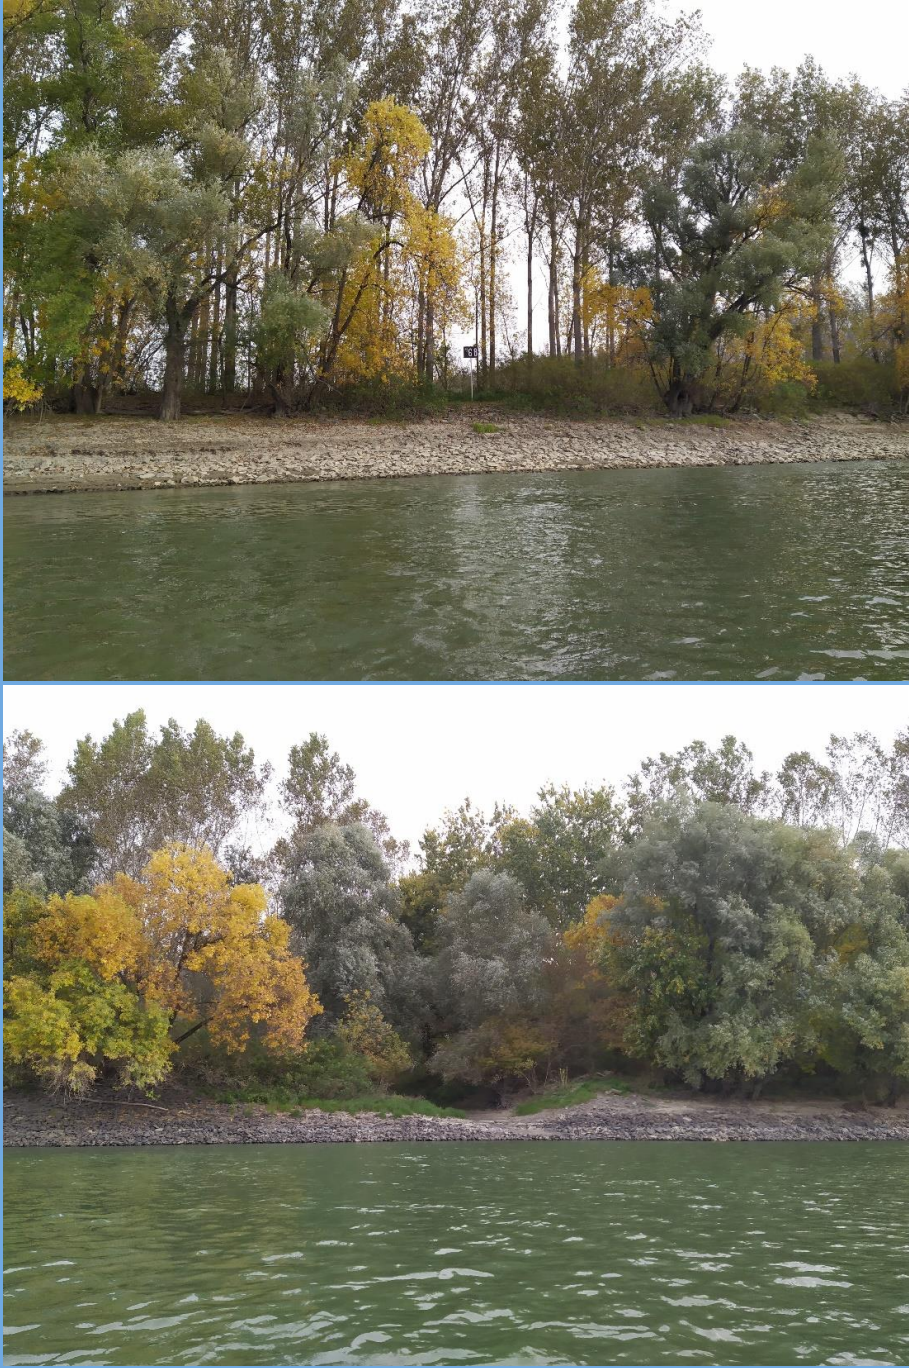
57. Left bank	Type:	Chainage (r.km)	Length (m)	Crown elevation (m.a.s.l.)
<b>1367-L1</b>	Revetment	1368+135 do 1367+521	686,66	77,34

- Infrastructure is in bad condition.
- River bank erosion protection failed.
- Stone revetment. River bank erosion behind revetment present. Visible material revetment at low water levels from the river side.

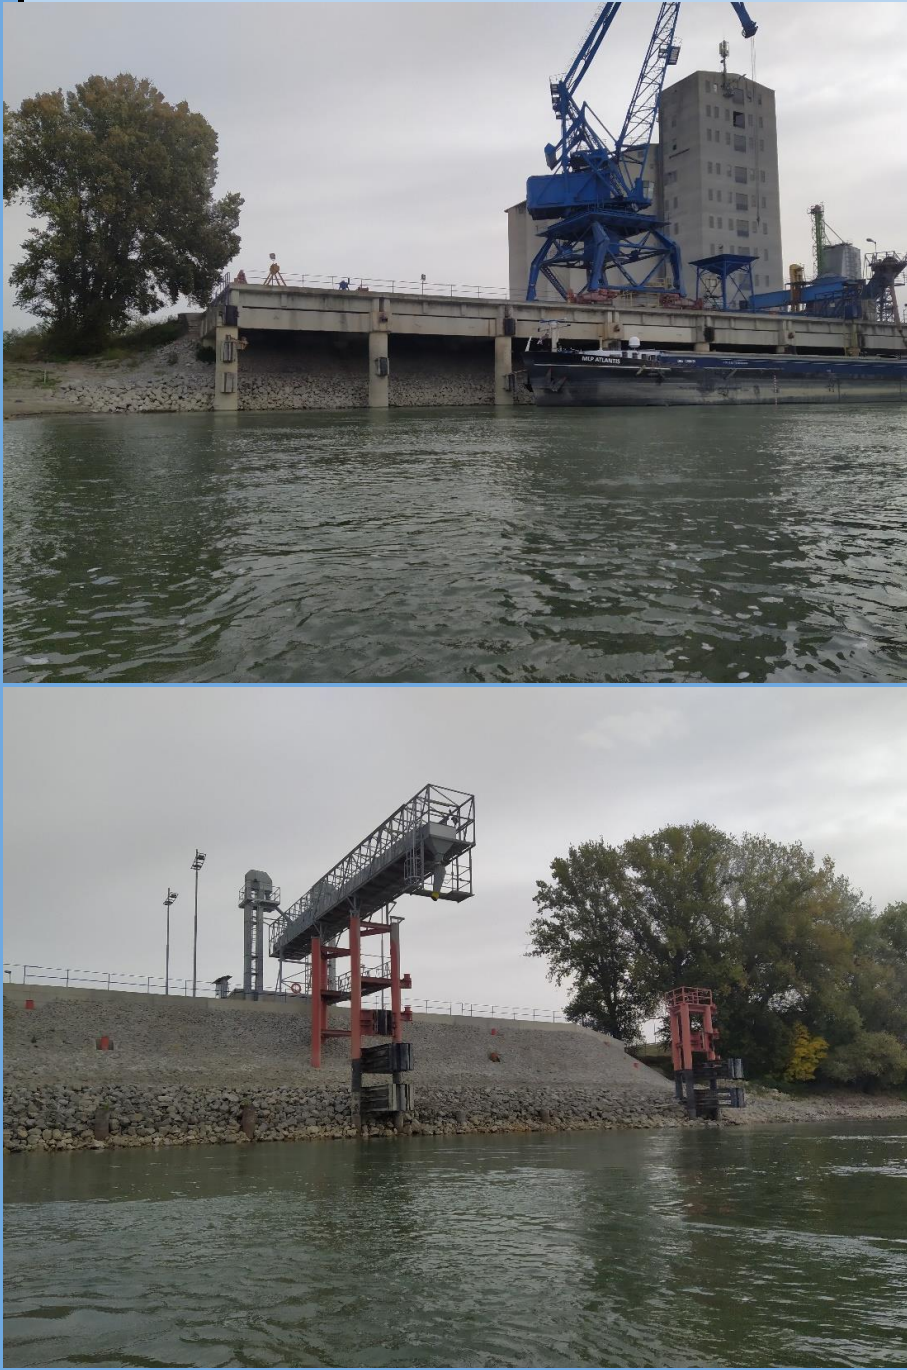
58. Left bank	Type:	Chainage (r.km)	Length (m)	Crown elevation (m.a.s.l.)
<b>1366-L1</b>	Revetment	1367+510 do 1366+727	834,08	77,28

- Infrastructure is in good condition.
- River bank erosion protection ongoing at high water levels.
- Stone revetment. Visible material revetment. Vegetation and trees present above the infrastructure. Downstream on the revetment operational plateau of the Port of Dunav-Bogojevo.

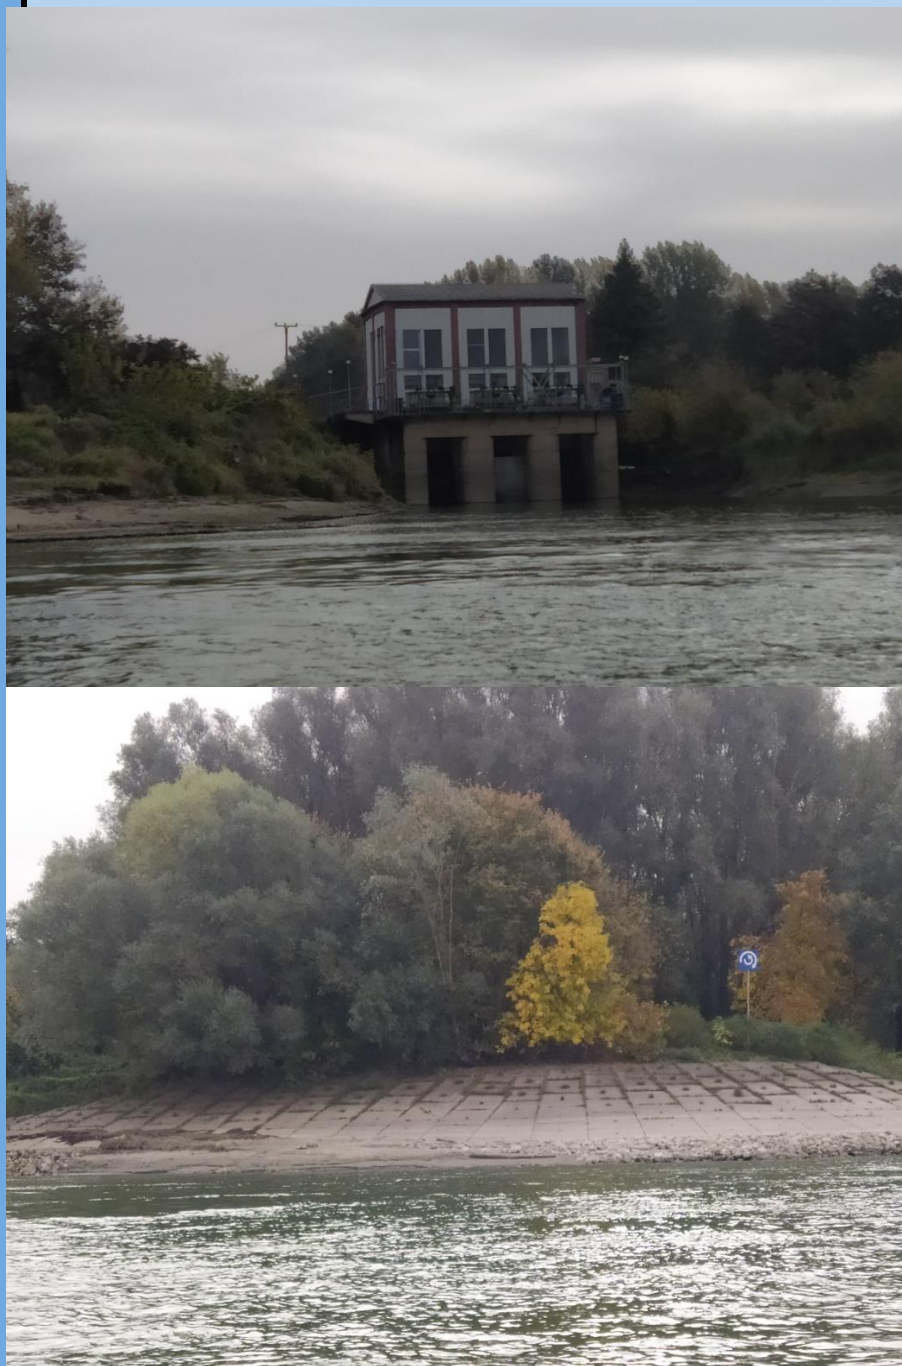
59. Left bank	Type:	Chainage (r.km)	Length (m)	Crown elevation (m.a.s.l.)
<b>1362-L2</b>	Revetment	1366+360 do 1361+862	4745,33	77,16

- Infrastructure is in bad condition.
- River bank erosion protection failed.
- Stone revetment. Irregular geometries of the structure. At the settlement of Bogojevo, concrete stairs were built along the slope of the revetment. At the floodgate on the Danube-Tisa-Danube canal, the revetment material is from stone blocks. Downstream of the floodgate partially visible material and vegetation above the structure.

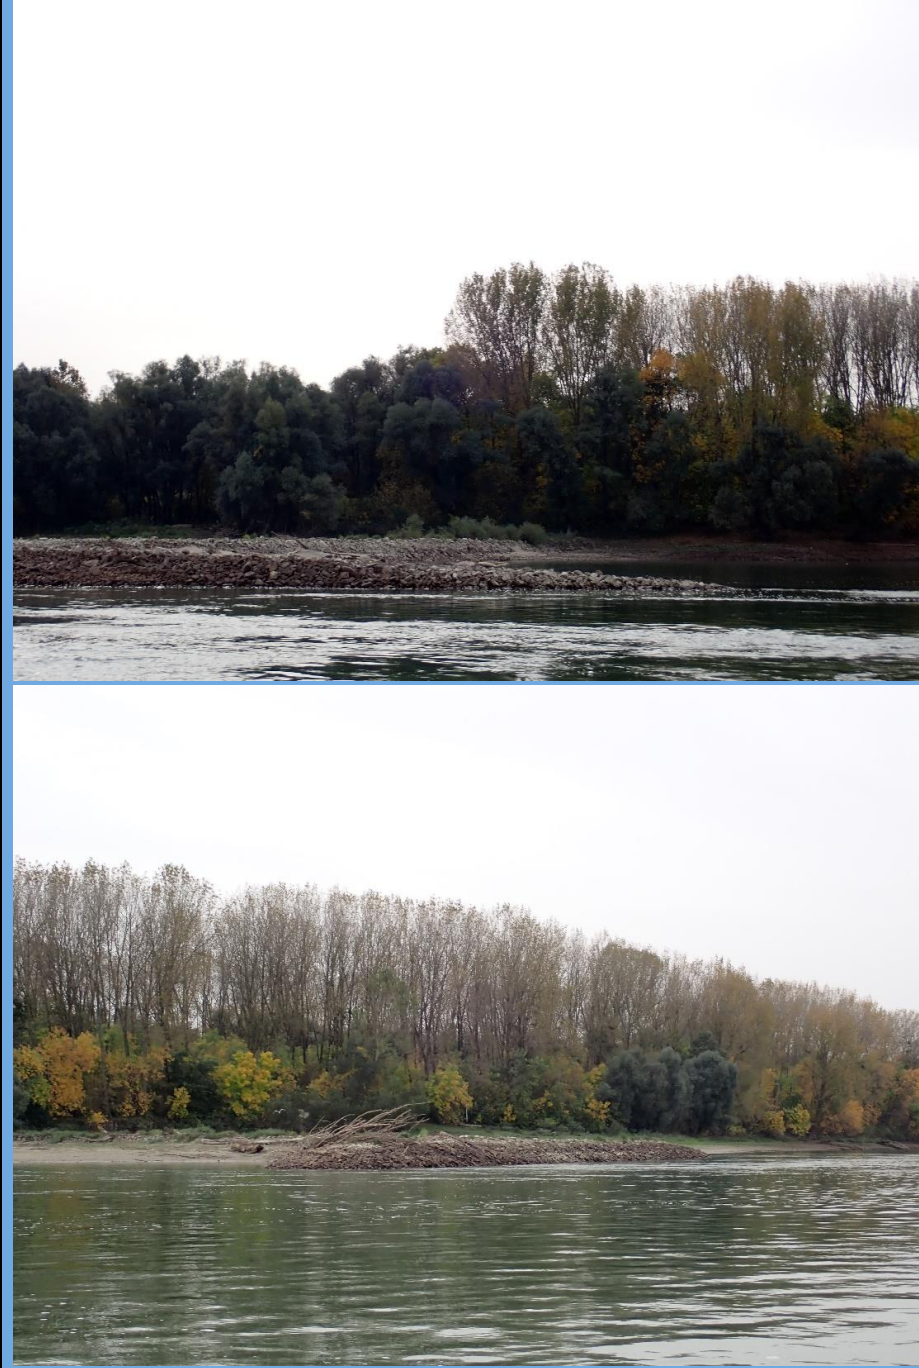
60. Left bank	Type:	Chainage (r.km)	Length (m)	Crown elevation (m.a.s.l.)
<b>1361-L1</b>	T-groyne	1361+336	53,75	78,10

- Infrastructure is in good condition.
- Effect of material deposition ongoing (upstream, downstream).
- Groyne connection, head material and starting effect of material deposition upstream and downstream visible. On the groyne connection downstream visible lack of stone below groyne crown.

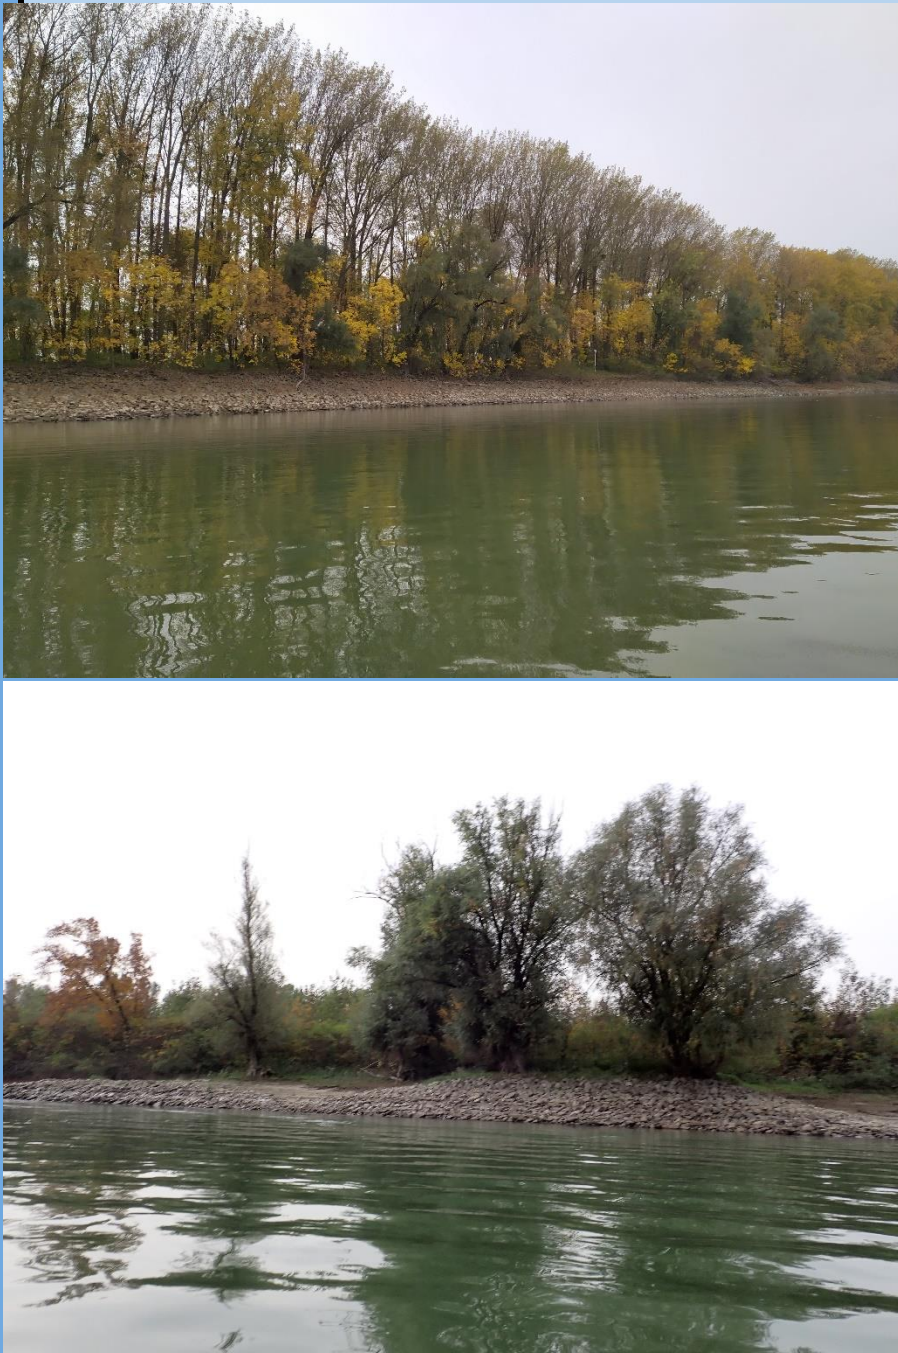
62. Left bank	Type:	Chainage (r.km)	Length (m)	Crown elevation (m.a.s.l.)
<b>1354-L1</b>	Revetment i Parallel structure	1360+121 do 1354+950	5051,73	77,19

- Infrastructure is in satisfying condition.
- River bank protection from erosion ongoing at low water levels. Effect of material deposition ongoing (upstream, downstream).
- Stone revetment. Visible material revetment. Above the structure vegetation and trees are present. Downstream of rkm 1355, the revetment is in bad conditions, river bank protection failed at low water levels. Visible parallel structure material. In continuity with the revetment.

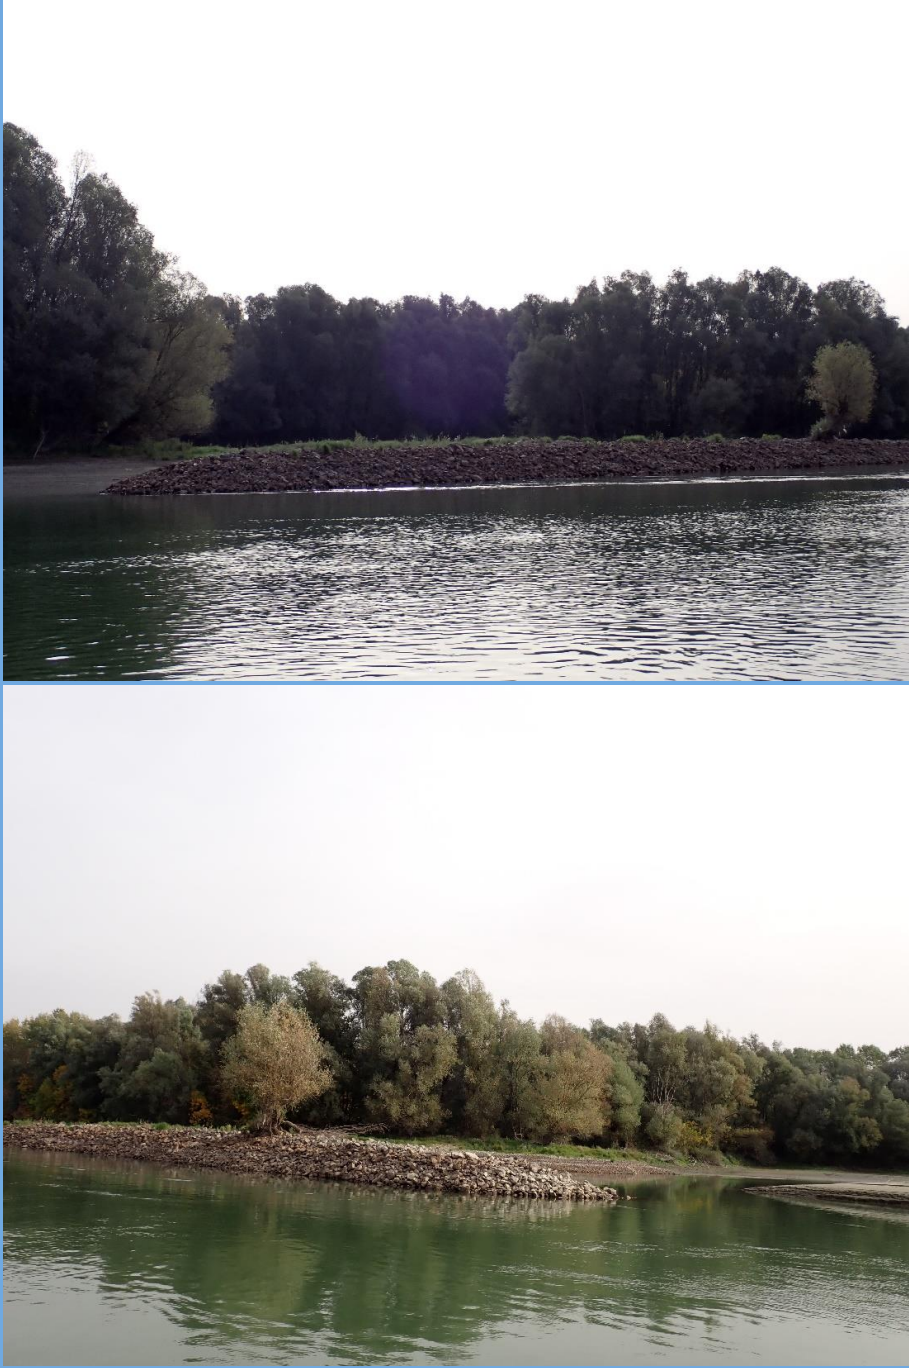
63. Left bank	Type:	Chainage (r.km)	Length (m)	Crown elevation (m.a.s.l.)
<b>1349-L2</b>	T-groyne	1349+818	76,62	78,94

- Infrastructure is in good condition.
- Effect of material deposition ongoing (upstream, downstream).
- Groyne connection, head material and starting effect of material deposition upstream and downstream visible. On the groyne connection downstream visible lack of stone below groyne crown.

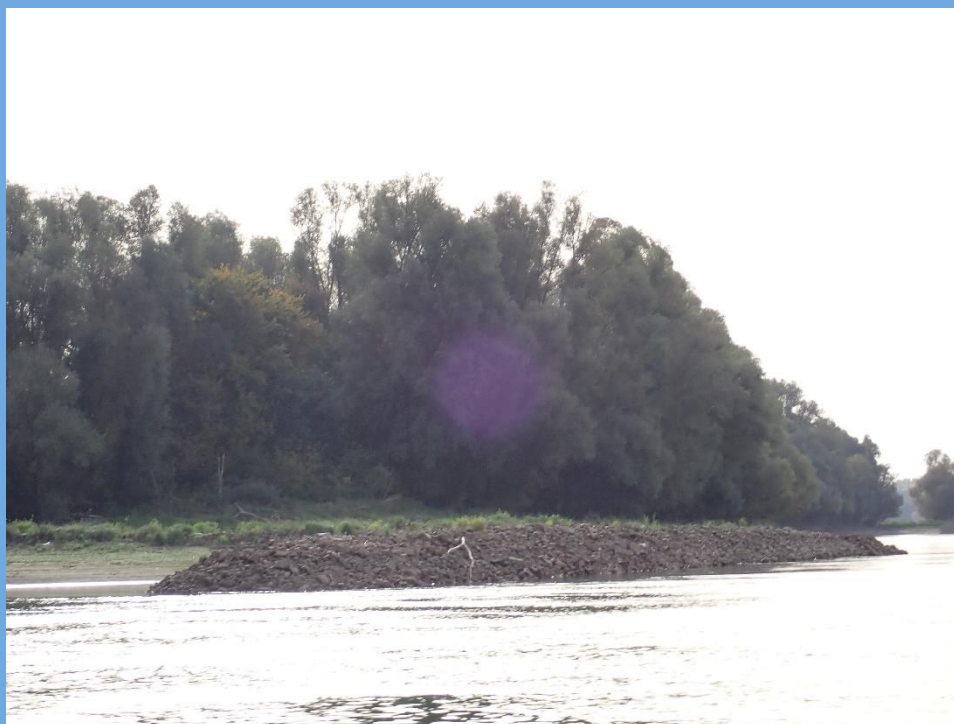
- Infrastructure is in good condition.
- Effect of material deposition ongoing (upstream, downstream).
- Groyne connection, head material and starting effect of material deposition upstream and downstream visible. Vegetation present on the groyne crown connection.

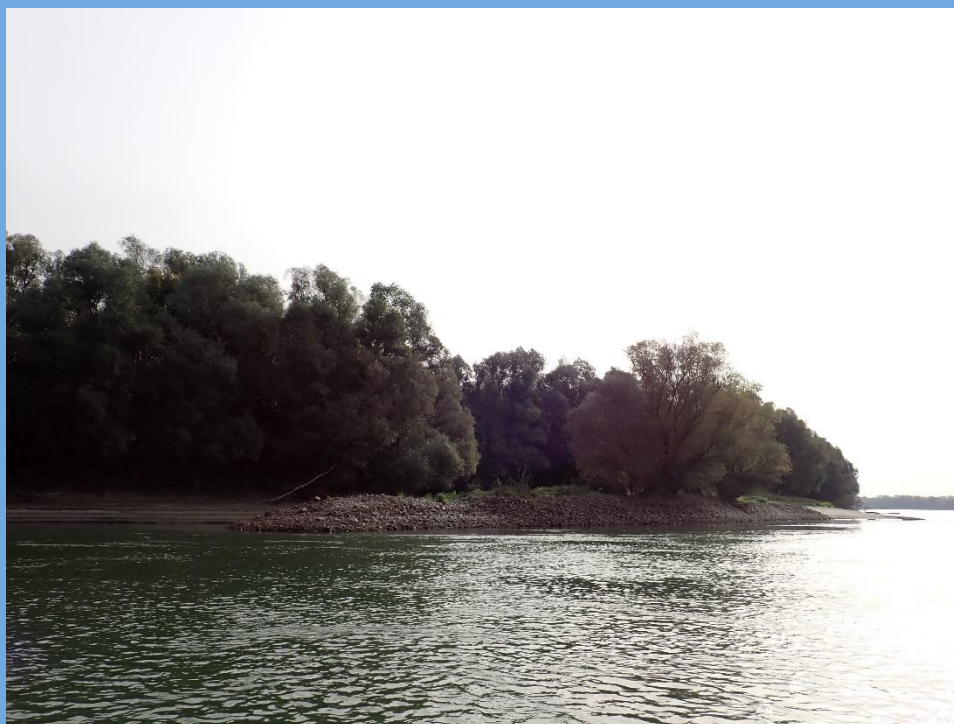
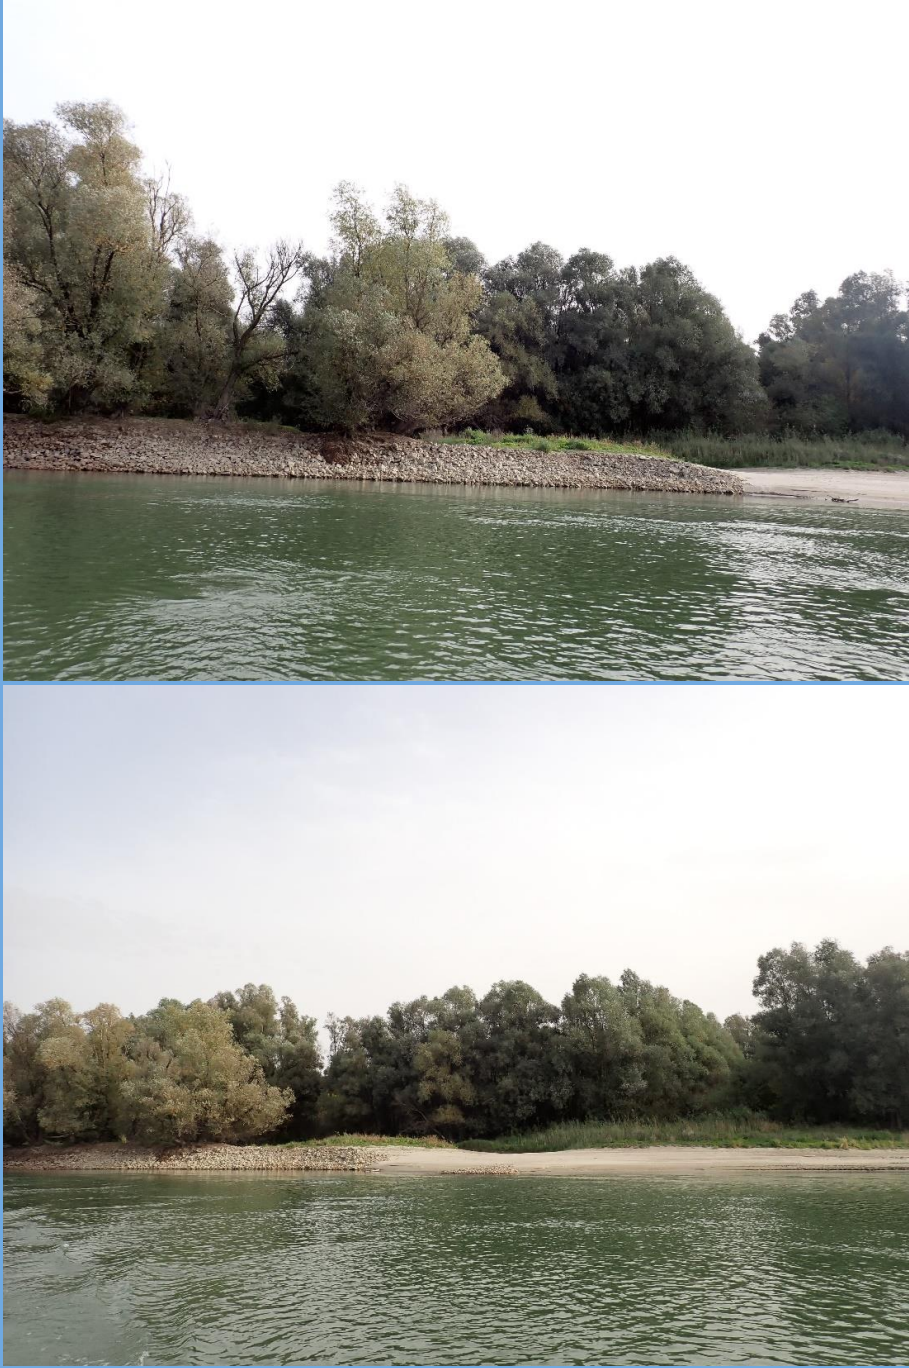
65. Left bank	Type:	Chainage (r.km)	Length (m)	Crown elevation (m.a.s.l.)
<b>1348-L1</b>	T-groyne	1348+577	86,19	79,05

- Infrastructure is in good condition.
- Effect of material deposition ongoing (upstream, downstream).
- Groyne connection and head material visible. Starting effect of material deposition upstream. Downstream effect of material deposition finished. Trees present on the groyne crown connection and head.

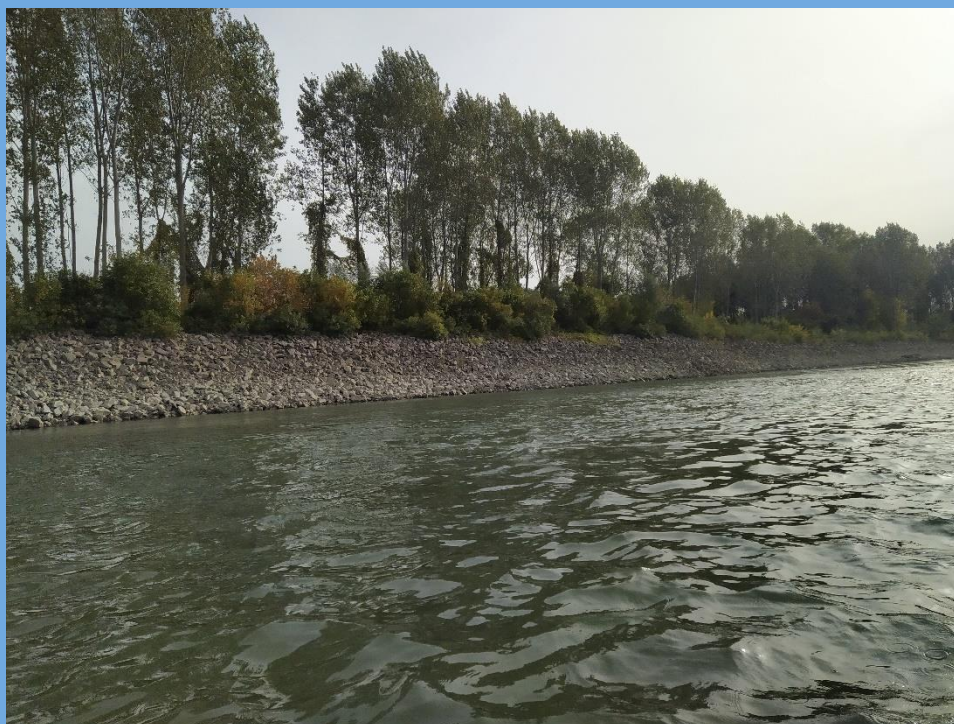
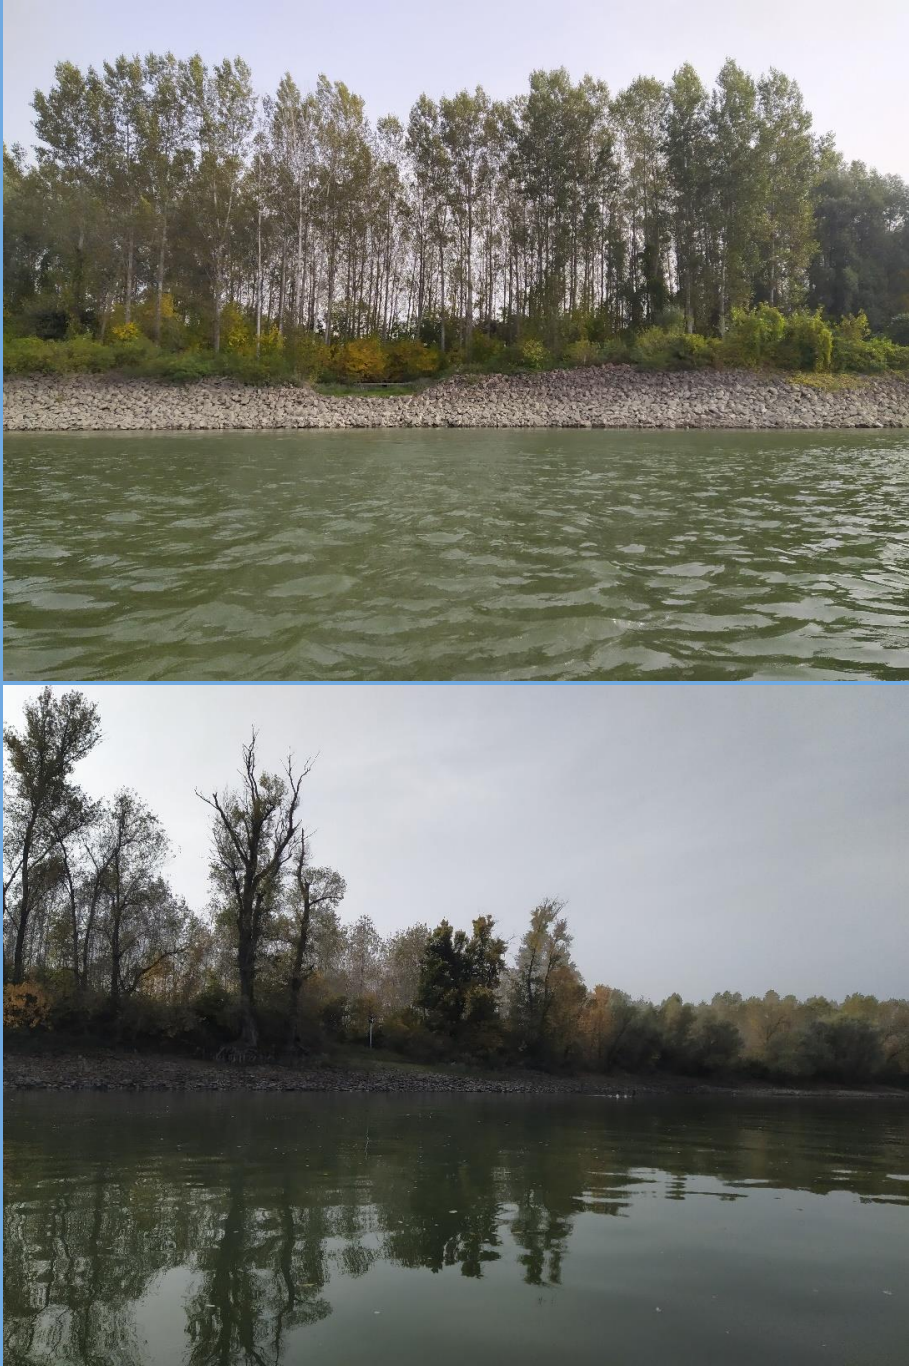
66. Left bank	Type:	Chainage (r.km)	Length (m)	Crown elevation (m.a.s.l.)
<b>1341-L1</b>	Revetment	1345+622 do 1341+684	5170,32	77,31

- Infrastructure is in excellent/bad condition.
- River bank erosion protection ongoing at medium water levels upstream from rkm 1345. Downstream from rkm 1345 river bank erosion protection failed.
- Upstream from rkm 1345, river bank erosion protection ongoing at medium water levels. Downstream from rkm 1345, the revetment is in bad condition, river bank erosion protection failed at low water levels.

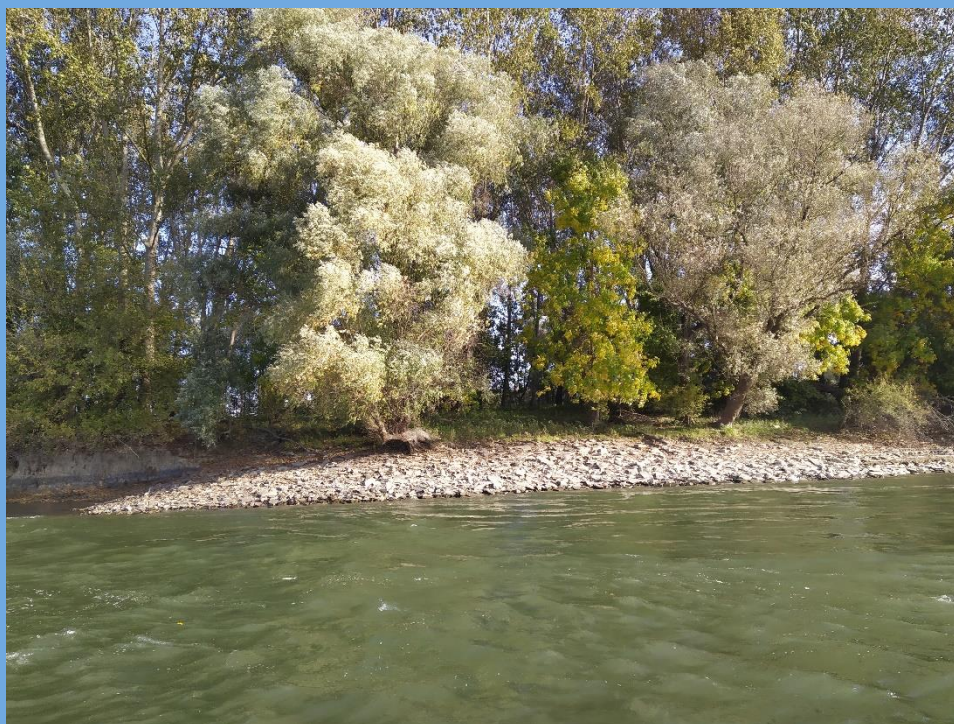
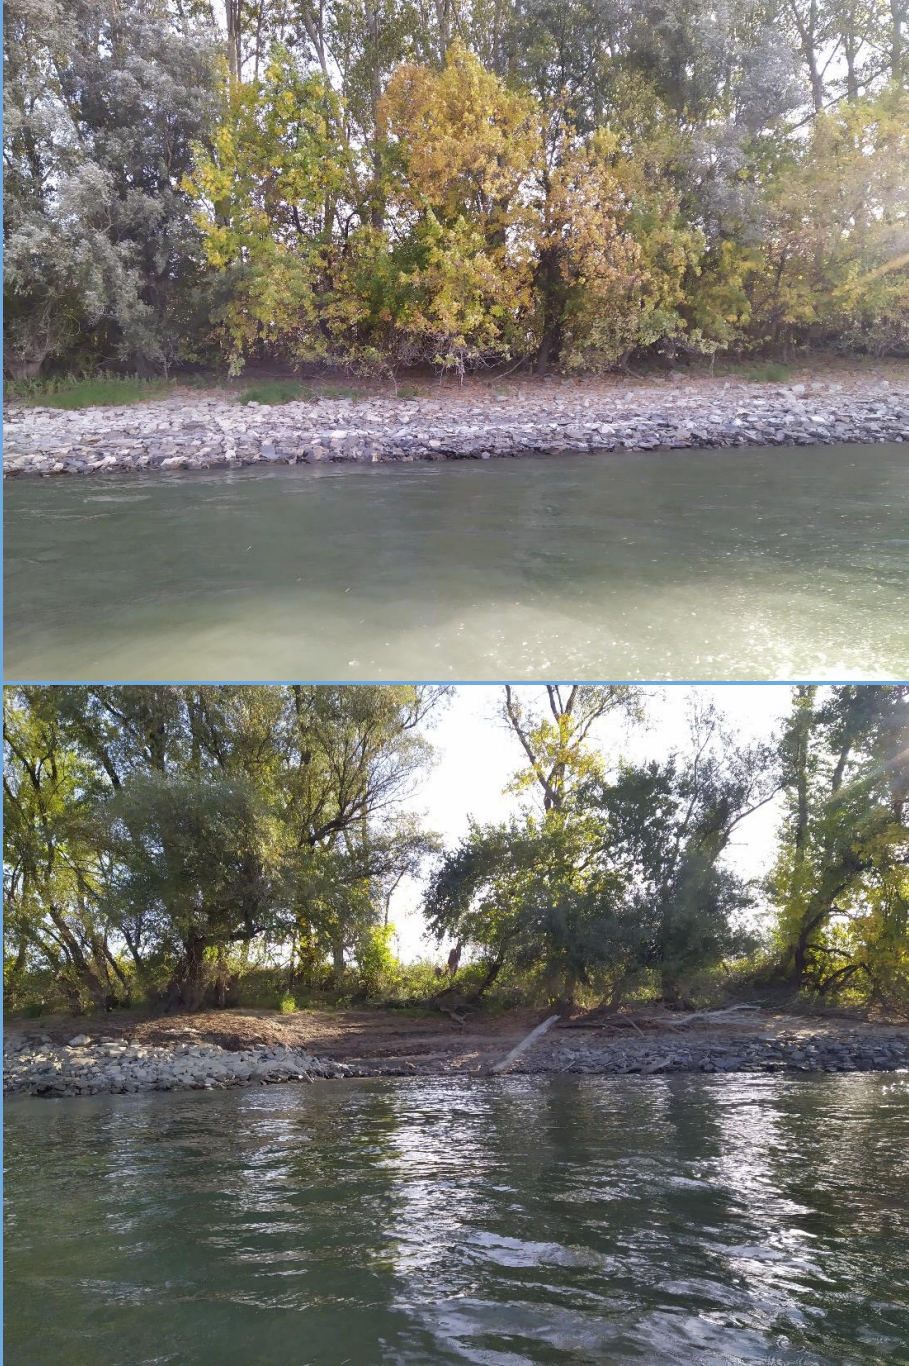
67. Left bank	Type:	Chainage (r.km)	Length (m)	Crown elevation (m.a.s.l.)
<b>1323-L1</b>	Revetment	1327+677 do 1323+925	3725,07	76,66

- Infrastructure is in satisfying condition.
- River bank erosion protection ongoing at low water levels.
- Revetment material visible at low water levels on the river side. River bank erosion behind revetment present. Vegetation present above the infrastructure.

46	It is not visible in "Cadastre"	1323-L1	No data	Revetment	1327+677 do 1323+925	3725,07	76,66	No data	No data	No data	No data	No data	Satisfying	River bank erosion protection ongoing at low water levels.	Revetment material visible at low water levels on the river side. River bank erosion behind revetment present. Vegetation present above the infrastructure.
47	1383/12 1383/11	1382-L2	2/11	Revetment	1383+971 do 1382+473	1309,07	78,10	No data	No data	No data	No data	No data	Bad	River bank erosion protection failed.	Stone revetment. River bank erosion behind revetment present. Visible material revetment at low water levels. Revetment in continuity.

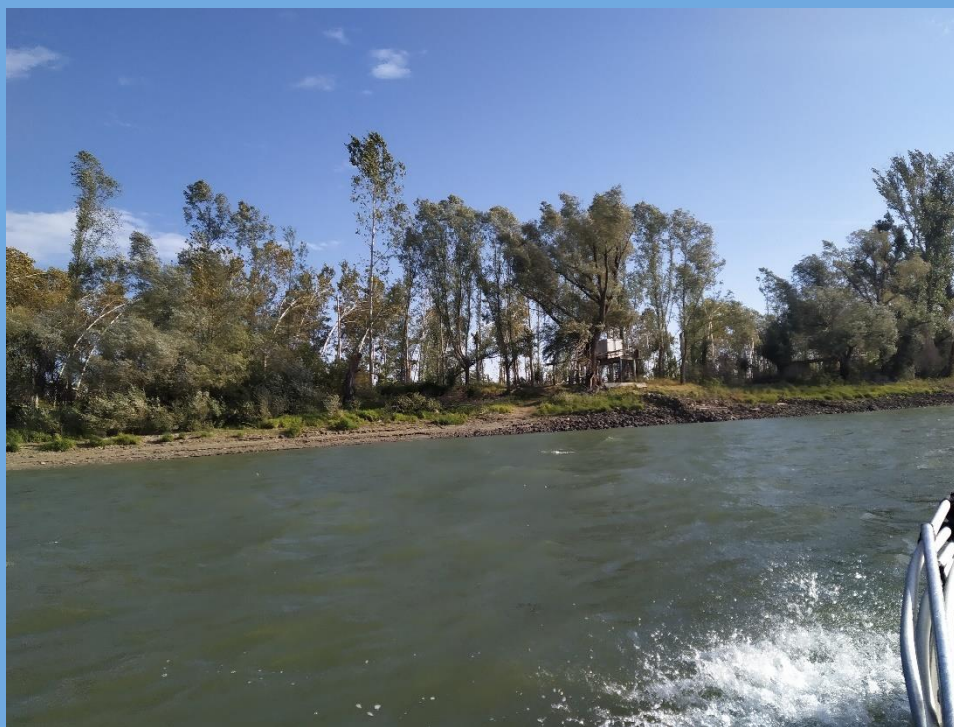
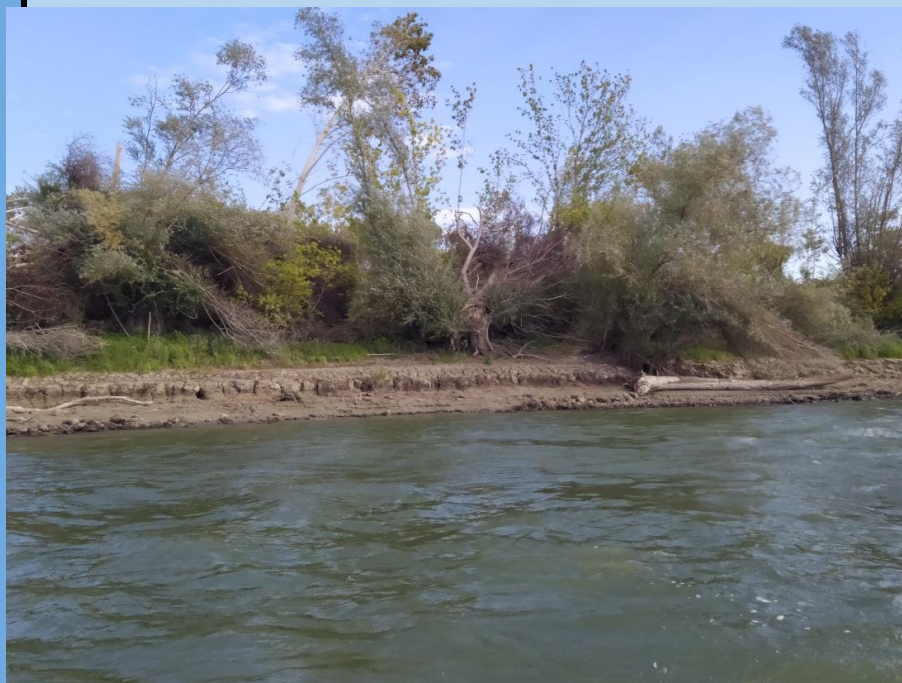
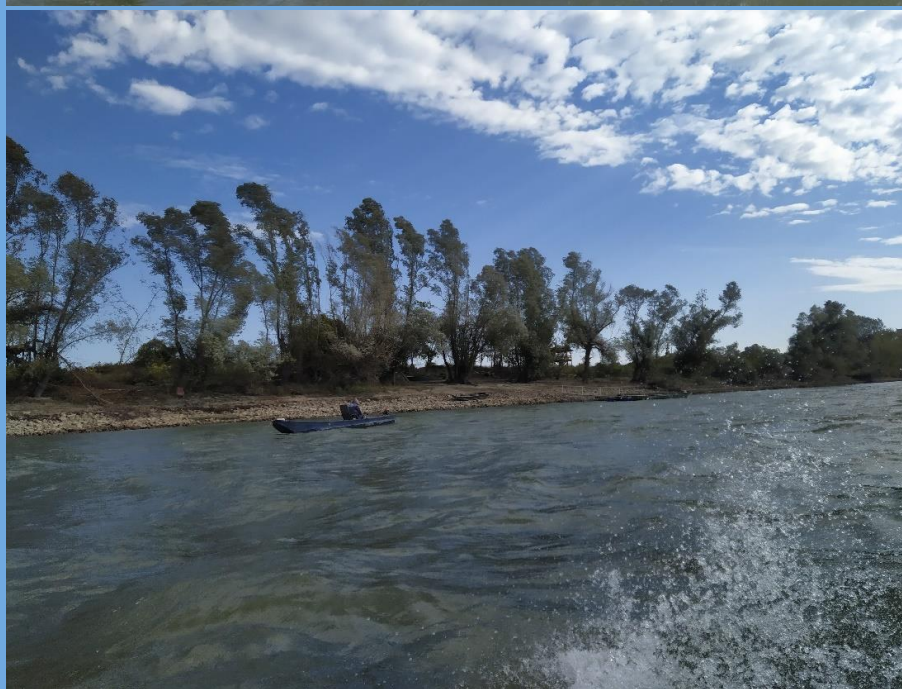
68. Left bank	Type:	Chainage (r.km)	Length (m)	Crown elevation (m.a.s.l.)
<b>1315-L1</b>	Revetment	1318+381 do 1315+187	3561,75	75,81

- Infrastructure is in bad condition.
- River bank erosion protection failed.
- Stone revetment. Visible material revetment. Vegetation and trees present above the infrastructure.
