**MONITORING OF HYDROLOGICAL, HYDRAULIC AND MORPHOLOGICAL CHARACTERISTICS OF THE DANUBE RIVER AND INVENTORY OF BIODIVERSITY COMPONENTS ON THE JOINT CROATIAN-SERBIAN SECTOR OF THE DANUBE RIVER**

**INVENTORY OF RIVER REGULATION INFRASTRUCTURE RELATED TO NAVIGATION**

**Project number:** I-2206/24

**LOCATION:** Danube river from rkm 1295,5 (Ilok) to rkm 1433,1  
(border with Hungary)

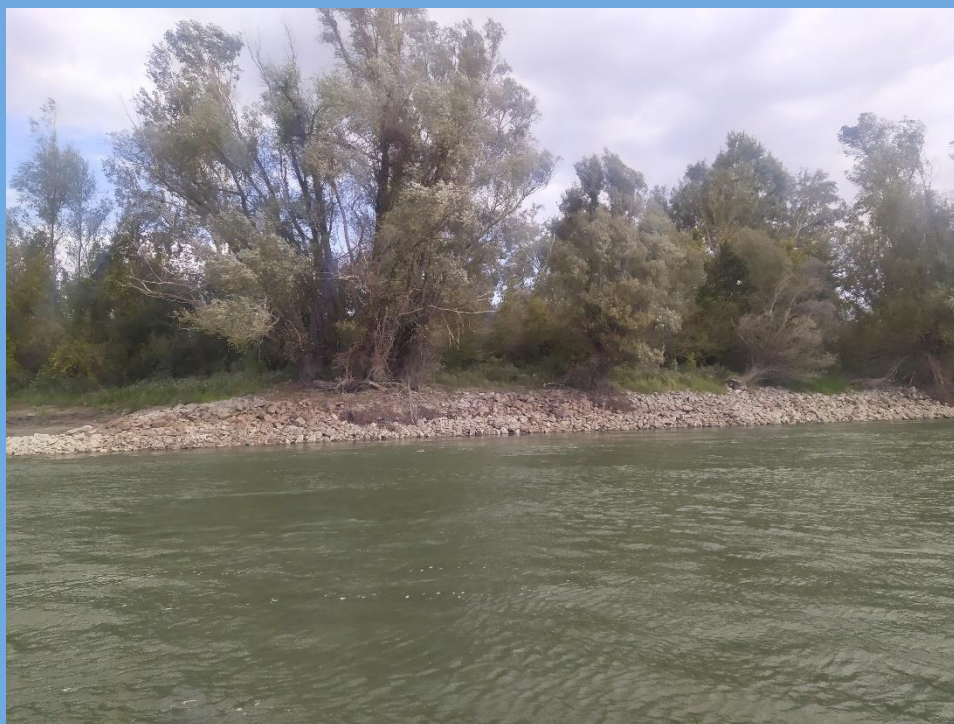
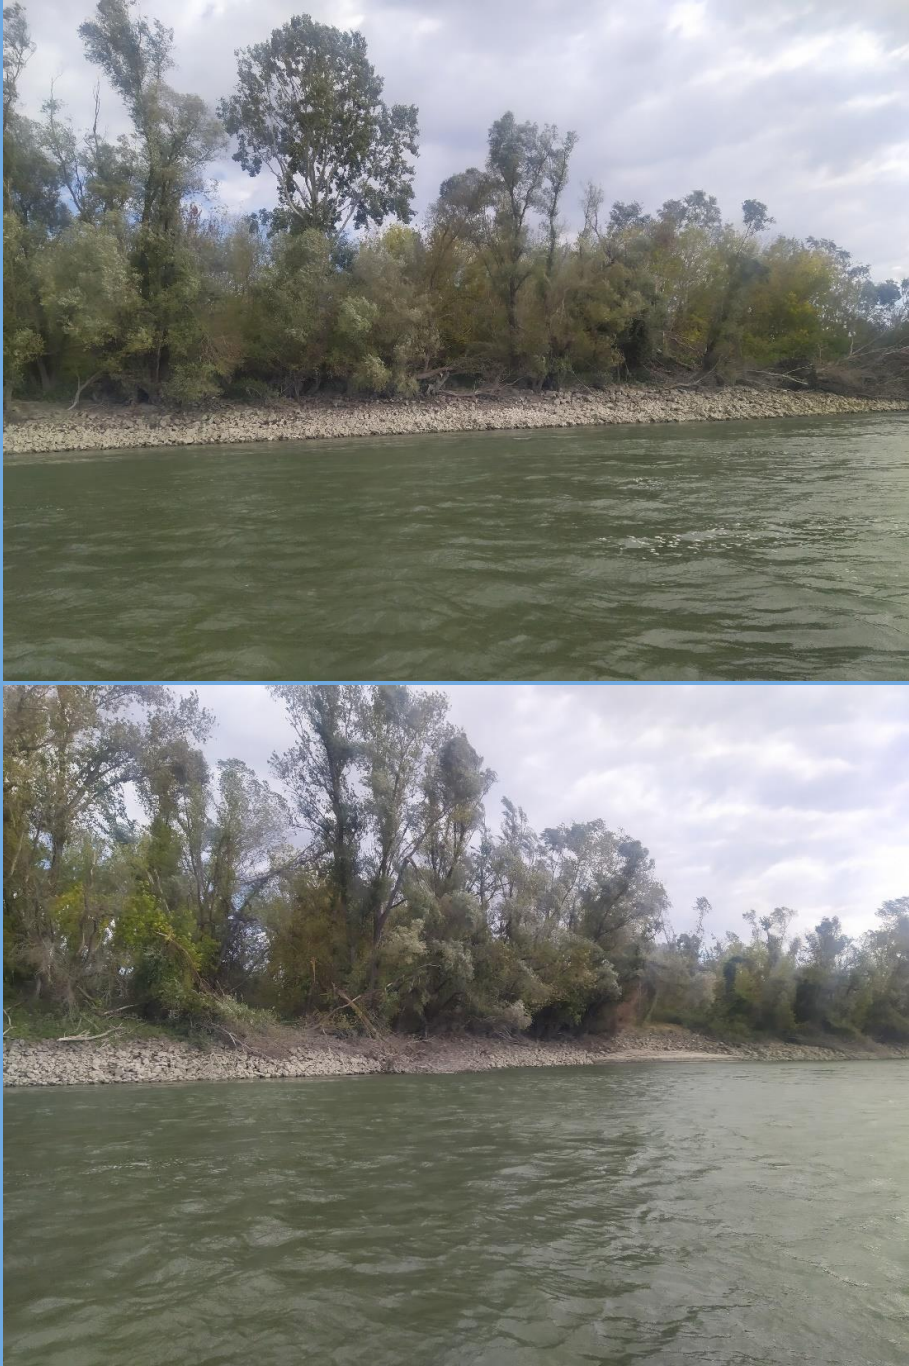
69. Left bank	Type:	Chainage (r.km)	Length (m)	Crown elevation (m.a.s.l.)
<b>1308-L1</b>	Revetment	1309+840 do 1308+617	1468,76	75,55

- Infrastructure is in good condition.
- River bank erosion protection ongoing at low water levels.
- Stone revetment. Visible material revetment. Vegetation and trees present above the infrastructure.

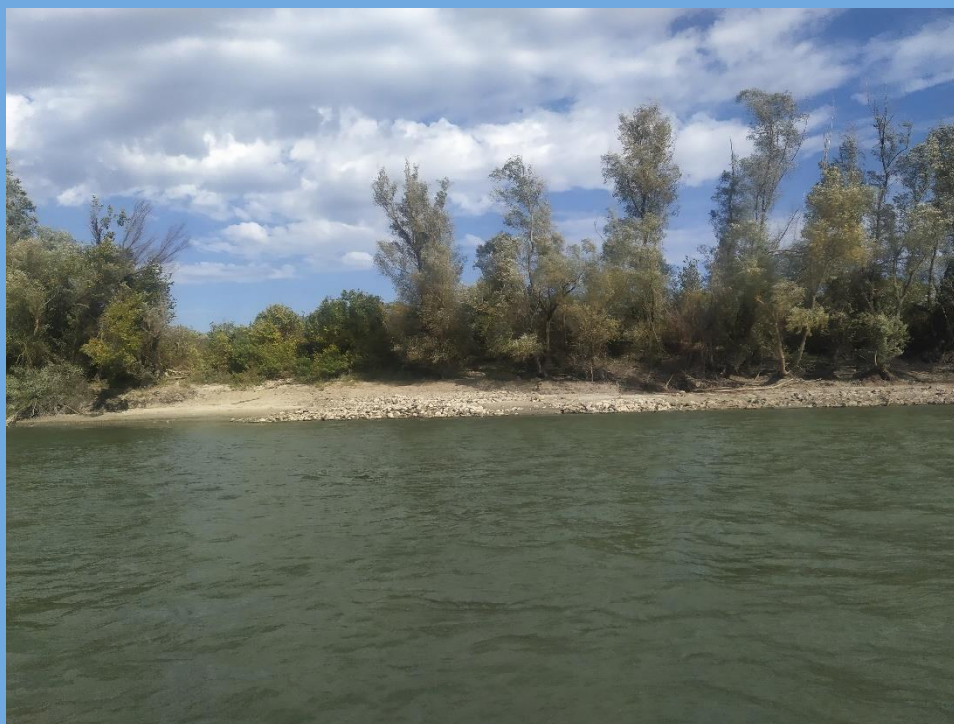
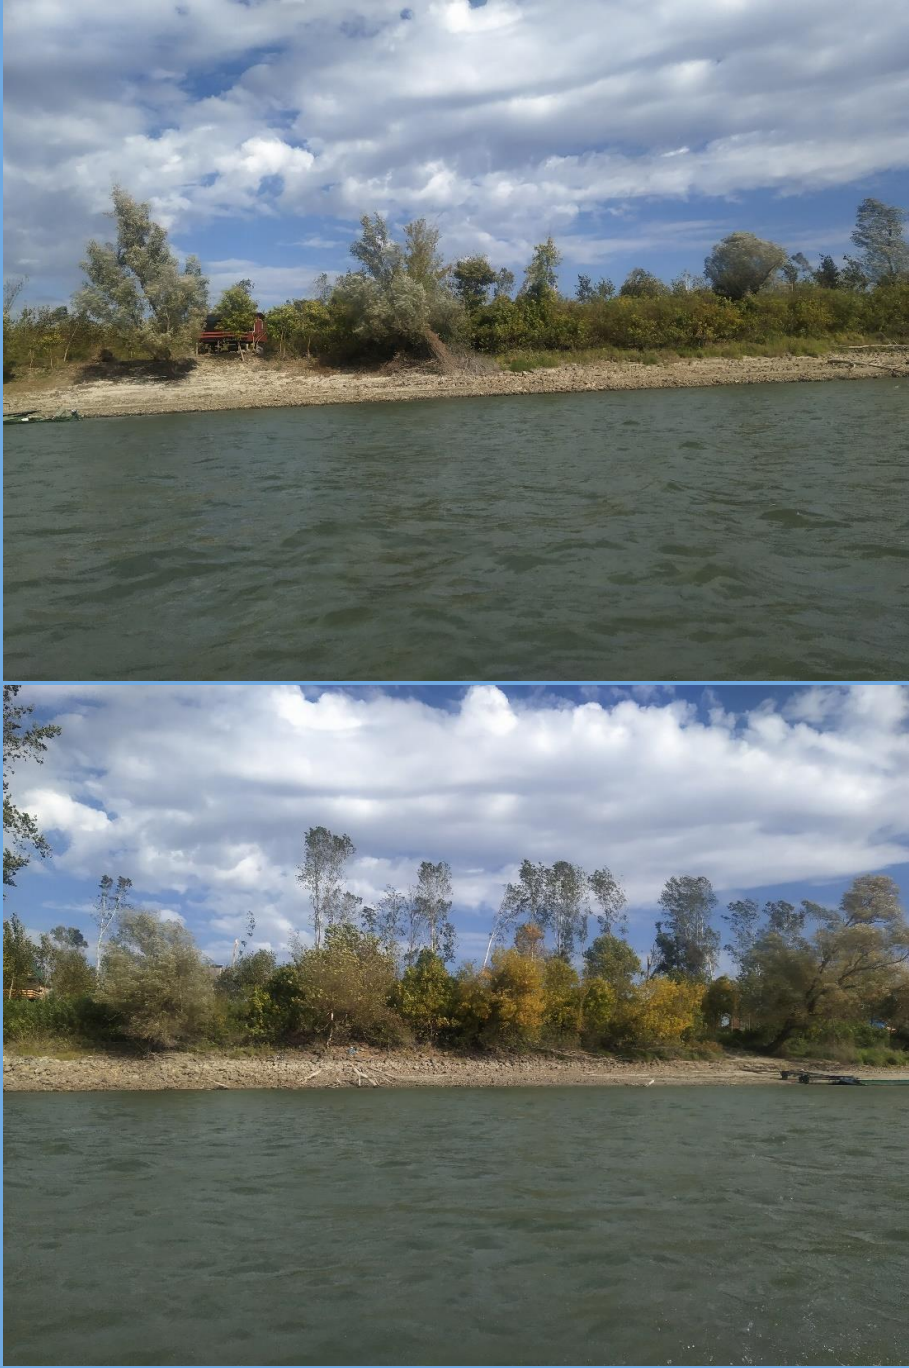
70. Left bank	Type:	Chainage (r.km)	Length (m)	Crown elevation (m.a.s.l.)
<b>1305-L1</b>	Revetment	1308+282 do 1305+842	2249,99	75,39

- Infrastructure is in bad condition.
- River bank erosion protection failed.
- Stone revetment. Visible material revetment at low water levels. Part of the revetment is washed away, visible material behind from the river side.

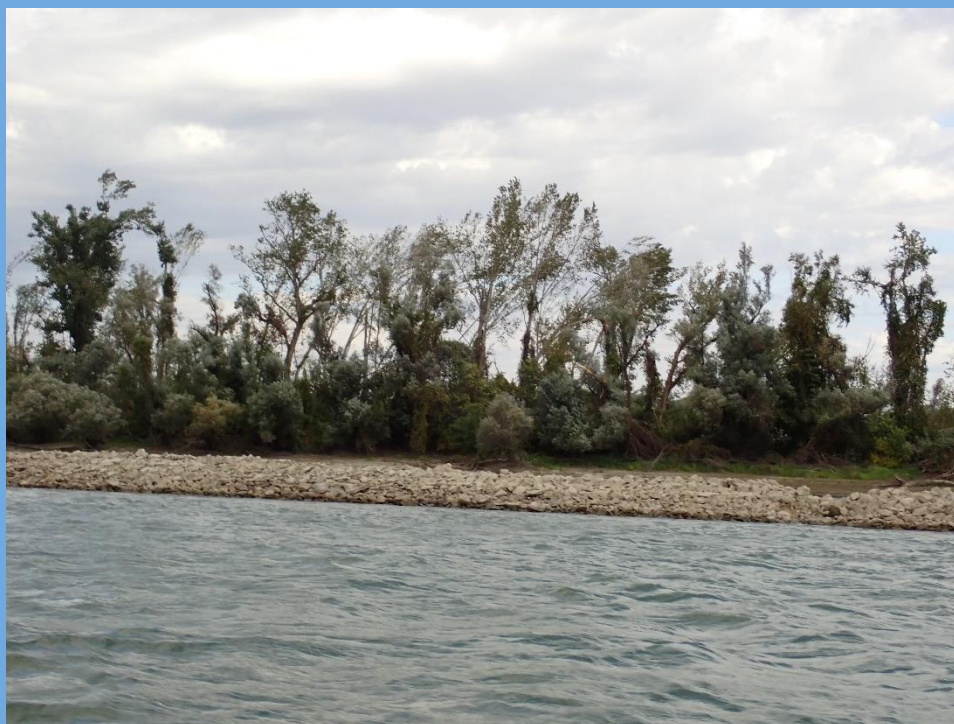
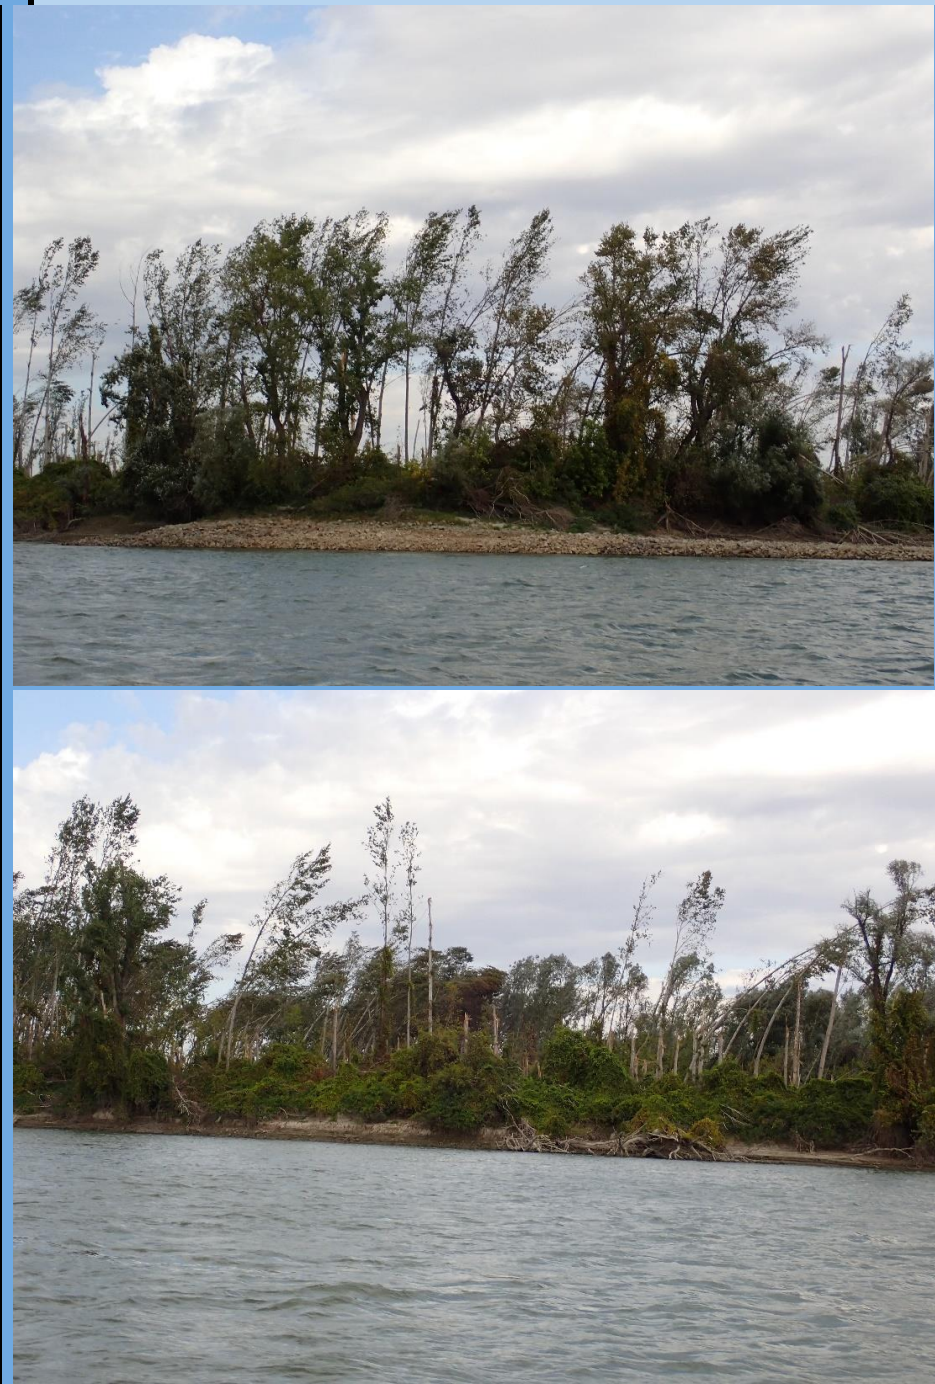
71. Left bank	Type:	Chainage (r.km)	Length (m)	Crown elevation (m.a.s.l.)
<b>1300-L1</b>	Revetment	1300+805 do 1300+116	746,58	75,34

- Infrastructure is in bad condition.
- River bank erosion protection failed.
- Stone revetment. River bank erosion behind revetment present. Revetment material visible at low water levels on the river side.

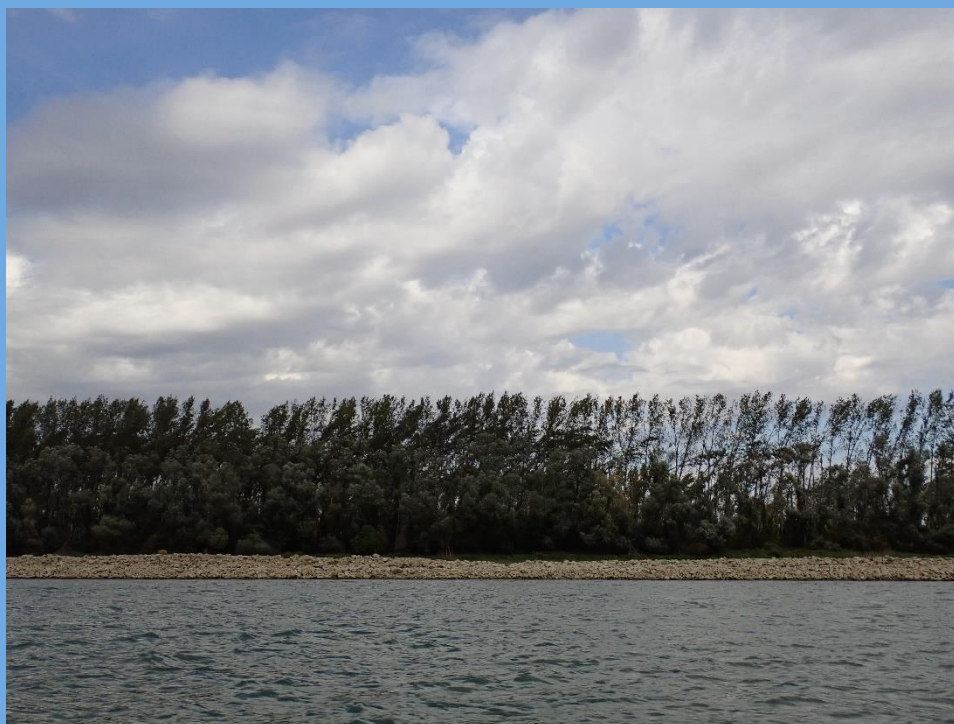
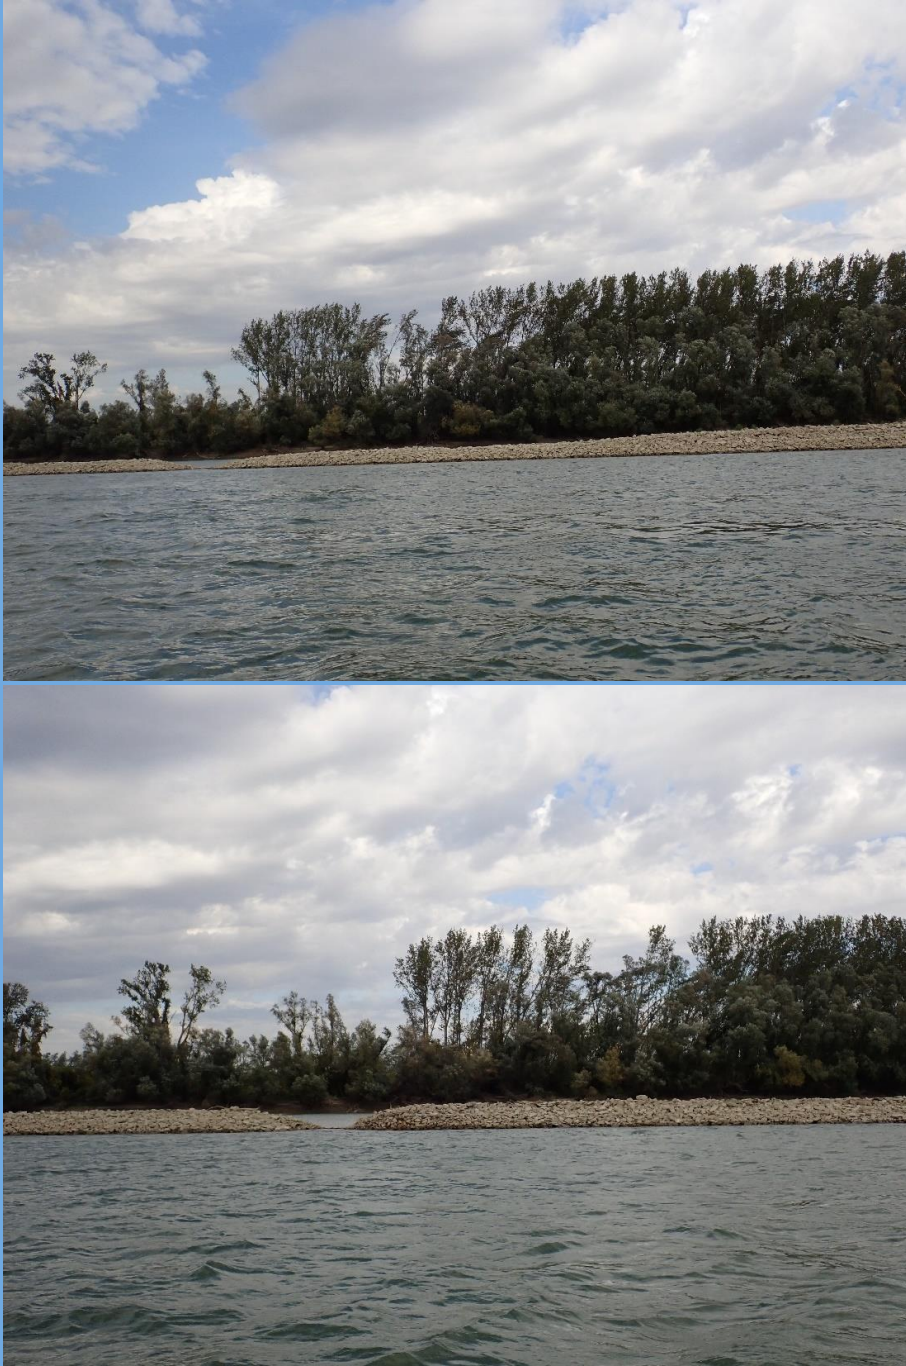
72. Left bank	Type:	Chainage (r.km)	Length (m)	Crown elevation (m.a.s.l.)
<b>1299-L1</b>	Parallel structure	1300+116 do 1299+648	527,23	75,35

- Infrastructure is in satisfying condition.
- Effect of material deposition ongoing (upstream, downstream).
- Material on the parallel structure visible. Crown elevation it is not in continuity.

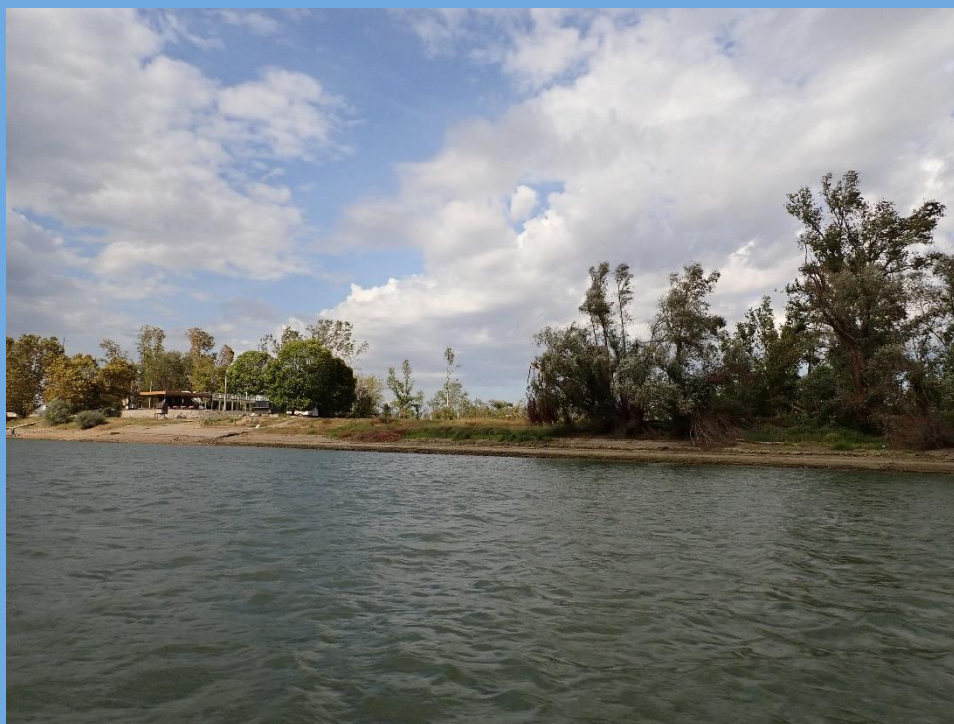
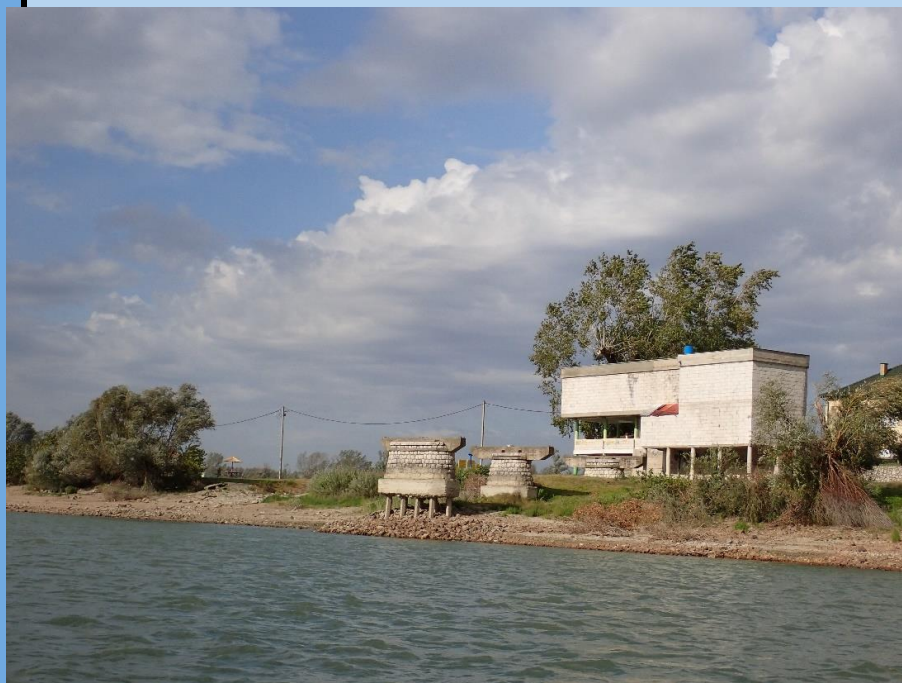
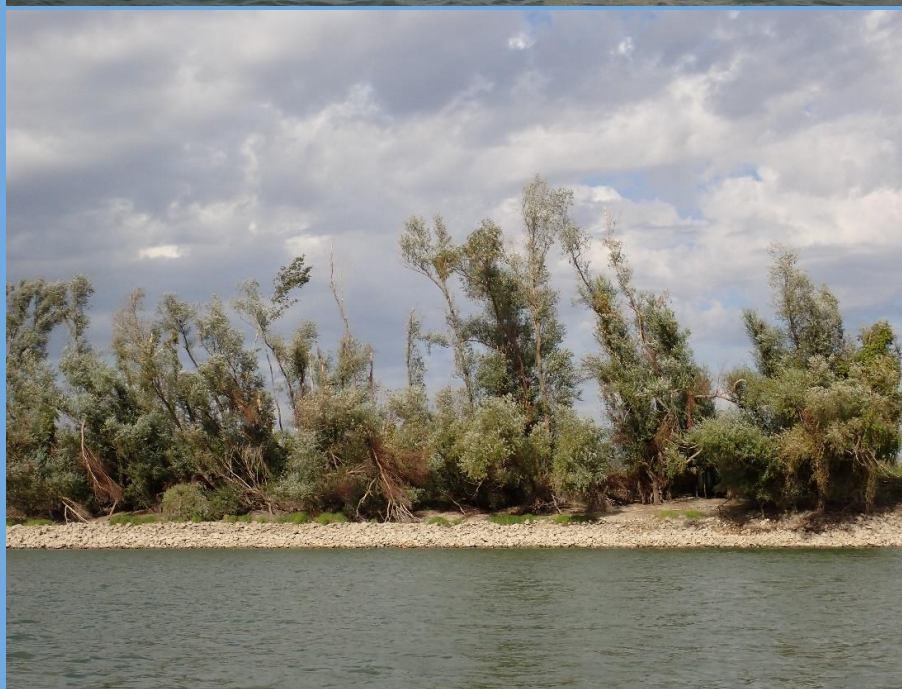
73. Left bank	Type:	Chainage (r.km)	Length (m)	Crown elevation (m.a.s.l.)
<b>1298-L1</b>	Revetment	1299+648 do 1298+275	1426,43	76,34

- Infrastructure is in bad condition.
- River bank erosion protection failed.
- Stone revetment. River bank erosion behind revetment present. Revetment material visible at low water levels on the river side.

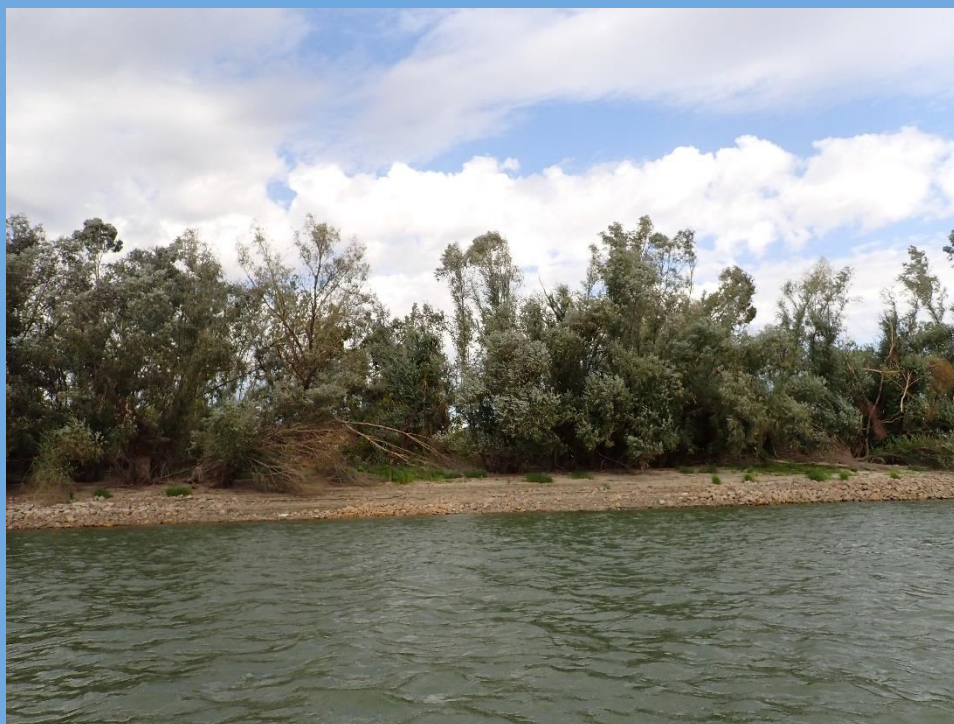
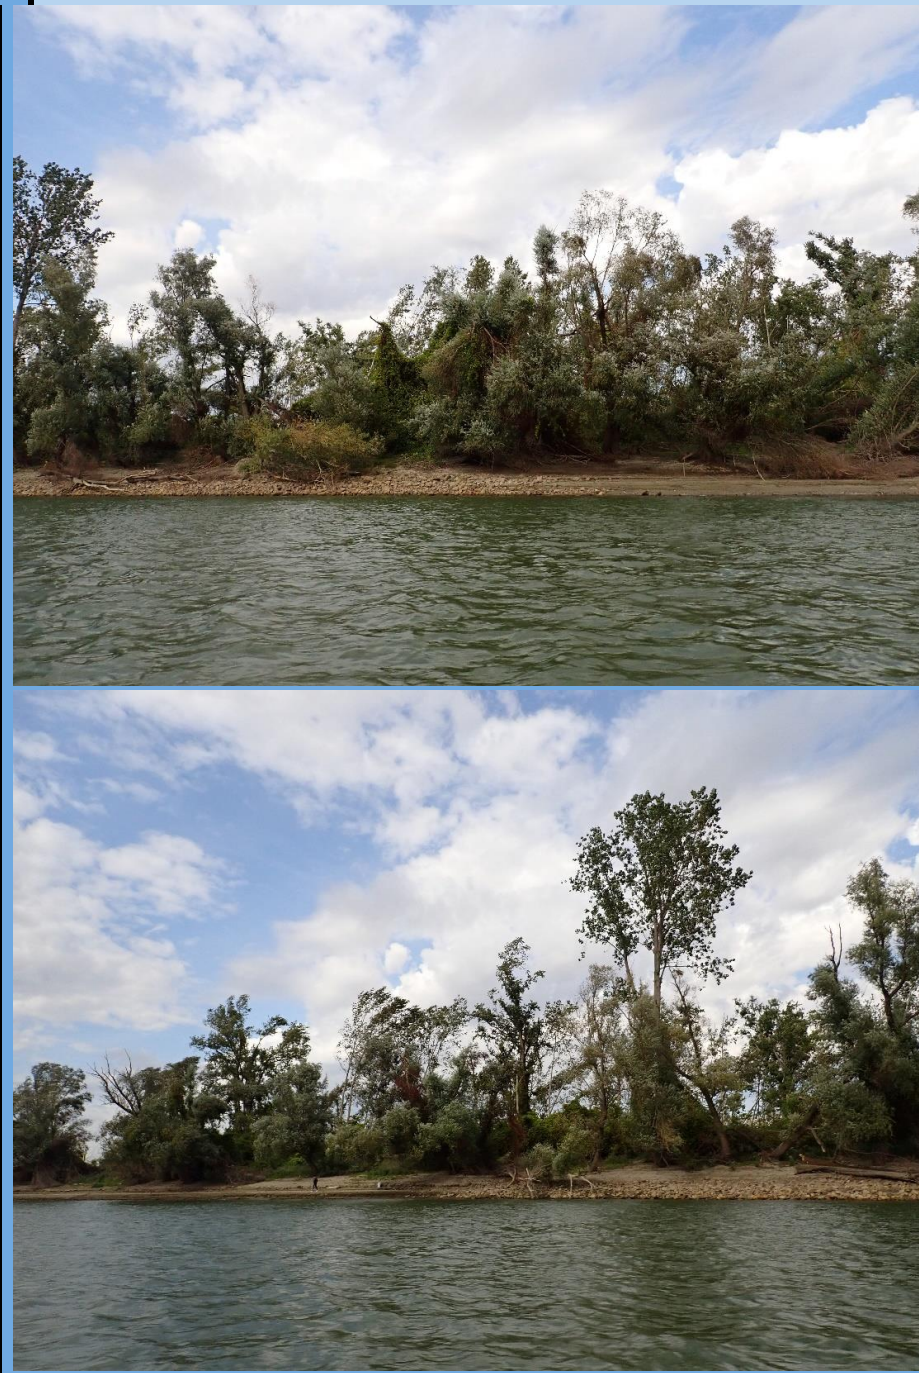
74. Left bank	Type:	Chainage (r.km)	Length (m)	Crown elevation (m.a.s.l.)
<b>1297-L3</b>	T-groyne	1297+889	252,48	75,94

- Infrastructure is in satisfying condition.
- Effect of material deposition finished (upstream, downstream).
- Groyne head material and vegetable on groyne crown visible. Downstream and upstream effect of material deposition finished. Connected with groyne head 1297-L2.

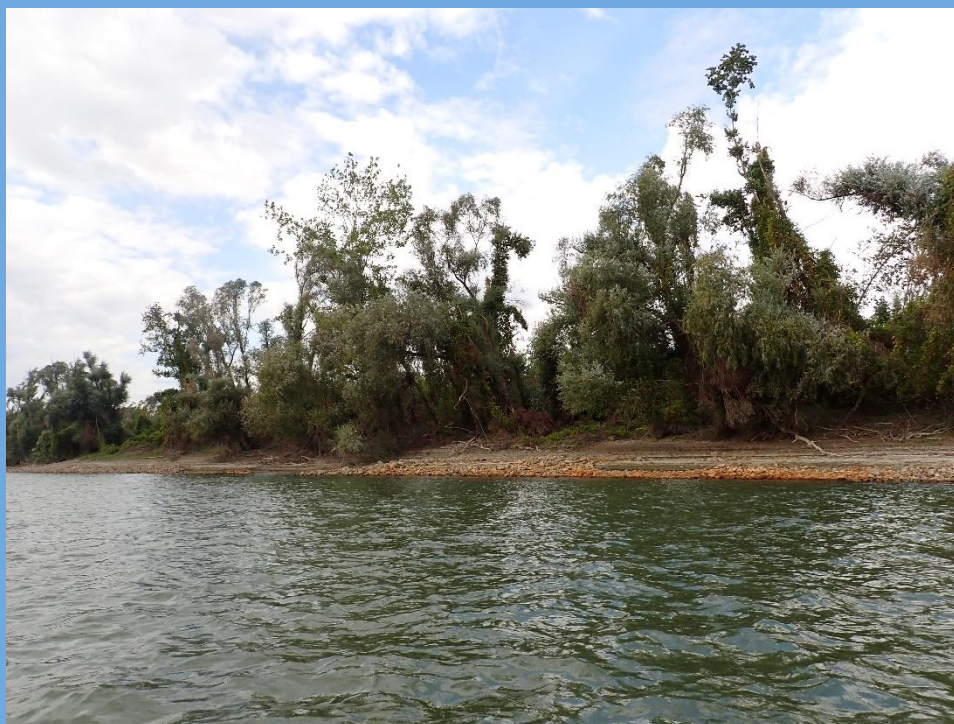
- Infrastructure is in satisfying condition.
- Effect of material deposition finished (upstream, downstream).
- Groyne head material and vegetable on groyne crown visible. Downstream and upstream effect of material deposition finished. Connected with groyne head 1297-L3.

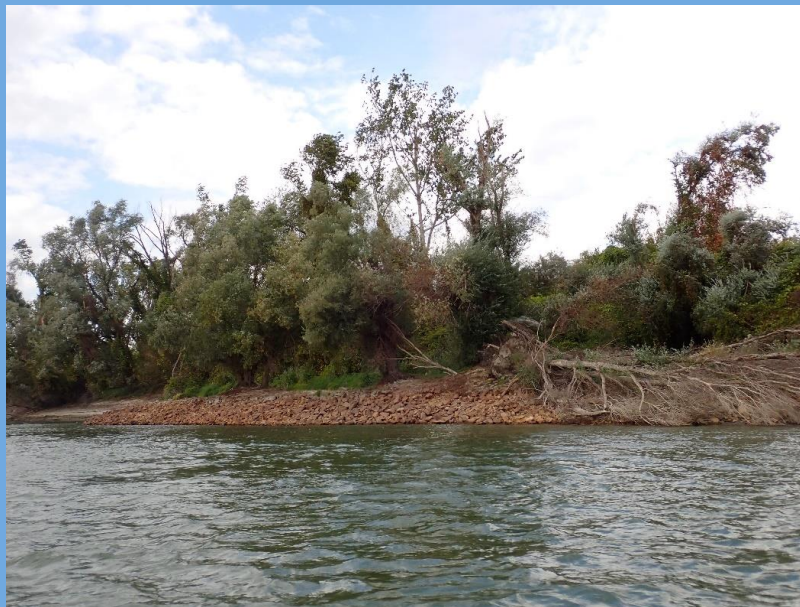
- Infrastructure is in good condition.
- Effect of material deposition ongoing (downstream).
- Groyne head material and vegetation on groyne crown visible. Downstream and upstream effect of material deposition ongoing.

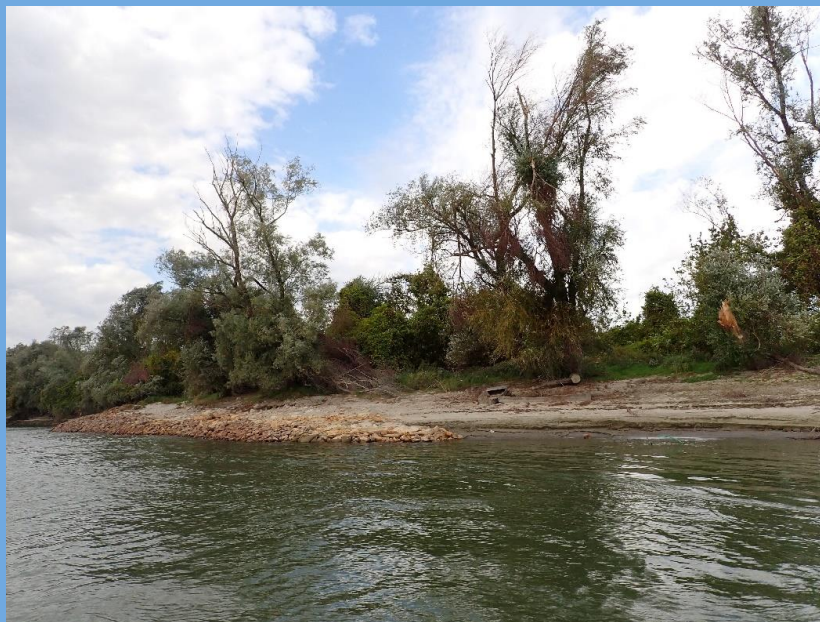
- Infrastructure is in good condition.
- Effect of material deposition ongoing (downstream).
- Groyne head material and vegetable on groyne crown visible. Downstream and upstream effect of material deposition ongoing.

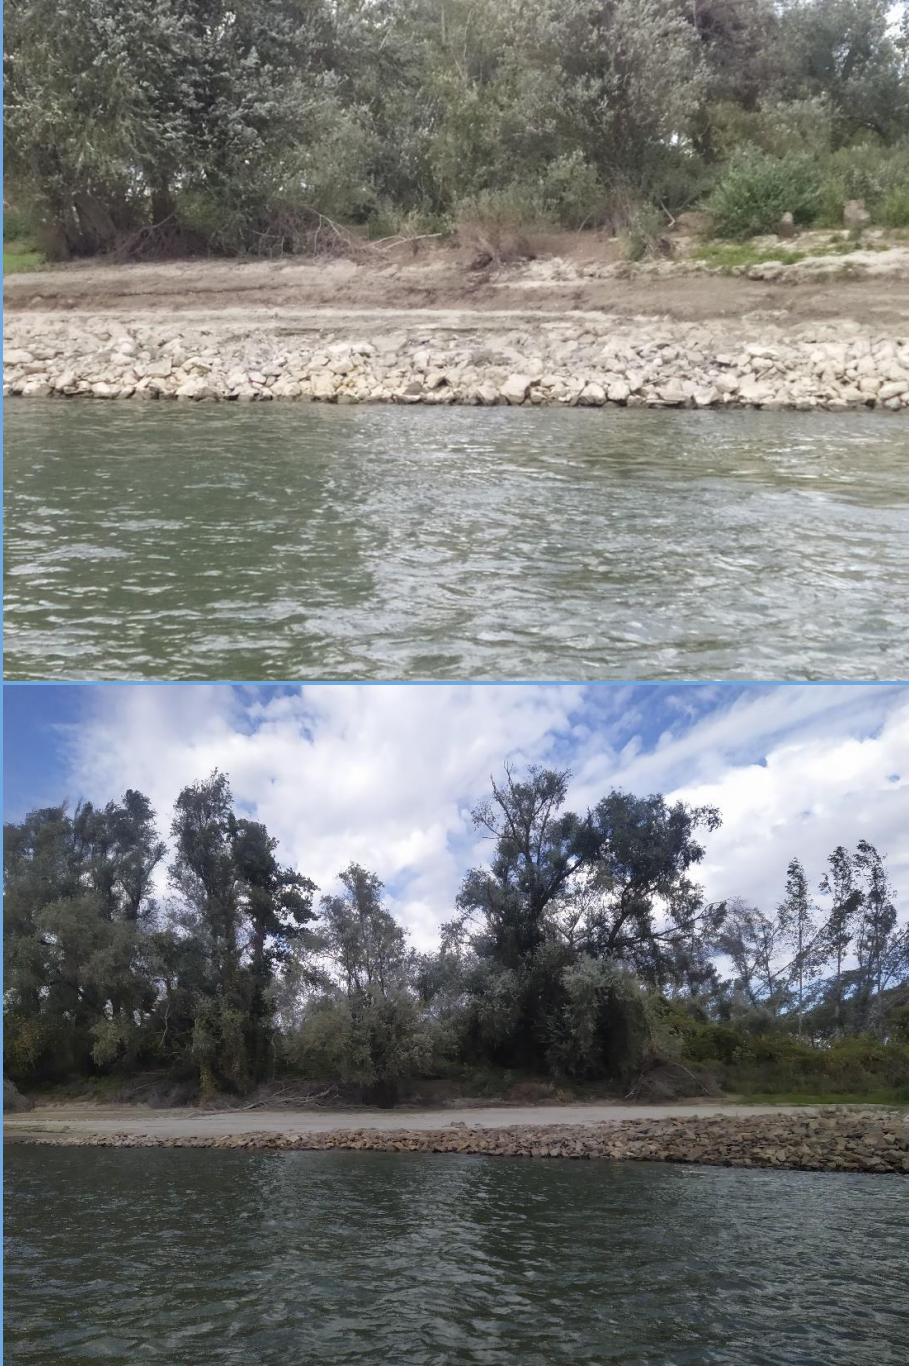
78. Left bank	Type:	Chainage (r.km)	Length (m)	Crown elevation (m.a.s.l.)
<b>1296-L1</b>	T-groyne	1296+413	285,83	75,24

- Infrastructure is in good condition.
- Effect of material deposition ongoing (downstream).
- Groyne head material and vegetable on groyne crown visible. Downstream and upstream effect of material deposition ongoing.
